ENGINE - TRANSFER GEARBOX MODULE (72-62-00) - REPETITIVE INSPECTION OF TGB SCAVENGE SCREENS

SERVICE BULLETIN

This Service Bulletin is applicable to all CFM LEAP-1B engines: LEAP-1B21, -1B23, -1B25, -1B27, -1B28, -1B28B1, -1B28B2, -1B28B2C, -1B28B3, -1B28BBJ1, -1B28BBJ2.

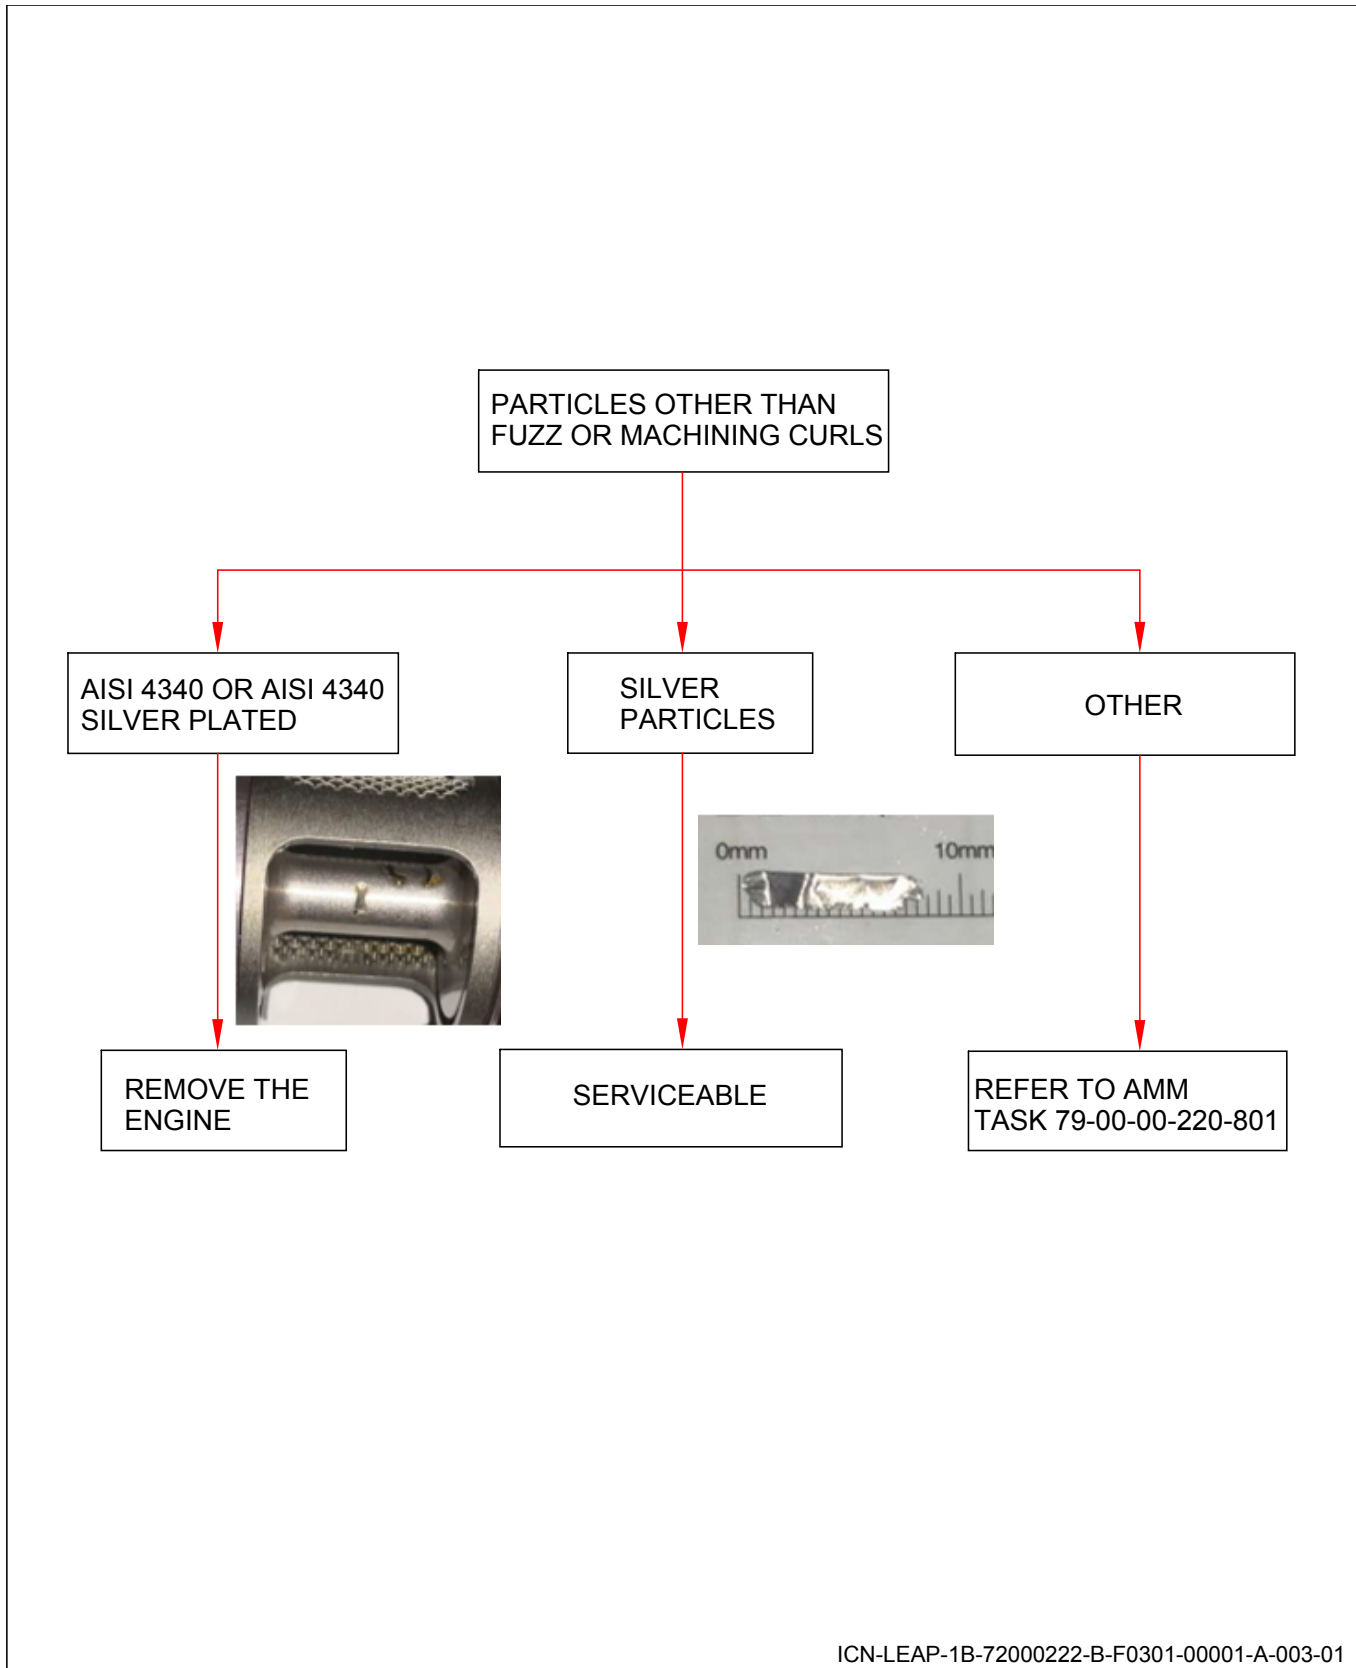
TGB Screen Decision
Figure 1

- (2) RC - If metallic particles are found, other than normal fuzz (Any quantity of material that is less than or equal to 0.004 in (0.1 mm)) or machining curls, identify the nature of the particles and send the particles for laboratory analysis, if necessary.

NOTE: It is not necessary to send the particles to laboratory for analysis if there are:
Non-magnetic particles - checked with magnet.
Evidence of silver particles.

(a) Silver Particles: Serviceable.

(b) AISI4340 or AISI4340 Silver Plated (magnetic): Remove the engine.

(c) Other: Refer to **AMM**, TASK 79-00-00-220-801.

- (4) RC - As soon as the particles nature is identified, follow these steps for the material you find: Refer to **Figure 1**.

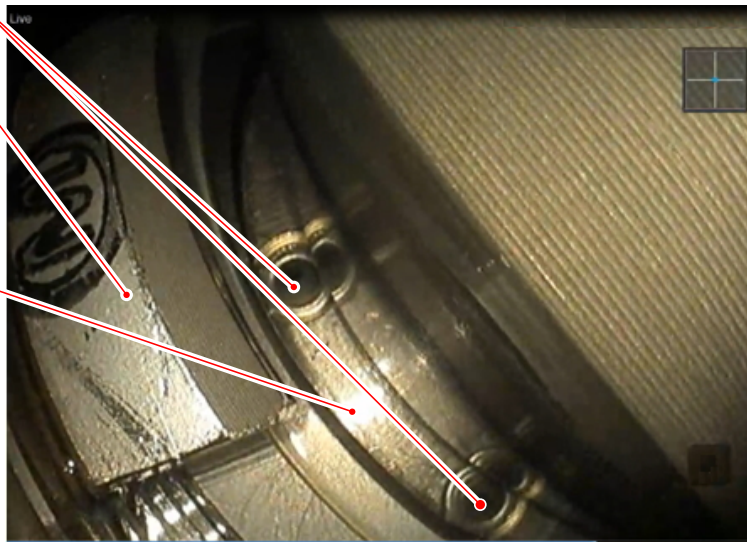
RDS Bearing
Figure 8

(g) Once the **BSI** lens has gone all the way until the end of the **RDS** scavenge hole, it will reach the **RDS** bearing (See **Figure 8**). Do the inspection of the **RDS** bearing as follows. Rotate the N2 rotor while you do the inspection in order to have a 360° view of **RDS** bearing cage. Refer to the **AMM**, 72-00-00, TASK 72-00-00-910-801-G00.

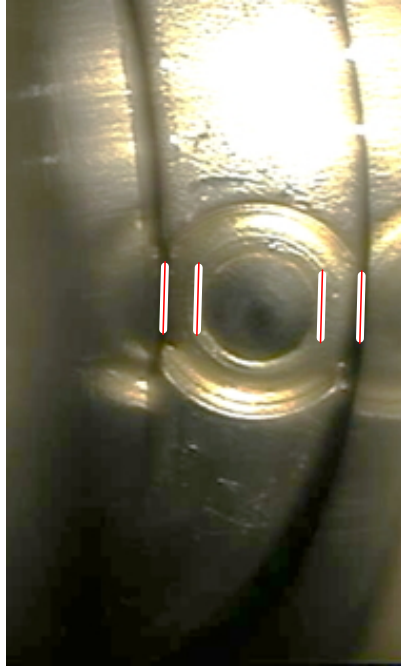
1 SATISFACTORY condition (See **Figure 9**):

Oil coke traces are not visible on the cage.

Burrs or missing material is not visible on the cage inner diameter.

SATISFACTORY
RIVET CENTERED ON THE
CAGE - NO OIL COCKING

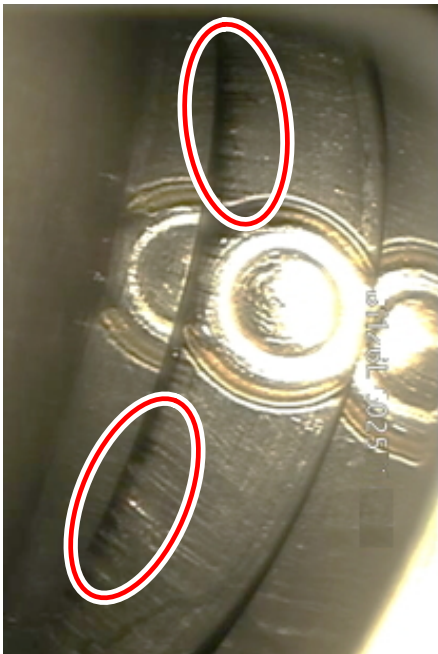
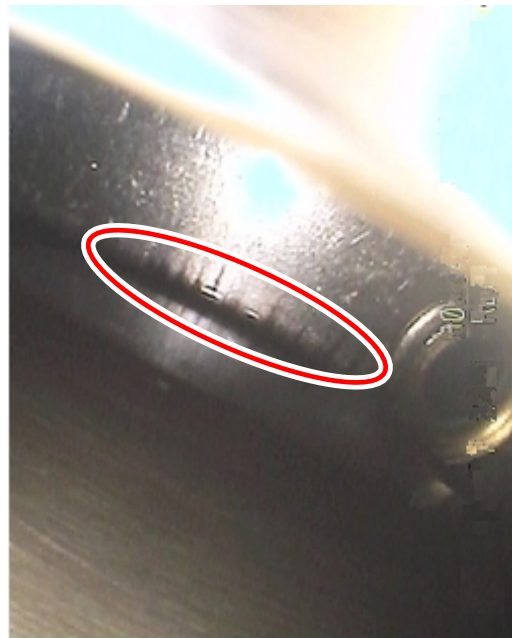
*RDS Bearing Inspection
Figure 9 (Sheet 1 of 2)*

2 UNSATISFACTORY condition (See **Figure 9**):

- Oil coke traces on the cage.

UNSATISFACTORY - DARK TRACES

Refer to paragraph 3.E. for further instructions.

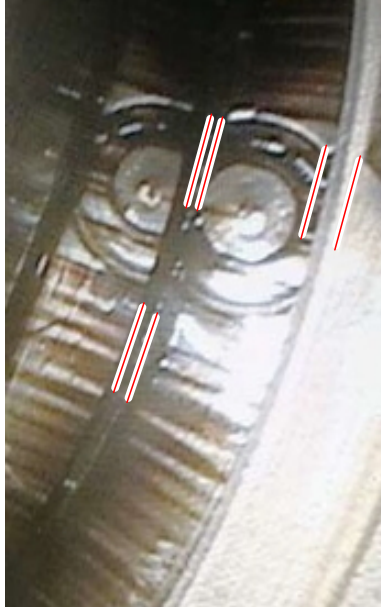
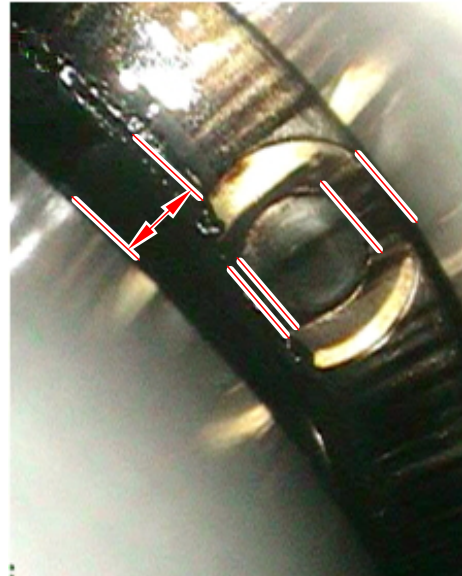
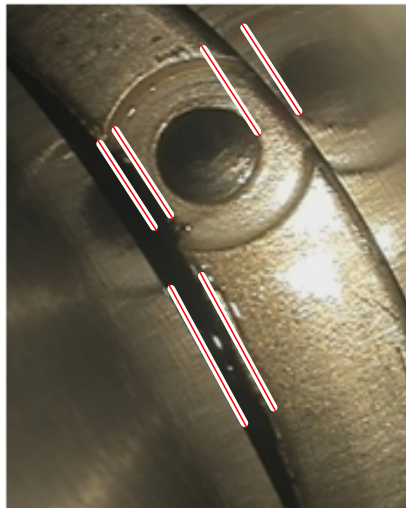
*RDS Bearing Inspection
Figure 9 (Sheet 2 of 2)*

- Burrs or missing material on cage inner diameter.

UNSATISFACTORY - MISSING MATERIAL

CLEARANCE ON CAGE INNER
DIAMETER - RIVET DECENTERED
