ALERT OPERATORS TRANSMISSION - AOT

SUBJECT: ATA 25 – Slide raft and Escape slide reservoir pressure check

AIRCRAFT TYPE: A318,A319,A320,A321

OUR REF.: A25N019-19 Rev 00 dated 23-DEC-2019

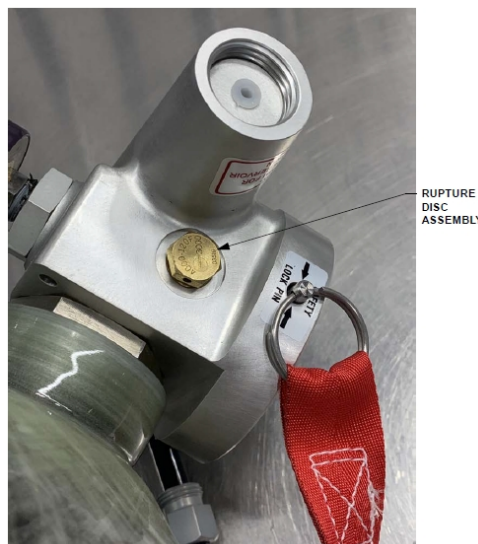
Figure1: Example of the location of Rupture Disc on reservoir

The rupture disc assembly is part of a safety feature installed in the slide pressure reservoir valve, which is activated in high pressure conditions and releases gas to prevent the reservoir from being damaged under high pressure conditions. The burst disc has a pre-defined value at which it is activated (approx. 4200 - 5000 psig at 160° F).

One instance of loud bang on aircraft from the field was reported and was confirmed resulting from the activation of the rupture disc fitted on the slide reservoir.

In the reported case, the inspection team found the slide reservoir pressure indicating “Zero” pressure.

Investigation has shown that the rupture disc assemblies manufactured between April 2017 and March 2019 could potentially be activated below their designed activation pressure of 4200 – 5000 psig at 160°F.

The failure of the rupture disc will result in a sudden loss of the reservoir pressure and the slide will remain unusable. Slide with depleted gas reservoir will not function in case of emergency as per CCOM Ref. 8.

All the A320 family operators having slide raft or escape slide (except for the offwing emergency exit door) not connected to CIDS for pressure monitoring in Flight Attendant Panel (FAP) are recommended to perform repetitive visual inspections of reservoir pressure in accordance with AMM Ref. 1.

The interval of the repetitive check is 50 days or 100 Flight Cycles (FC), whichever occurs first.

In case of slide reservoir pressure not found in line with AMM Ref. 1, either apply MMEL Ref. 6 or MMEL Ref. 7 or replace the slide or reservoir prior next flight as per:
