ALERT SERVICE BULLETIN

PROTECTIVE MEASURE
TAIL ROTOR DRIVE – Tail Gear Box (TGB)
Checking there is no oil retention in the recess of the TGB housing

HELICOPTER(S) CONCERNED	NUMBER	Version(s)	
		Civil	Military
AS365	65.00.19	N1, N2, N3	F, Fi, K, K2
AS565	65.00.09		MA, MB, MBe, SA, SB, UB
SA366	65.06		GA
EC155	65A008	B, B1

Revision No.	Date of issue
Revision 0	2019-07-10

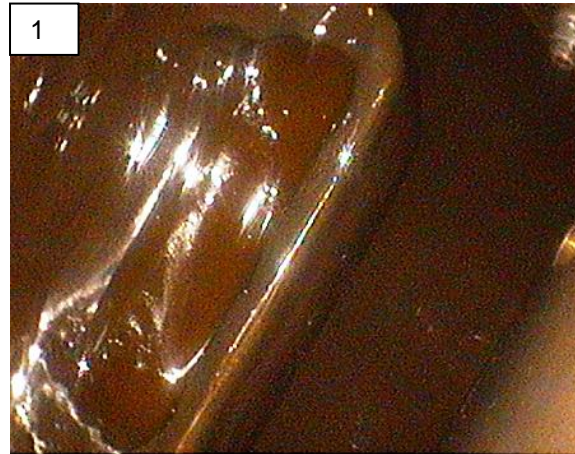
- Oil retention in the recess of the TGB oil housing (The 2 T holes are not visible as per Photo 1):
 - . Comply with paragraph 3.B.3.

- Remove the TGB control rod as per the Work Card 65-21-00-701 (MRM) or Task 65-20-01-066 (AMM).
- Inspect the TGB (c) oil duct (k) ([Figure 2](#), Detail D).
- Remove any foreign object visible in the oil duct (k) ([Figure 2](#), Detail D).
- Wait for 15 seconds to make sure that the oil housing (g) empties its operating oil.
- Insert the endoscope head (zz) or (ss) in the TGB (c).
- Position the endoscope head (zz) or (ss) towards the TGB (c) oil housing recess (g) (towards the rear of the helicopter) ([Figure 2](#), Section C-C).
- Make sure there is no oil retention in the TGB (c) housing recess (g) (Photo 2).

- If there is oil retention in the TGB (c) oil housing recess (g) (Photo 1):
 - .. Remove the head of the endoscope (zz) or (ss) from the TGB (c).
 - .. Mark the TGB as not fit for helicopter installation and return it to Airbus Helicopters as per [paragraph 2.D.](#)
 - .. Replace the TGB as per [paragraph 3.B.3.c.](#)
- . If there is no oil retention in the TGB (c) housing recess (g) (Photo 2) :
 - .. Remove the head of the endoscope (zz) ou (ss) from the BTA (c).
 - .. Continue the procedure as per paragraph 3.B.3.b.

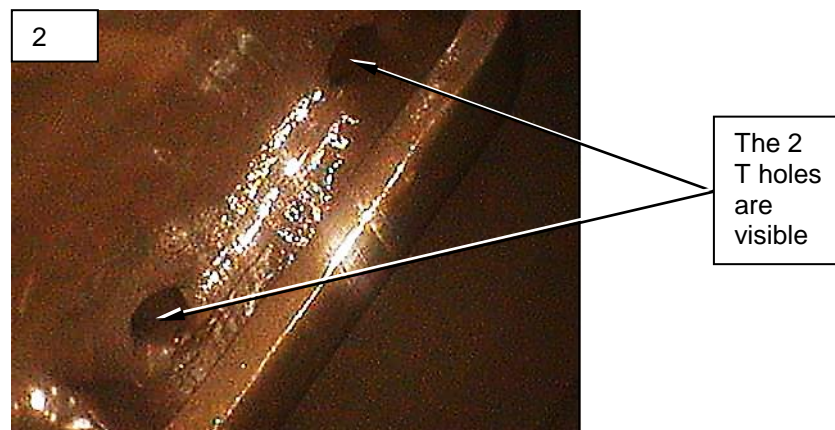
- No oil retention in the recess of the TGB oil housing (The 2 T holes are visible as per Photo 2):
 - . Comply with [paragraph 3.B.4.](#)

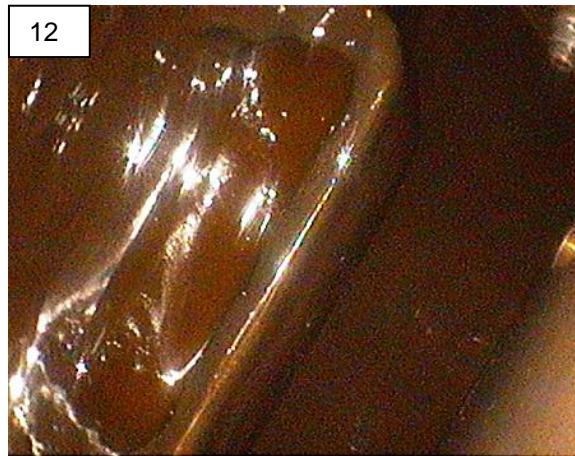
- Fill the housing recess with operating oil (g) using the syringe (yy) (Photo 12).

- . If there is oil retention in the TGB (c) housing recess (g) (The 2 T holes are not visible as per Photo 12):
 - .. Remove the endoscope (zz).
 - .. Make sure that the adhesive tape (tt) is still correctly positioned on the hose (xx) and the head of the endoscope (zz).
 - .. Remove the adhesive tape (tt) and the hose (xx) from the endoscope.
 - .. Comply with [paragraph 3.B.6.c.](#)

- Remove the TGB control rod as per the Work Card 65-21-00-701 (MRM) or Task 65-20-01-066 (AMM).
- Inspect the TGB (c) oil duct (k) ([Figure 2](#), Detail D).
- Remove any foreign objects visible from the oil duct (k) ([Figure 2](#), Detail D).
- Wait for 15 seconds to make sure that the oil housing (g) empties its operating oil.
- Check that the oil housing (g) is empty by re-inserting the endoscope (zz).
 - . If there is oil retention in the TGB (c) housing recess (g) (Photo 12):
 - .. Mark the TGB as not fit for helicopter installation and return it to Airbus Helicopters as per [paragraph 2.D.](#)
 - . If there is no oil retention in the TGB (c) housing recess (g) (Photo 13):
 - .. Remove the head of the endoscope (zz) from the TGB (c).
 - .. Continue the procedure as per paragraph 3.B.6.c.2.

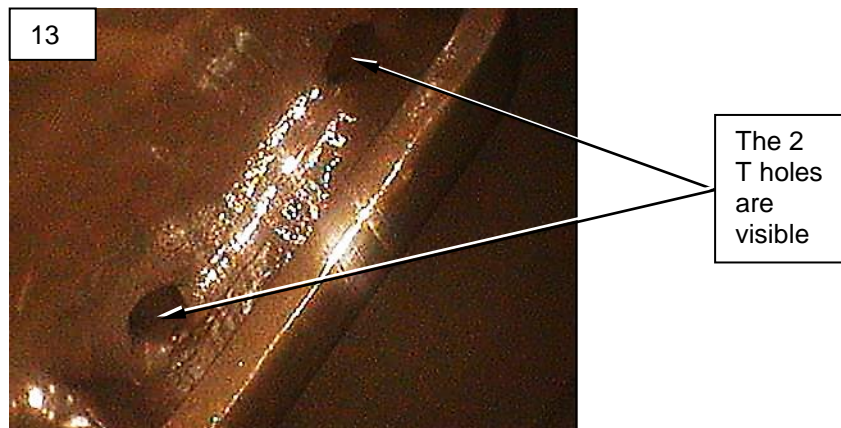
- Wait for 15 seconds to make sure that the oil housing (g) empties its operating oil. (Photo 13).
- Check that the oil housing (g) is empty using the endoscope (zz).
 - . If there is no oil retention in the TGB (c) housing recess (g) (The 2 T holes are visible as per Photo 13):
 - .. Remove the endoscope (zz).
 - .. Make sure that the adhesive tape (tt) is still correctly positioned on the hose (xx) and the head of the endoscope (zz).
 - .. Remove the adhesive tape (tt) and the hose (xx) from the endoscope.
 - .. Comply with [paragraph 3.B.6.d.](#)

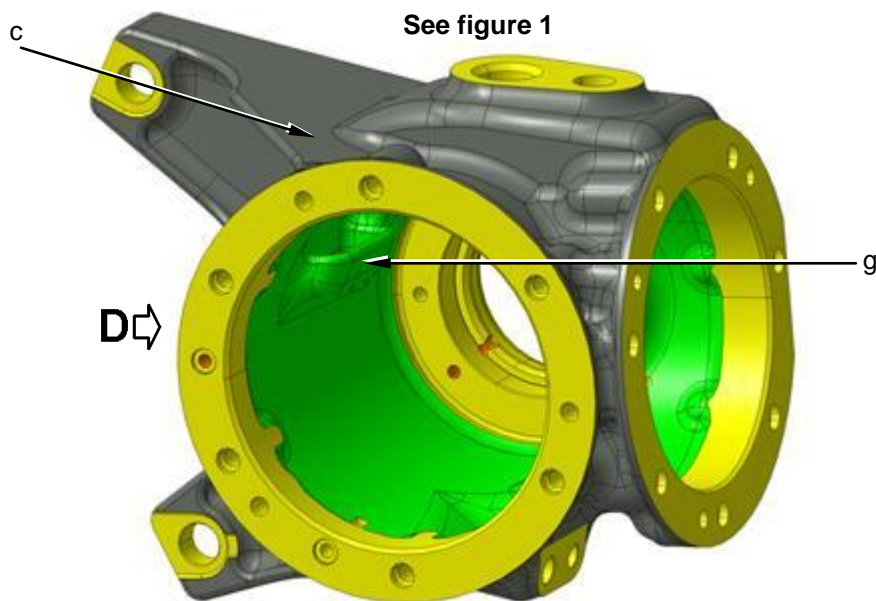
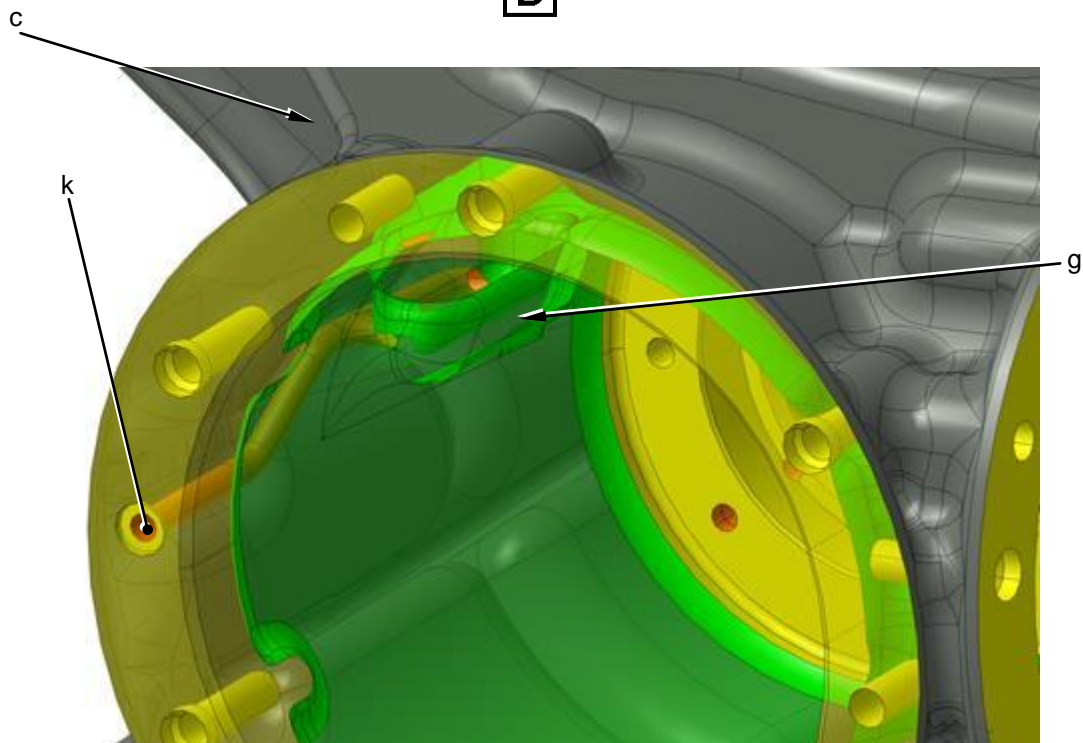
Figure 2

- Insert the head of the endoscope (zz) or (ss) in the TGB (c).
- Position the head of the endoscope (zz) or (ss) towards the TGB (c) oil housing recess (g) (towards the rear of the helicopter) ([Figure 2](#), Section C-C).
- Make sure there is no oil retention in the TGB (c) housing recess (g) (Photo 2).
- Interpret the results as per paragraph 3.B.2.b.
- Remove the head of the endoscope (zz) or (ss) from the TGB (c).

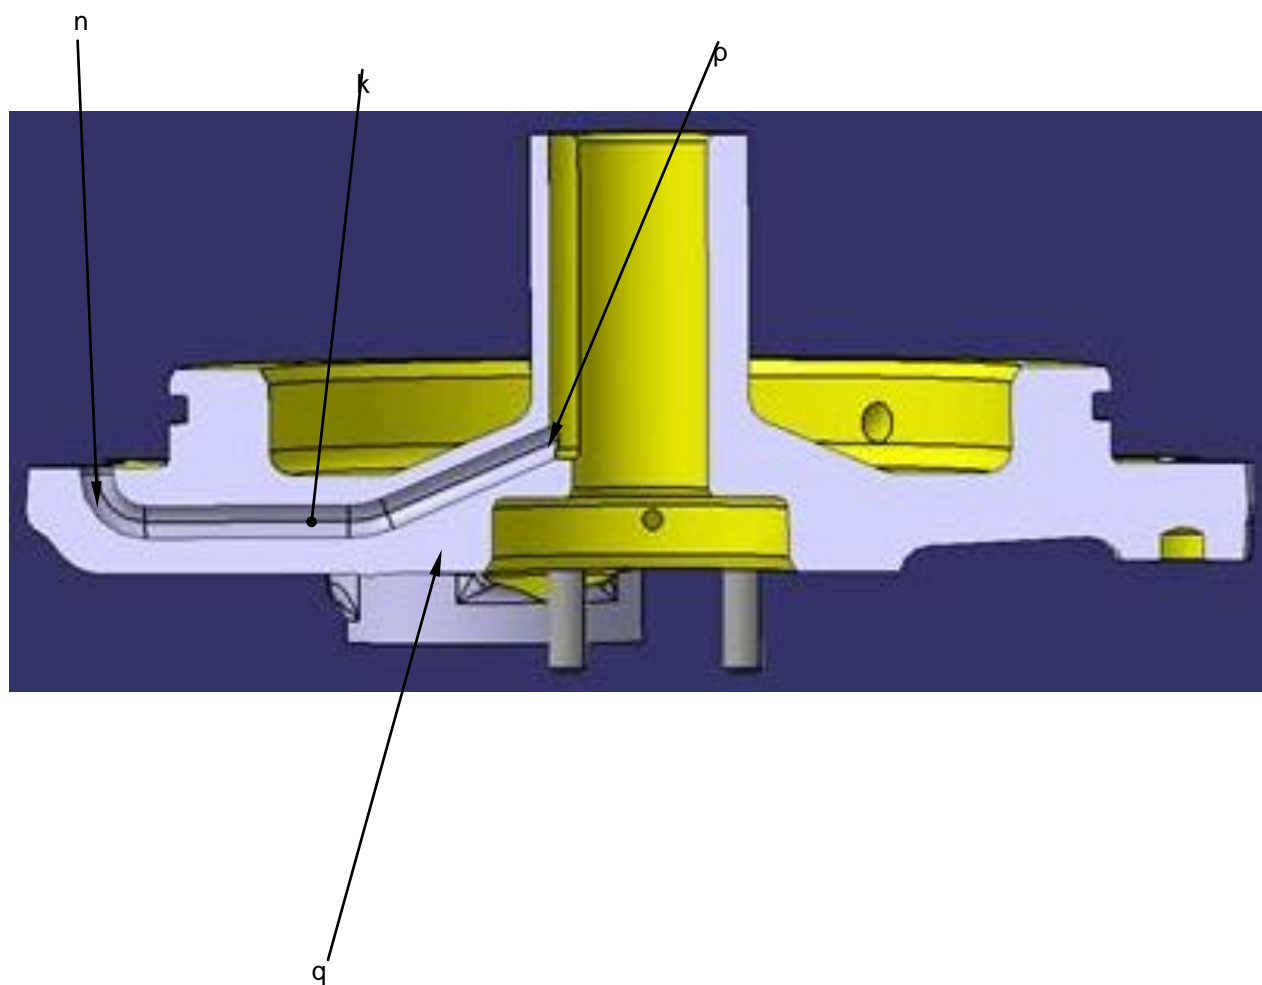
Figure 3

- Make sure that the operating oil flows at the end (p) of the oil duct (k) BTP (q) cover ([Figure 3](#), Section E-E).
- If the operating oil does not flow at the end (p) of the oil duct (k) BTP (q) cover:

- . Mark the TGB as not fit for helicopter installation.
 - . Replace the TGB as per [paragraph 3.B.3.c.](#) or contact Airbus Helicopters to plan a field intervention (operations will be performed on field by seconding Airbus Helicopters specialists qualified for this operation).

- If the operating oil flows at the end (p) of the oil duct (k) BTP (q) cover:
 - . Replace the TGB control rod bearing (m) (not shown) with a new bearing (1) (not shown) as per Work Card 65-21-00-702 (MRM) or Task 65-20-01-961 (AMM).
