Date: August 16, 2016
To: All Kidde Fire Systems Distributors
From: Product Management
Subject: Safety Bulletin: Engineered Mechanical Control Heads on Nitrogen Pilot Cylinders – Remediation Plan
Reference: Bulletin #16-24K dated May 26, 2016

IMPORTANT SAFETY NOTICE

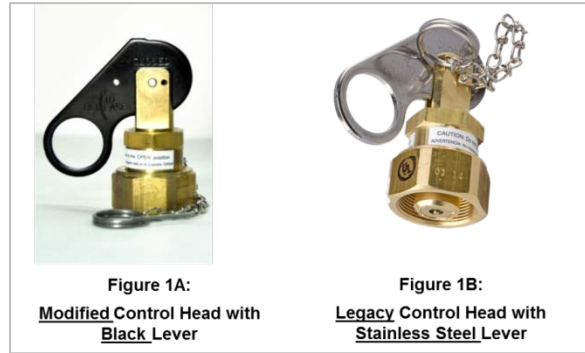
We have internally modified the Engineered Mechanical Control Heads listed in Table 1 to preclude timing issues caused by tolerance stack-ups and, as advised in Bulletin 16-24K, have externally modified the manual levers to help differentiate from the respective legacy versions as shown in the following Figures 1A and 1B:

Kidde is committed to ensuring that all actuation systems function fully as intended. To ensure correct functionality, referring table 1 below, this bulletin requires the mandatory replacement of the *Suspect P/Ns* (Stainless steel levered Control Heads and Pilot Cylinder combination) by the *Replacement P/Ns* (Black levered Control Heads and Pilot Cylinder combination) when used in the listed Clean Agent and HP-CO2 applications.

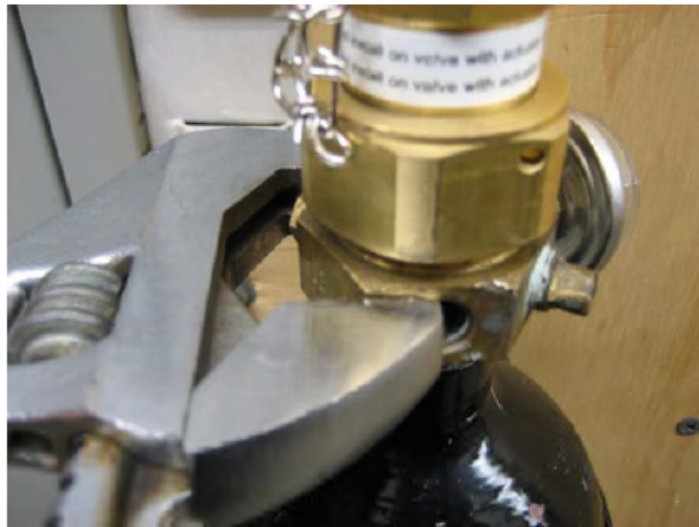
Figure 1. Outlet Fitting (P/N: WK-699205-010) Removed and Wrench Shown on Valve Flats

7. Position a 1-1/2" smoothed jawed adjustable wrench on to the pilot cylinder valve body flats so as to secure the pilot cylinder (see Figure 1). Alternate methods to directly secure the pilot cylinder (to prevent its movement) are also acceptable. Please exercise caution to not damage the pilot cylinder.

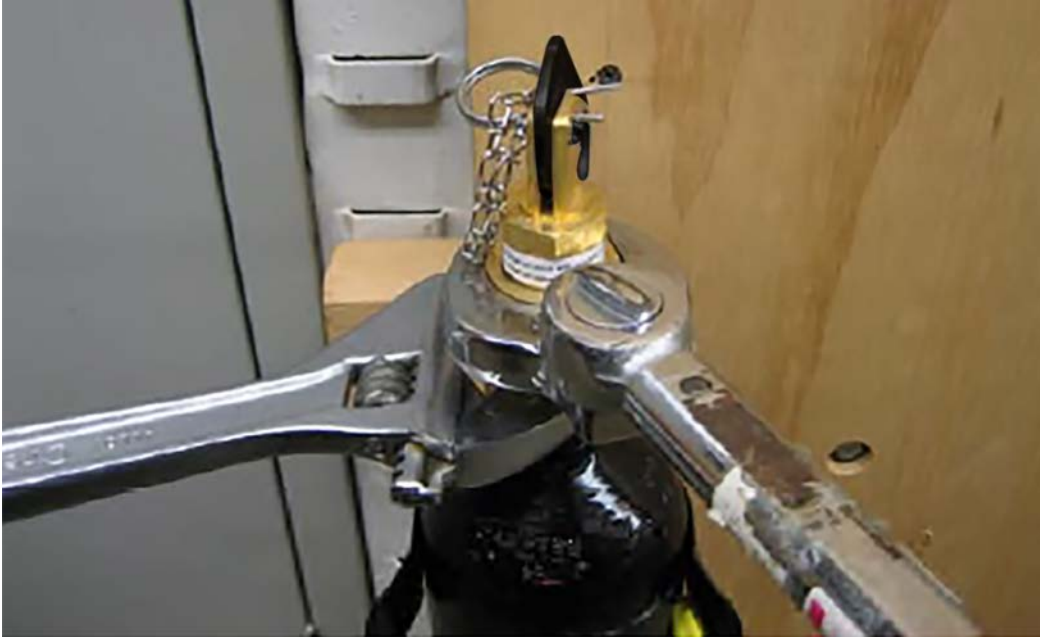
**Figure 2. Lever Operated Head (P/N: WK-870652-000) tightened using Torque Wrench with 1-1/2” Crowfoot.
Always use black lever style per Bulletin 16-24K.**

8. Using the torque wrench* fitted with 1-1/2" crowfoot wrench tighten to a minimum torque of 60 ft. lb.** (see figure 2).

*Recommended 10-100 ft.lb. ½" drive torque wrench. Other ranges are acceptable provided 40-60 ft. lb. is within optimum tolerance for the tool.

**Set wrench to a minimum setting of 55 ft. lb.
