Condition Assessment and Rehabilitation Plan Hangar One

for NASA Headquarters and
Ames Research Center, California

Volume 1
Condition Assessment

Hangar One – Ames Research Center, Moffett Field, CA

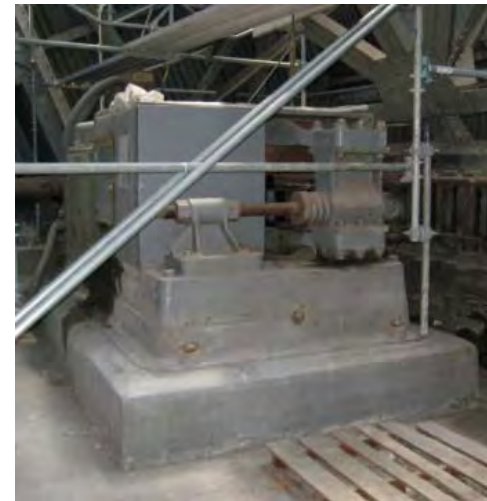
Figure 2.12

There are four individual motors that operate the hangar doors – one motor for each door leaf. The south hangar doors were last known to be operational in 2001 according to the Page & Turnbull Condition Matrix (see Appendix B) but have not been operated since. Additionally, at this time only three of the four motors are known to be operational. The non-working motor is located on the north hangar door. The last known operational date for the north hangar doors is not known. Each motor is located on top of a concrete curb, inside the hangar. They are located on either side of the hangar door openings. Of the three remaining operational hangar door motors it is expected that each will require maintenance and cleaning in order to become fully functional in the future. The missing motor will need to be replaced, or located, refurbished, and re-installed.

There are two dog houses at the top of the hangar that contain mechanisms for the hangar doors. These mechanisms have leaked oil over time. As part of the Navy removal action the oil has been drained and the dog houses cleaned. Some items may not be able to be thoroughly cleaned due to inability to completely disassemble some pieces or difficult locations of equipment.

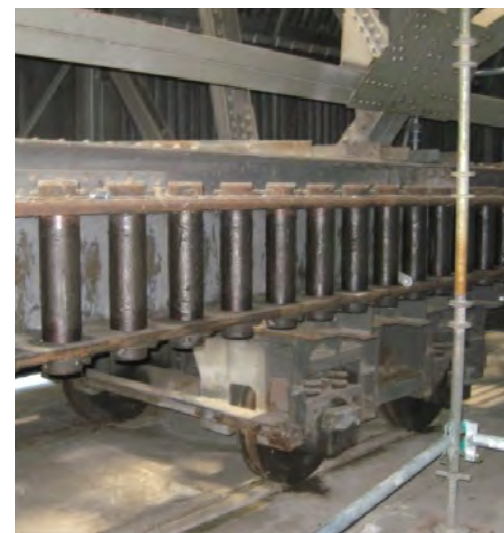
Figure 2.13

Each hangar door leaf sits on nine trucks (see figure 2.13) that consist of support for the door leaf and a series of wheels that roll on tracks that are mounted within the concrete hangar floor slab. These tracks extend beyond the building enclosure and allow the hangar door leaves to roll into their fully open position. At the end of each set of tracks is a door stop that would protect the hangar from the doors opening too far. The wheel and trucks appear to be in relatively decent shape based on visual inspection but because they have not been operational for many years they would require maintenance and cleaning in order to bring them to a fully functional state of operations. These motors may need electrical components replaced as well in order to meet current regulations.

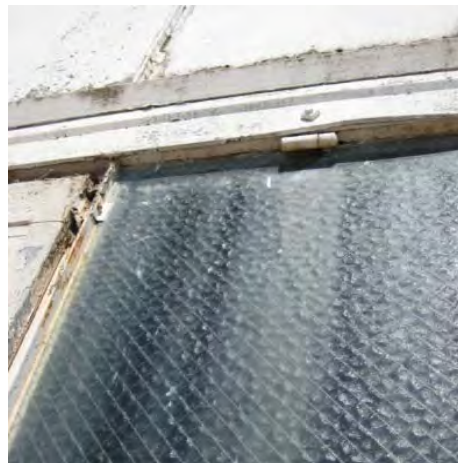
Figure 2.19

The frames of the windows consist of an industrial window framing system that is built-up steel angles and small steel members that make up the smaller panel frames. The steel window frames and mullions are non-thermally broken frames while the glazing is single-pane, non-insulated glass. These are interconnected to each other with simple bolted connections and additional steel framing that is attached to the

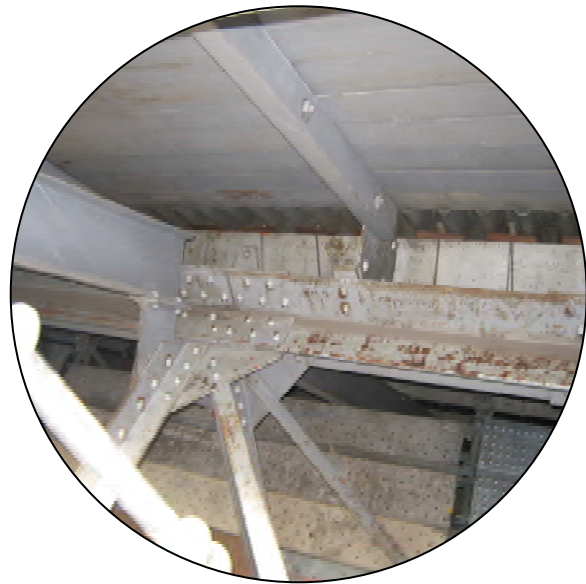
Figure 3-14: Corrosion at Gabled Frame Framing Below Window.

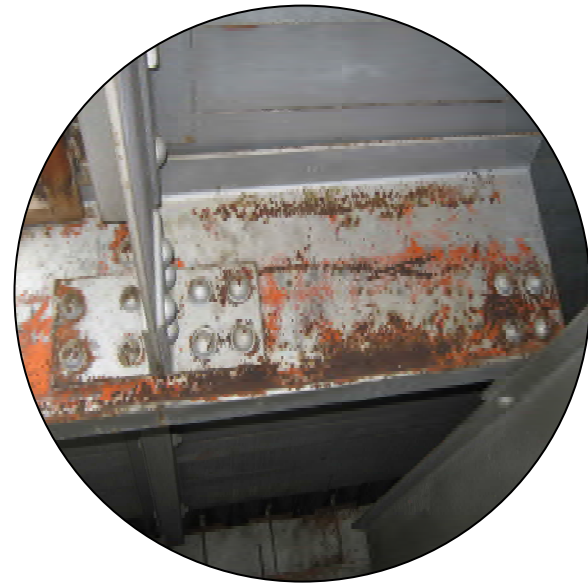
Figure 3-15: Corrosion at Wind Girt Below Window

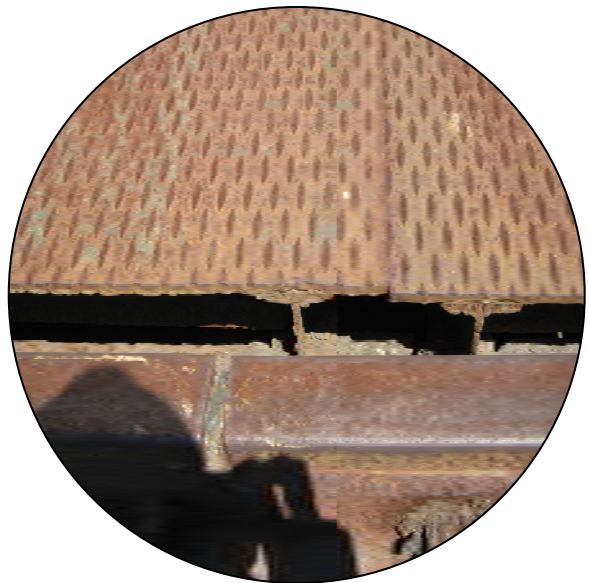
Figure 3-28: Repair Pit at Hangar Exterior Showing Corrosion
