January 14, 2022

Version 2

Product Improvement: Multi-Model 3G OTA TCU Software Update**AFFECTED VEHICLES**

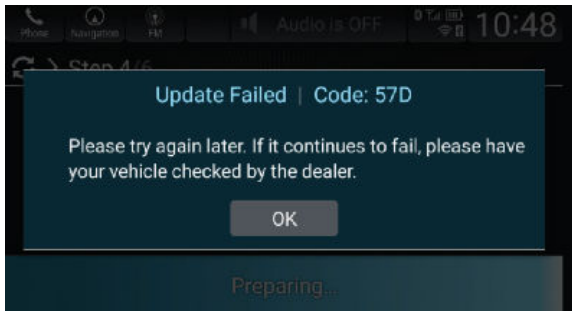
- If you see CODE: 57D or CODE: 5AC, the **Update Failed** due to **Poor cellular signal**.

- Move the vehicle to an open-air area to get **Optimal Cellular Signal** strength.

- Go back to step 1 to start the process once again

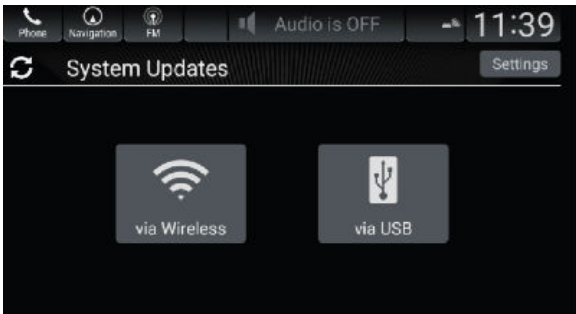
NOTE: If the System Updating bar completes and screen Step 6 of 6 clears without showing Update Complete go to SOFTWARE VERSION VERIFICATION - FRONT CONTROL BOX AND TELEMATICS CONTROL UNIT (TCU).
