**Seismic Vulnerability of Equipment in Critical Facilities:
Life-Safety and Operational Consequences**

November 24, 1993

Technical Report NCEER-93-0022

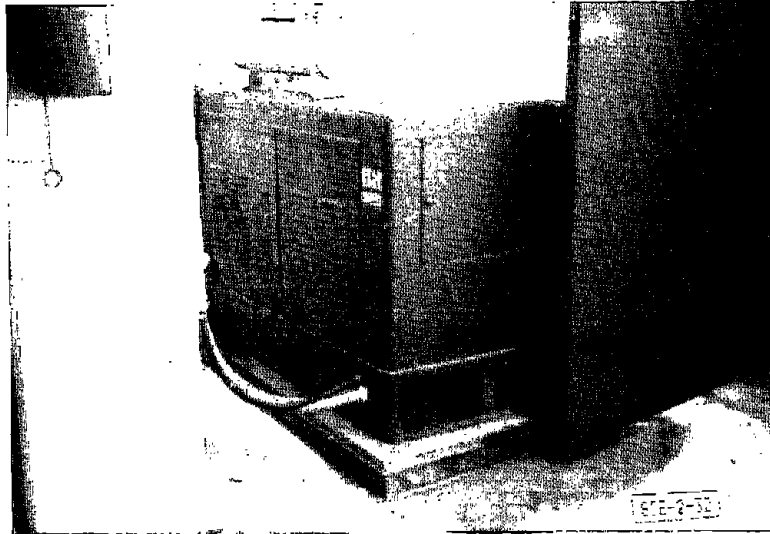
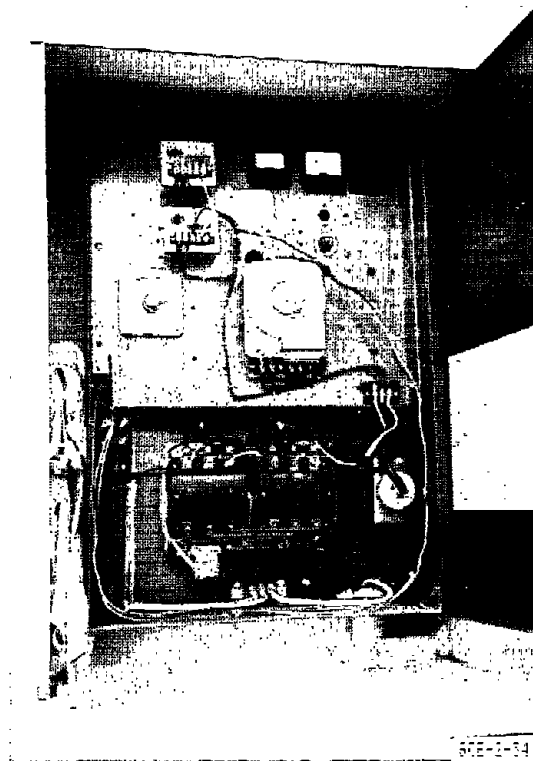
Figure 4-6: One of the 30-kW Onan diesel generators mounted on the roof of the building failed to start due to a faulty relay in its local control panel mounted to the adjacent wall (lower photograph). The equipment was affected by the 1987 Whittier Earthquake. Ground motion at the site is estimated to be 0.40g, with a duration in excess of 3 seconds.

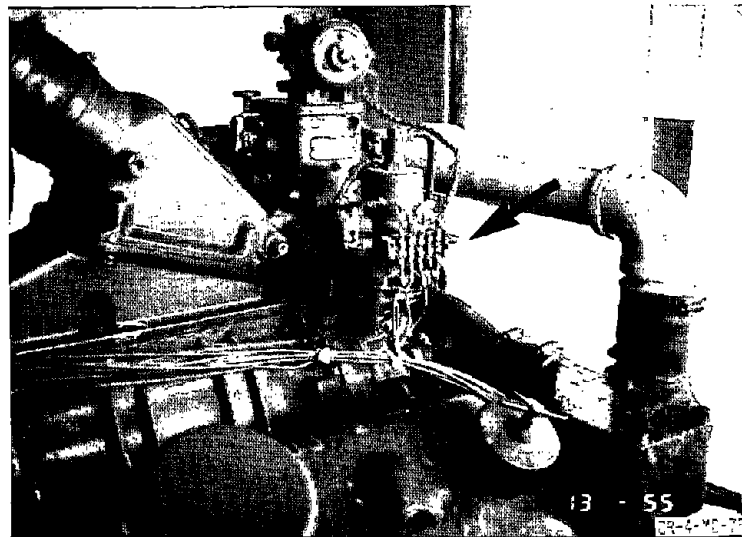
Figure 4-7: The diesel generator at this site did not respond to a manual start following the 1991 Costa Rica Earthquake (measured PGA of 0.12g). Inspection by a utility technician the day following the earthquake revealed a broken wire at the terminal connection serving the solenoid valve (arrow, lower photograph) that controls oil flow to the Woodward governor.

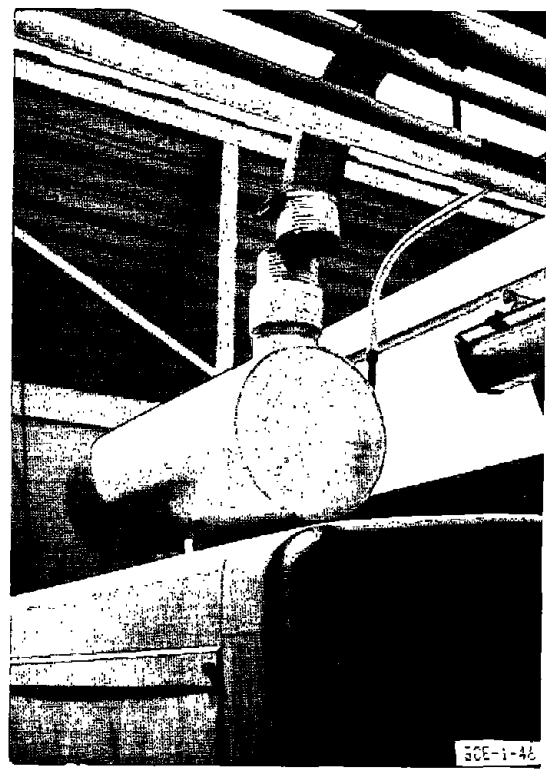
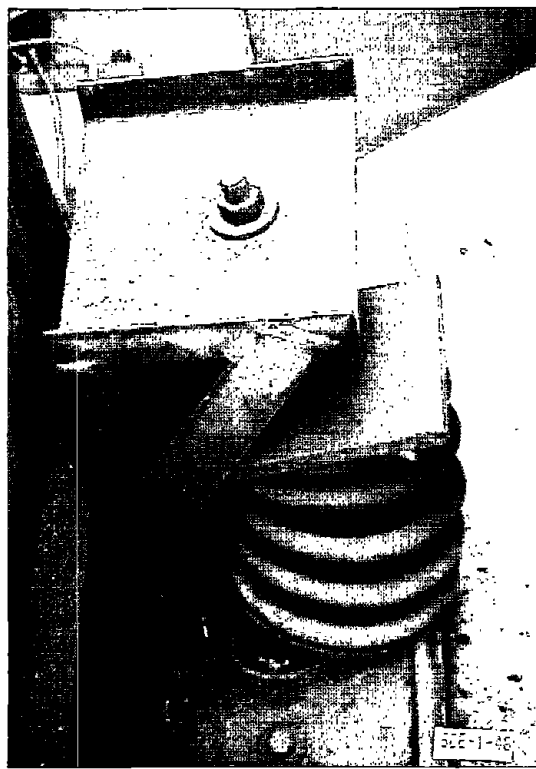
Figure 4-8: One of the 75-kW diesel generators mounted on the roof of a commercial building shifted laterally during the 1987 Whittier Earthquake, buckling its spring isolation mounts (lower photograph). Shifting of the unit broke the coupling of the exhaust pipe to the muffler mounted atop the diesel (upper right photograph). The ground motion is estimated to be 0.40g.

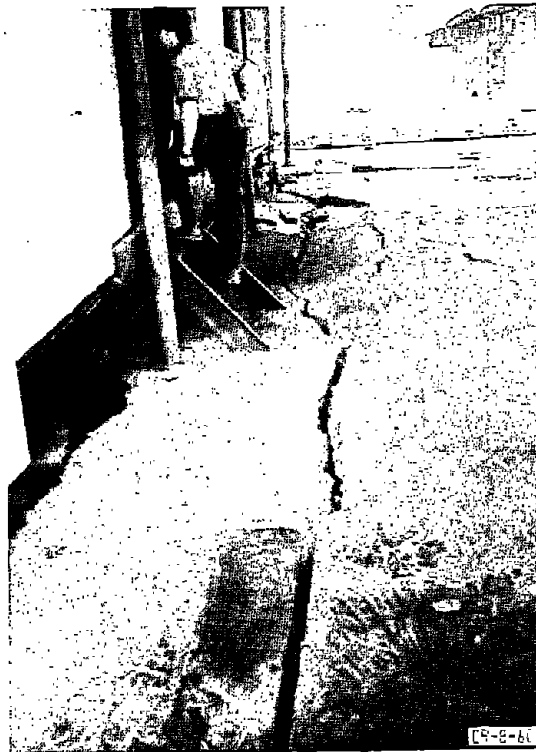
Figure 4-9: In the 1991 Costa Rica Earthquake, a fuel line that was routed along the concrete foundation mats of some of the diesels from nearby day tanks suffered breaks in its branch lines due to differential displacement imposed by settlement and soil spreading beneath the concrete mats.

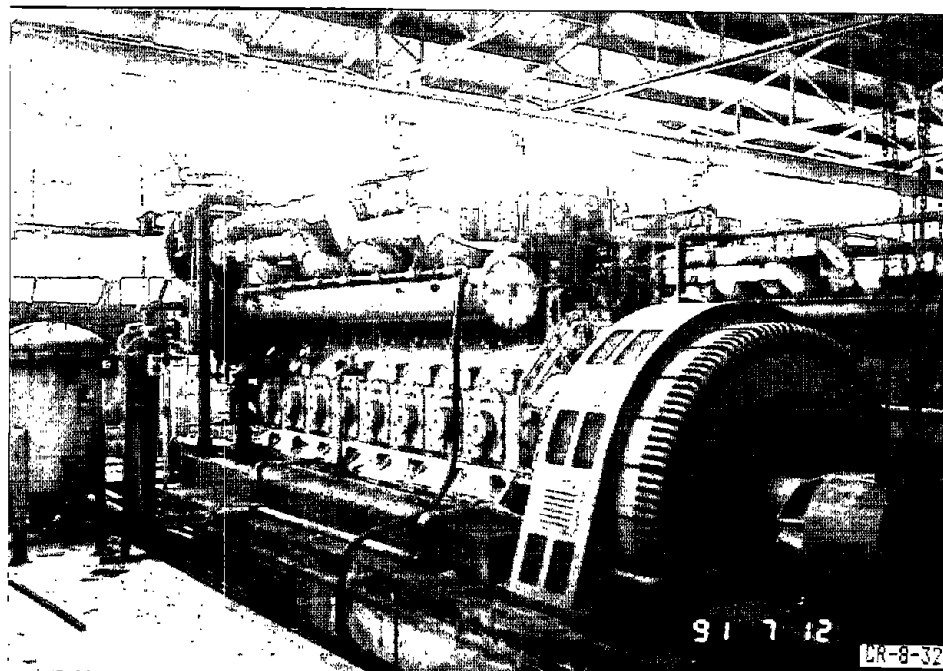
Figure 4-10: This diesel generator suffered severe shaft misalignment following the 1991 Costa Rica Earthquake. The misalignment was caused by differential settlement between the diesel foundation and the plant base mat (which supports the front of the generator drive shaft).

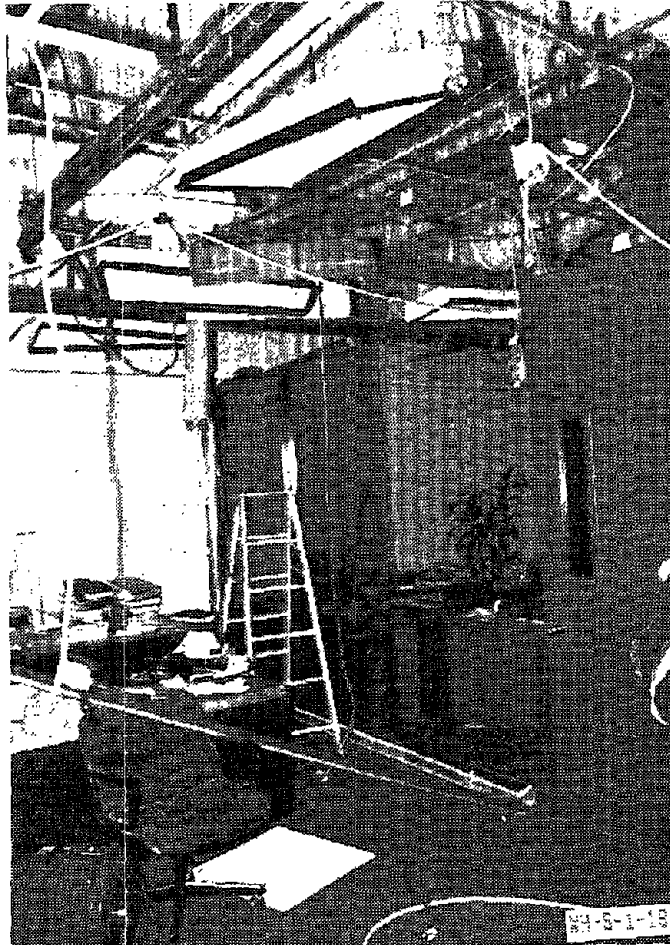
Figure 4-19: At a data processing facility, affected by the 1987 Whittier Earthquake, property losses occurred due to the actuation of the preaction automatic sprinkler system. Postulated causes of the system actuation included either dust-induced smoke detector actuation, or detector malfunction.

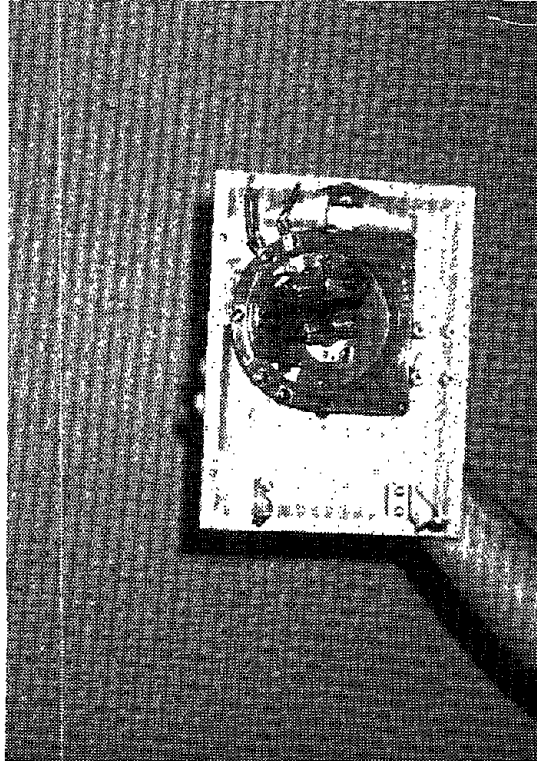
Figure 4-21: A typical fire pull station which operates using a mercury switch. These pull stations actuated in several of the buildings at a large university and its associated medical facility during the 1989 Loma Prieta Earthquake (estimated 0.25g).

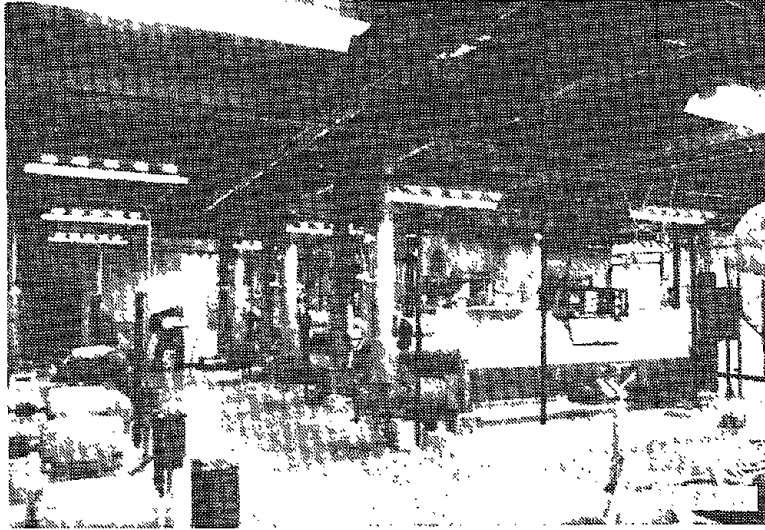
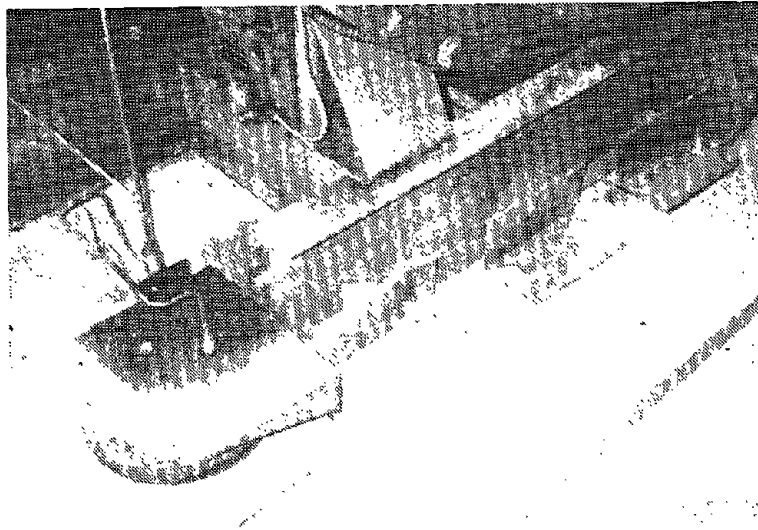
Figure 4-29: These chillers, located at two data processing facilities, affected by the 1987 Whittier Earthquake, shifted sufficiently on their vibration isolators to fracture attached piping, and render the units inoperable.

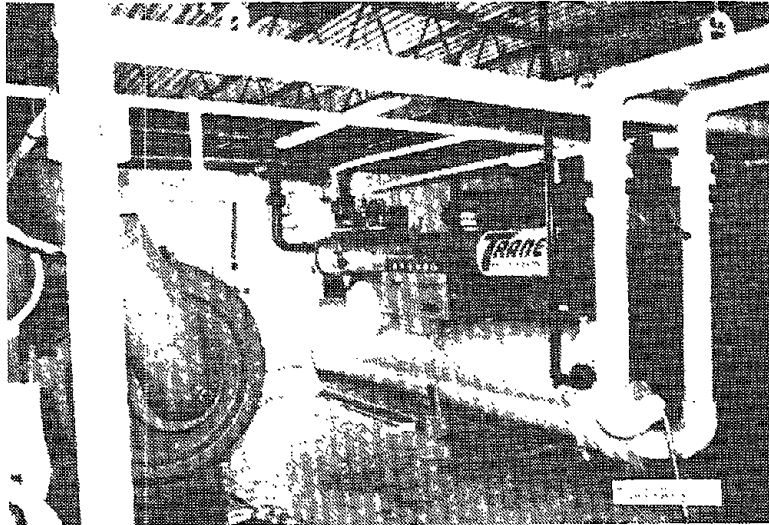
Figure 4-30: These chillers, located at a processing facility, affected by the 1987 Whittier Earthquake, shifted off their spring-type vibration isolators. The units remained operable during and following the earthquake.

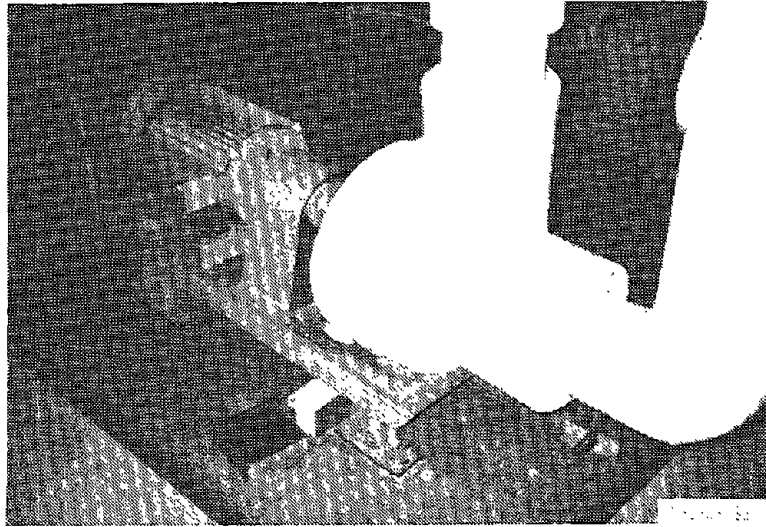
Figure 4-32: This horizontal pump in the penthouse of a data processing facility, affected by the 1987 Whittier Earthquake, dislodged from its vibration isolation mounts. The pump remained functional, in spite of the anchorage damage.

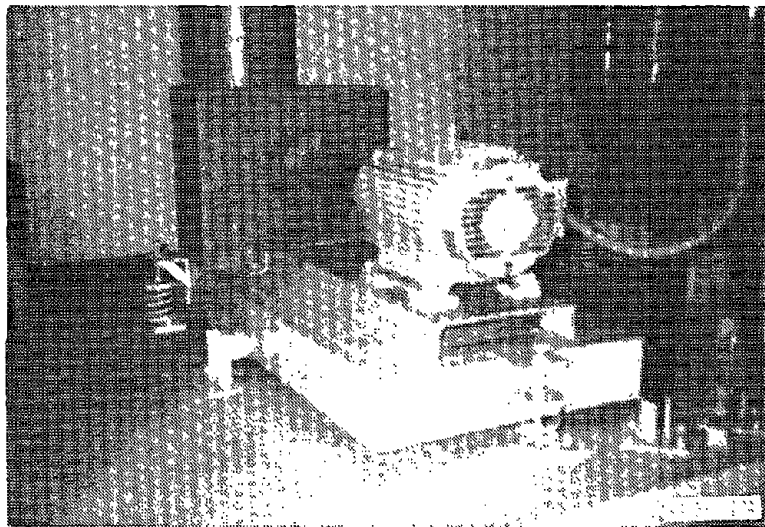
Figure 4-33: This pump mounted on vibration isolators with seismic stops, located at a second data processing facility affected by the 1987 Whittier Earthquake, showed evidence of movement. Some of the bolts anchoring the seismic stops showed evidence of minor prying; however, the pump continued to operate.

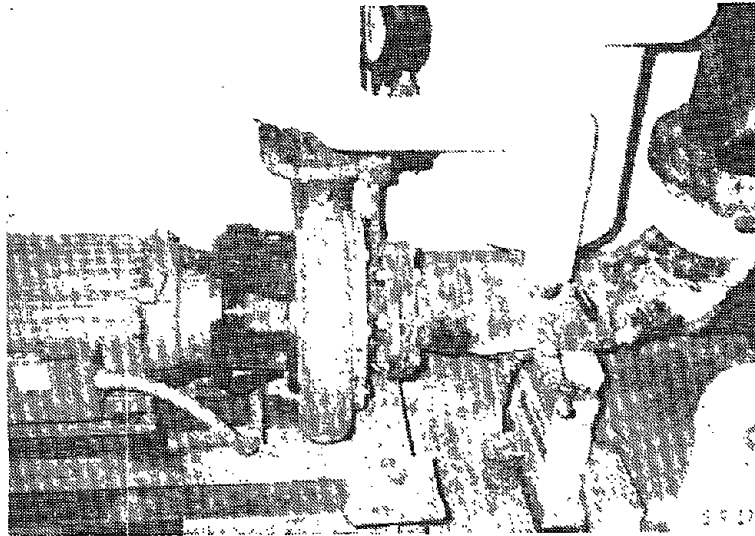
Figure 4-34: This chilled water pump at a data processing facility, affected by the 1987 Whittier Earthquake, sustained a cracked casing. The damage was apparently caused by seismic anchor movement. A chiller that was rigidly connected to the pump through piping moved six inches during the earthquake.

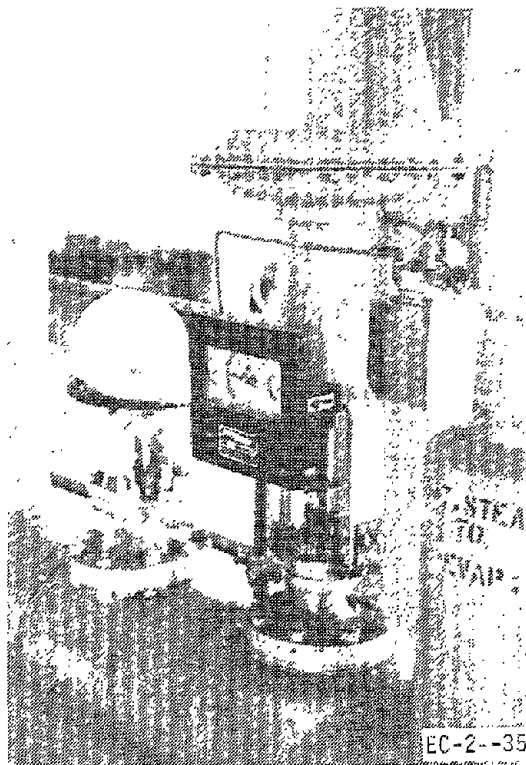
Figure 4-35: At a power plant, affected by the 1979 Imperial Valley Earthquake, the cast-iron yoke of a diaphragm-operated valve cracked, due to the repeated impact of its diaphragm housing with an adjacent steel column. The arrow points to the repair at the location of the damage.

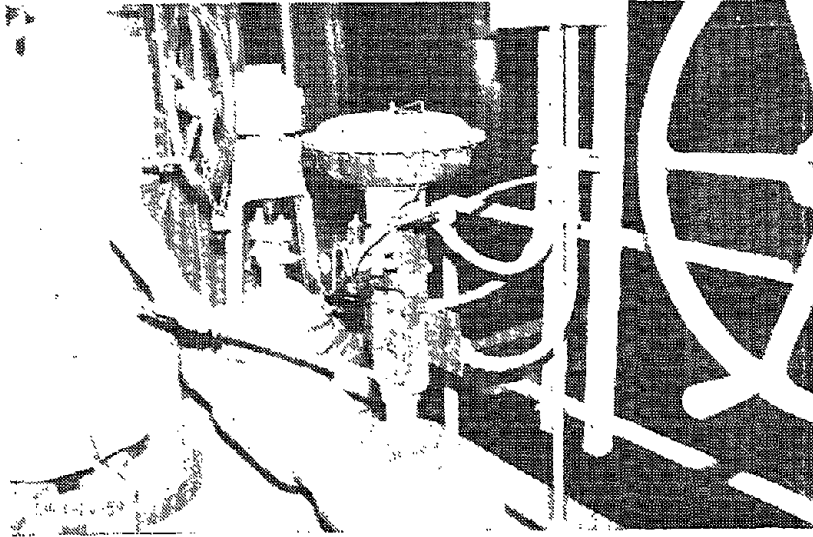
Figure 4-36: One of two diaphragm-operated valves at a power plant, affected by the 1985 Chile Earthquake, that were damaged due to the impact of their cast-steel yokes with an adjacent handrail approximately 10 inches away. On one operator, the connecting service air line broke, due to insufficient slack to accommodate the displacement of the operator.

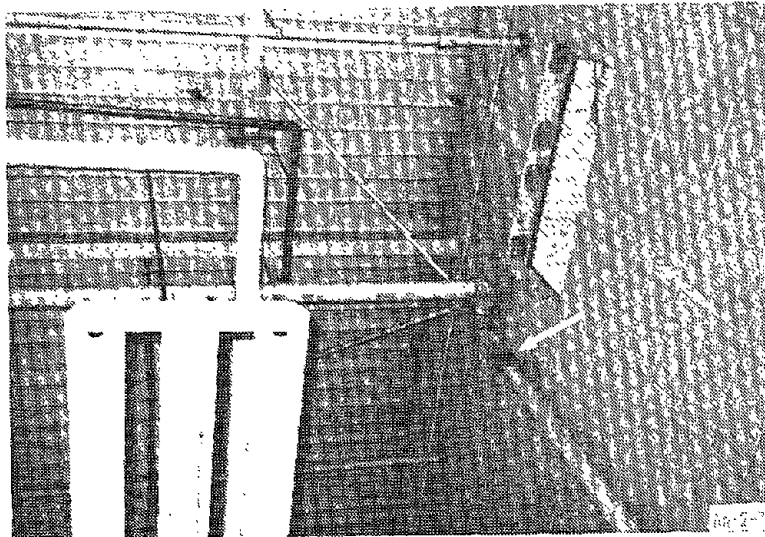
Figure 4-37: This chilled water line located at a navy base hangar, affected by the 1986 Alaska Earthquake, sustained damage when a Victaulic coupling broke. The mechanical coupling could not accommodate the lateral loads caused by the differential displacement of its supports.

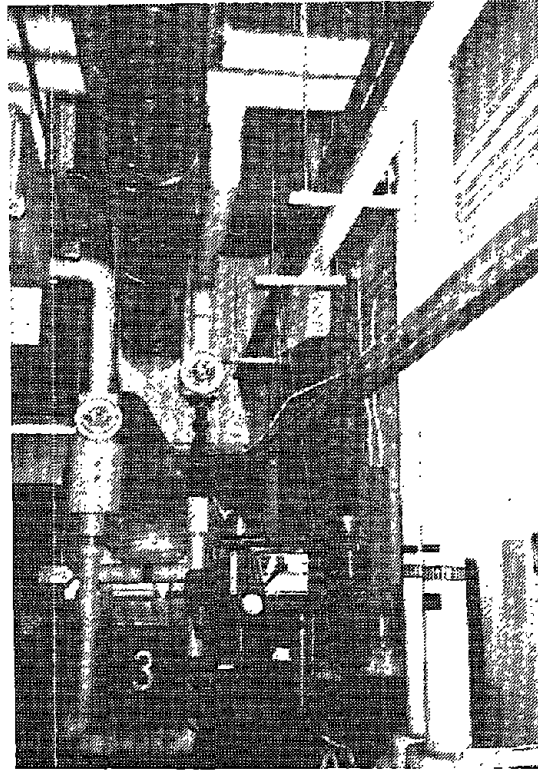
Figure 4-38: At a navy base, affected by the 1992 Cape Mendocino Earthquake, PVC chilled water piping attached to an air handler broke. The equipment was supported on vibration isolators that moved differentially from the pipe supports, causing the pipe to break.

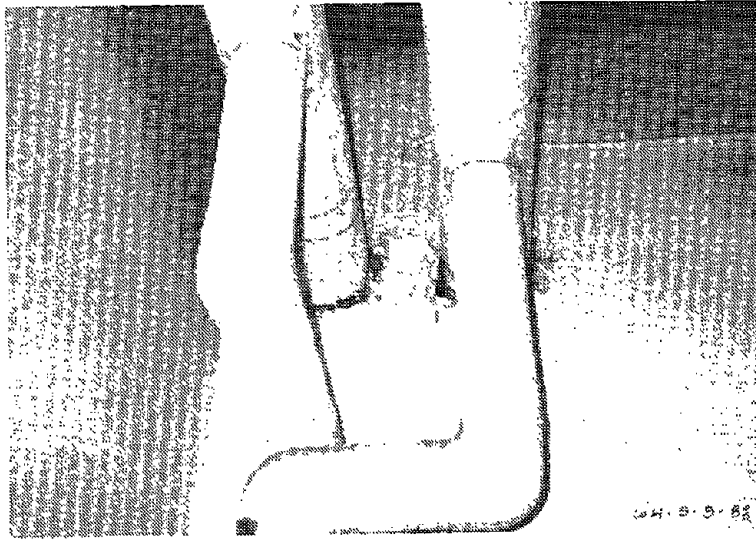
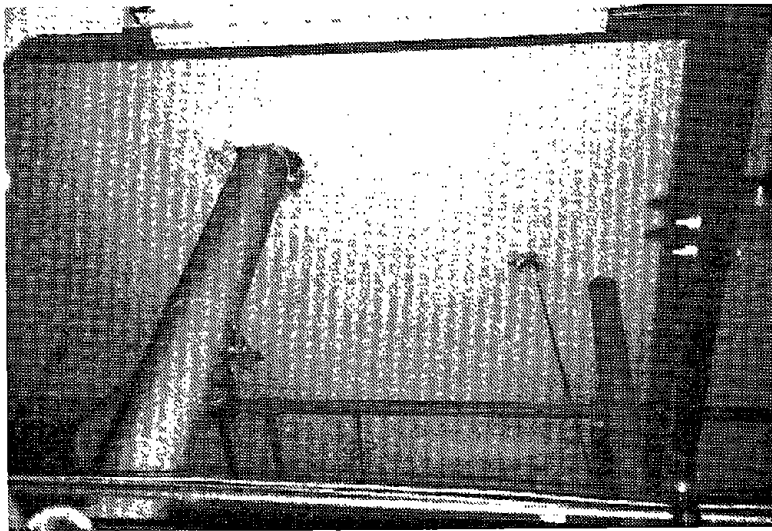
Figure 4-39: Two of three data processing facilities, affected by the 1987 Whittier Earthquake, where movement of piping damaged wall penetrations. The pipes were undamaged in all cases.

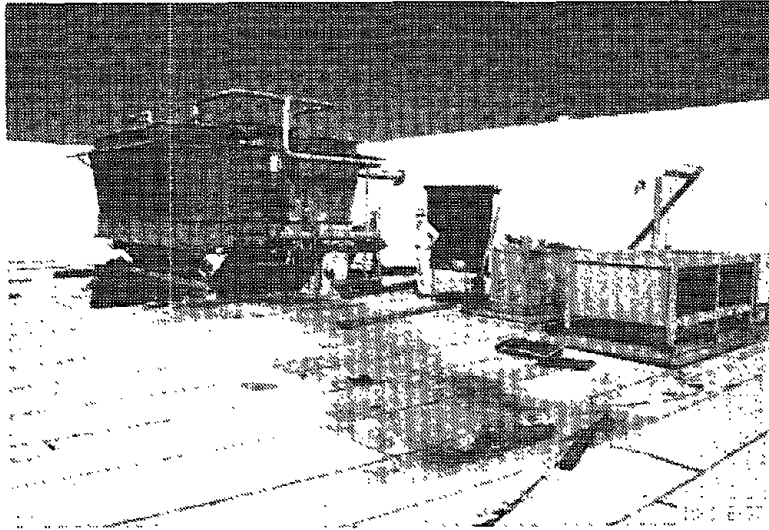
Figure 4-40: This forced-draft evaporative cooler at a data processing facility, affected by the 1987 Whittier Earthquake, shifted off its vibration isolators. The unit remained operable in spite of its anchorage damage.

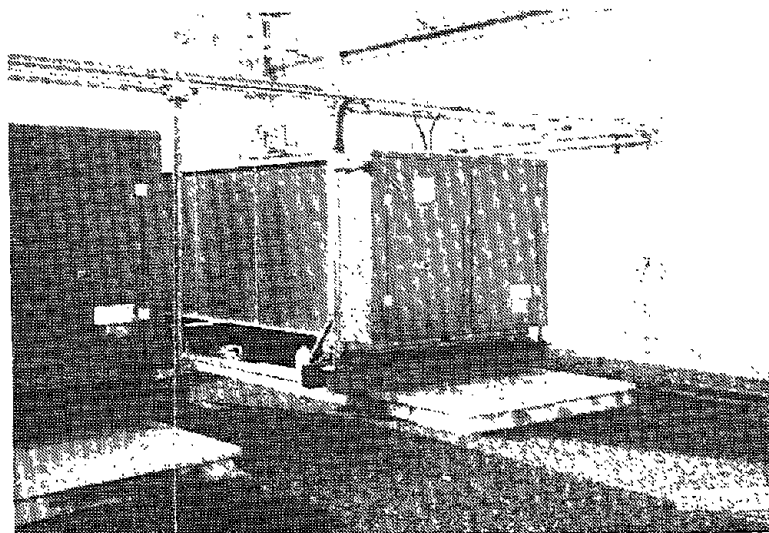
Figure 4-41: These evaporative coolers located at a telephone facility shifted off their vibration isolators during the 1987 Whittier Earthquake.

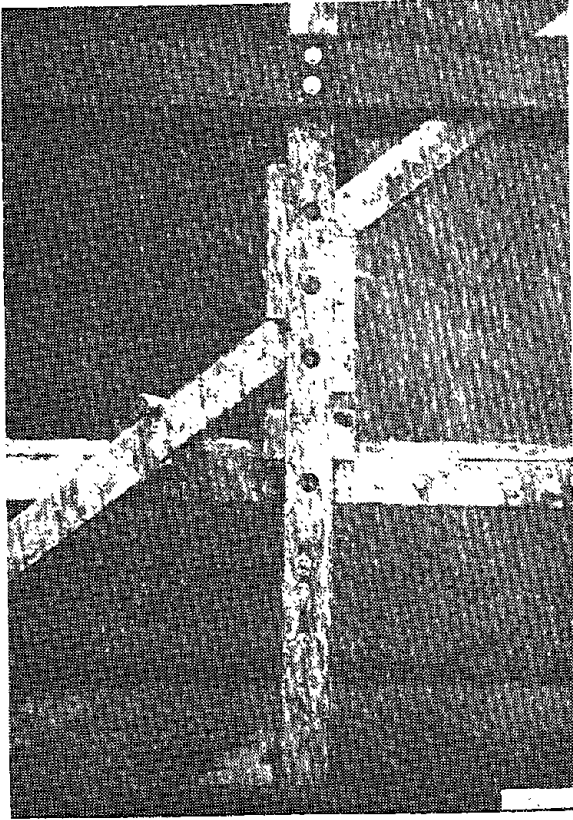
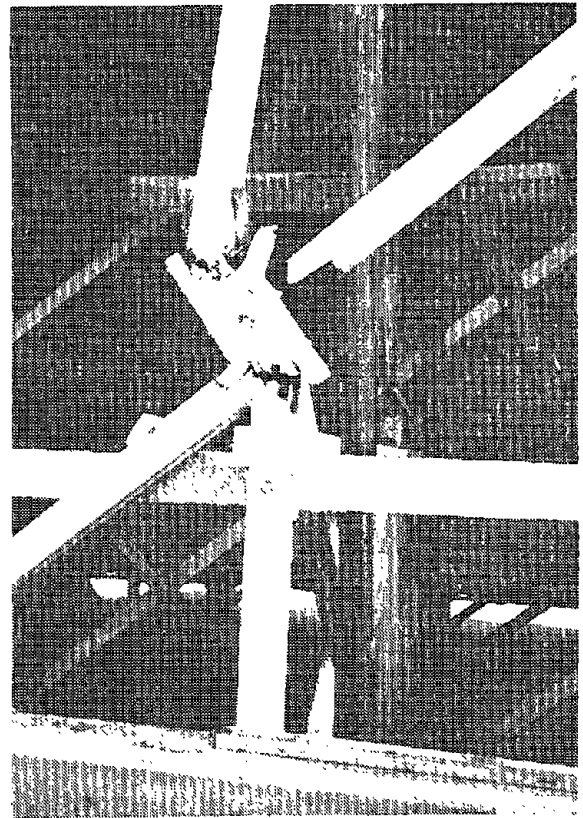
Figure 4-42: Eccentric connections damaged in cooling towers at a cogeneration plant in the 1992 Cape Mendocino Earthquake. Photo on left is an identical undamaged connection.

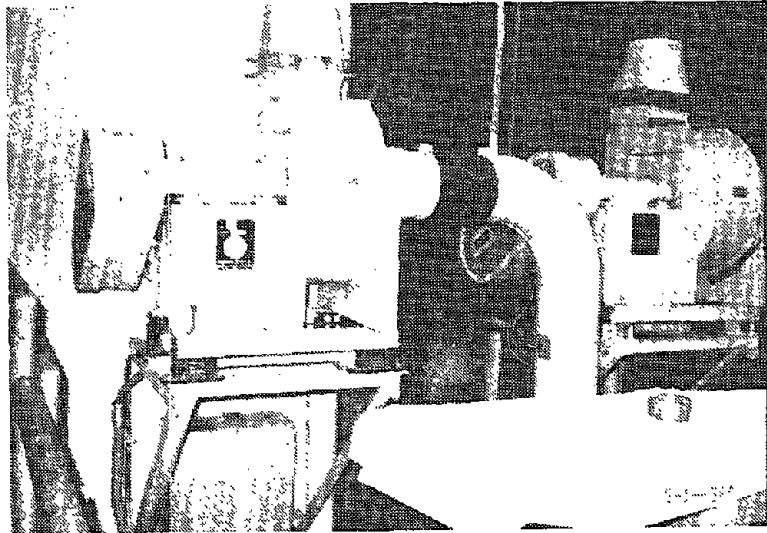
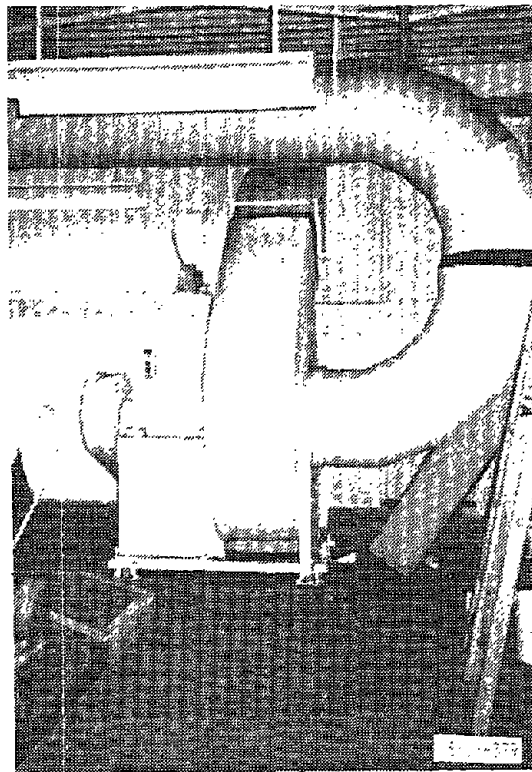
Figure 4-43: Two examples of damage to fans on vibration isolators occurred at a large electrical substation, affected by the 1971 San Fernando Earthquake. In one case, a centrifugal fan located in the third floor HVAC room, broke its cast-iron isolation mounts. In the second case, one of six frame-mounted fans, in the basement, broke its spring isolators.

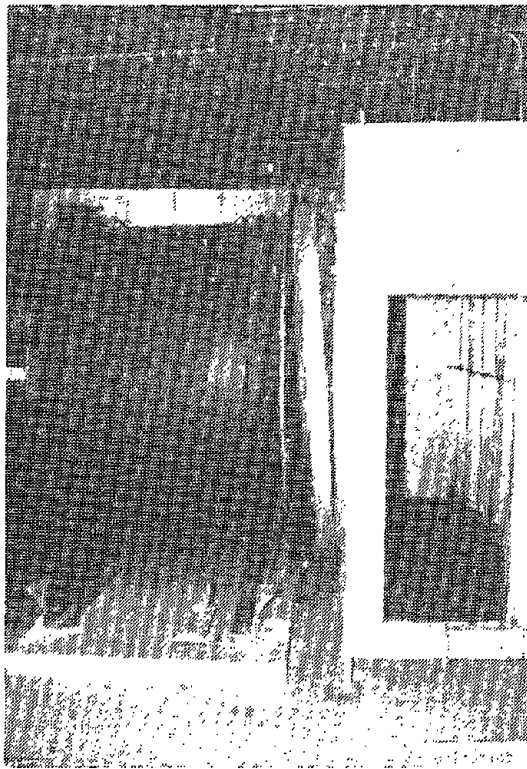
Figure 4-44: This fan, located in the penthouse at a data processing facility, affected by the 1987 Whittier Earthquake, was knocked from its non-seismically designed vibration isolation mounts. Not the torn duct connection.

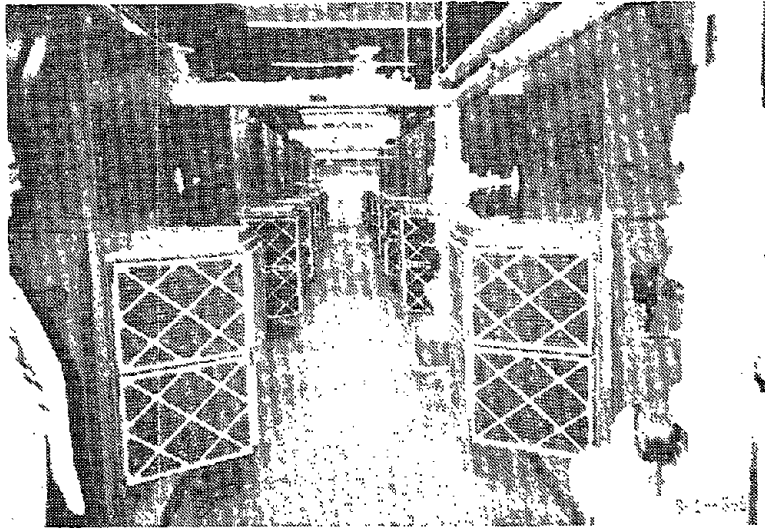
Figure 4-46: Most of the 48 air handling units located on the second floor of a large electrical substation, affected by the 1971 San Fernando Earthquake, were shaken from their isolation mounts. The mountings were not designed to accommodate seismic loads. On five of the units, the movement was sufficient to damage attached piping and ducts.

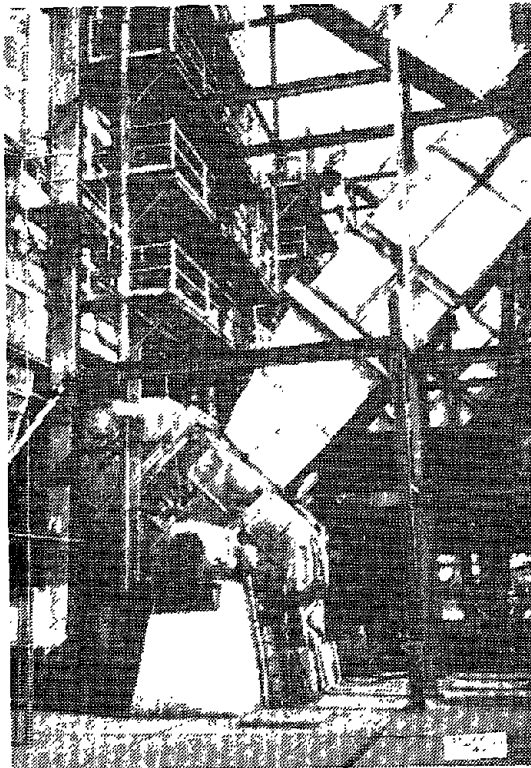
Figure 4-47: These forced-draft fans associated with the plant's boilers at a steel mill, affected by the 1985 Mexico Earthquake, suffered shaft misalignment. The boilers are tied to the fan housings through a large, heavy, rigidly attached duct system. The boilers shifted during the earthquake, pulling the duct, which in turn, pulled on and caused a misalignment of the fans.

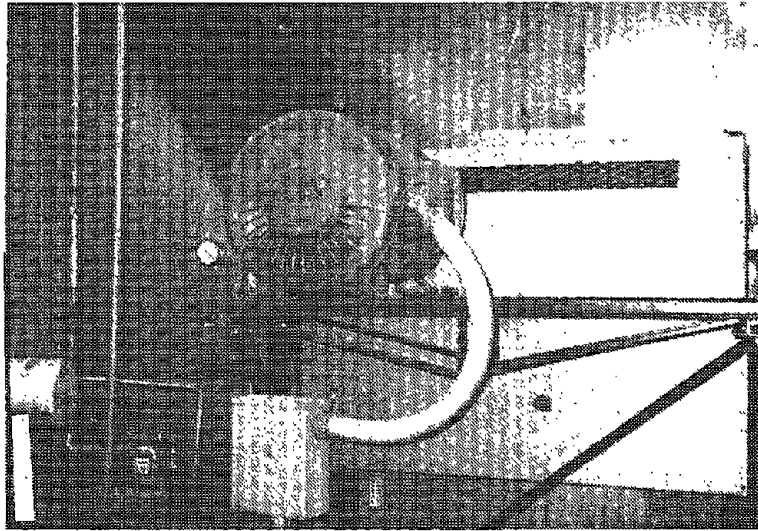
Figure 4-48: At a manufacturing facility, affected by the 1989 Loma Prieta Earthquake, a fan motor, mounted external to the air handler, sheared its anchor bolts. The cause appears to be differential flexure between the fan impeller (connected to the motor through the drive shaft) and the steel frame supporting the motor.

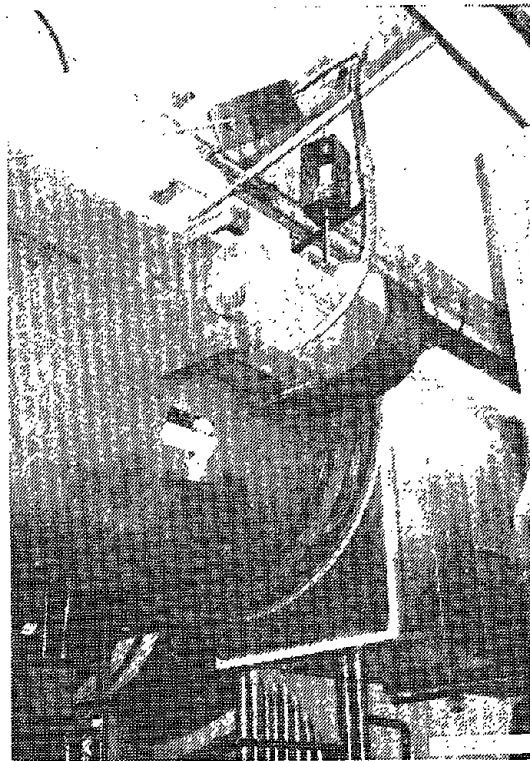
Figure 4-49: This in-line vane-axial fan at a small manufacturing facility, affected by the 1989 Loma Prieta Earthquake, tore the elastic bellows connecting the fan enclosure to the HVAC ducts. The fan enclosure did not fall and was otherwise undamaged.

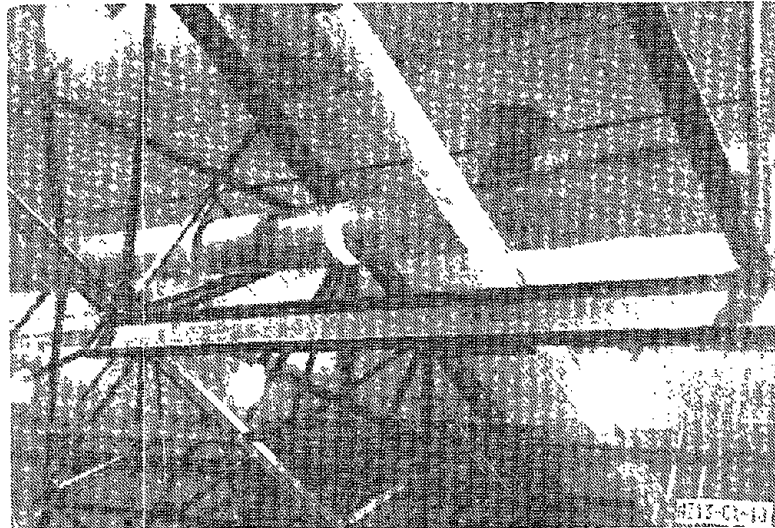
Figure 4-50: At a paper mill, affected by the 1987 New Zealand Earthquake, a section of rod-hung duct fell from its supports (Note new joint, shown as a light patch). The circular duct was fastened with riveted joints that pulled apart during the earthquake. Inspection of the fallen section of duct revealed severe corrosion at the riveted joint.

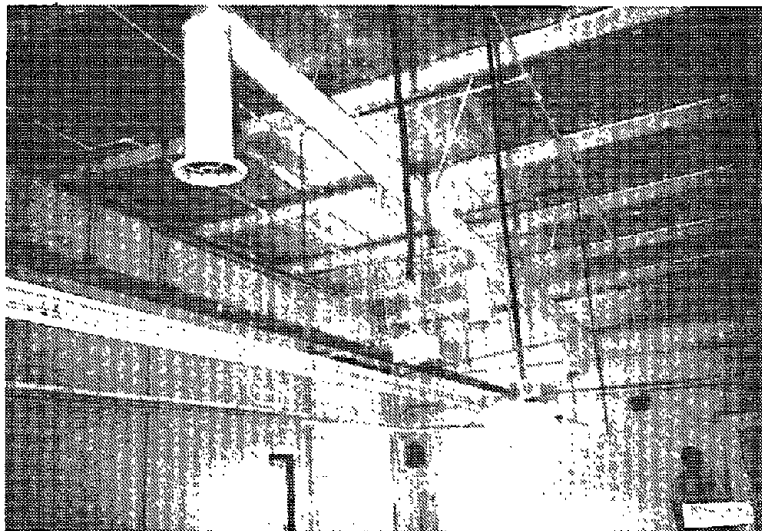
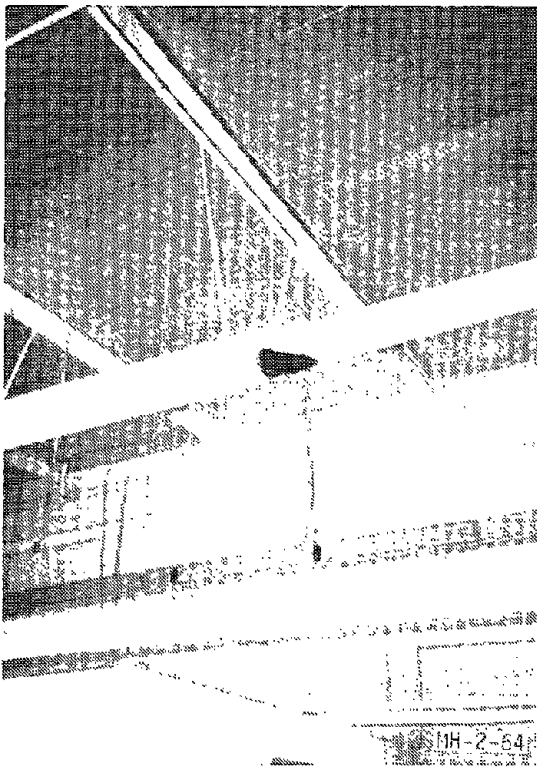
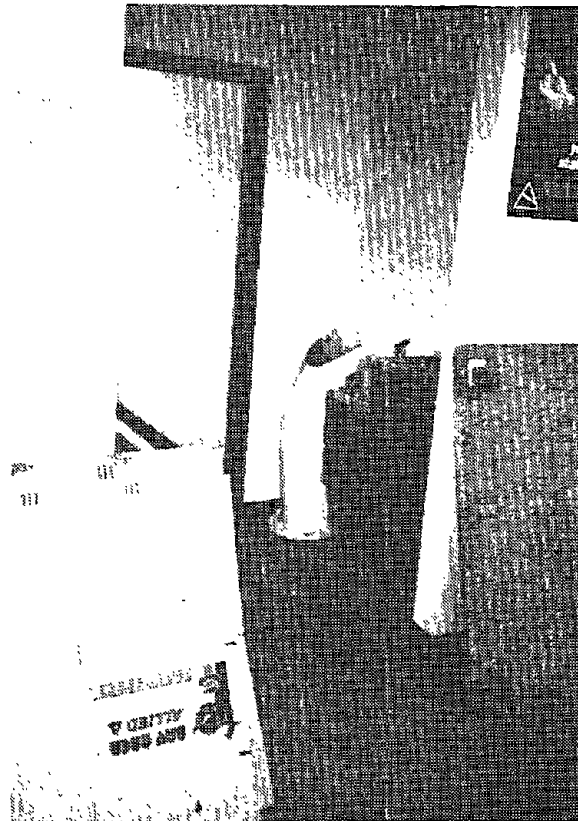
Figure 4-51: At a small electronics manufacturing facility, affected by the 1984 Morgan Hill Earthquake, a cantilevered, vertical section of HVAC duct broke from its horizontal header and fell.

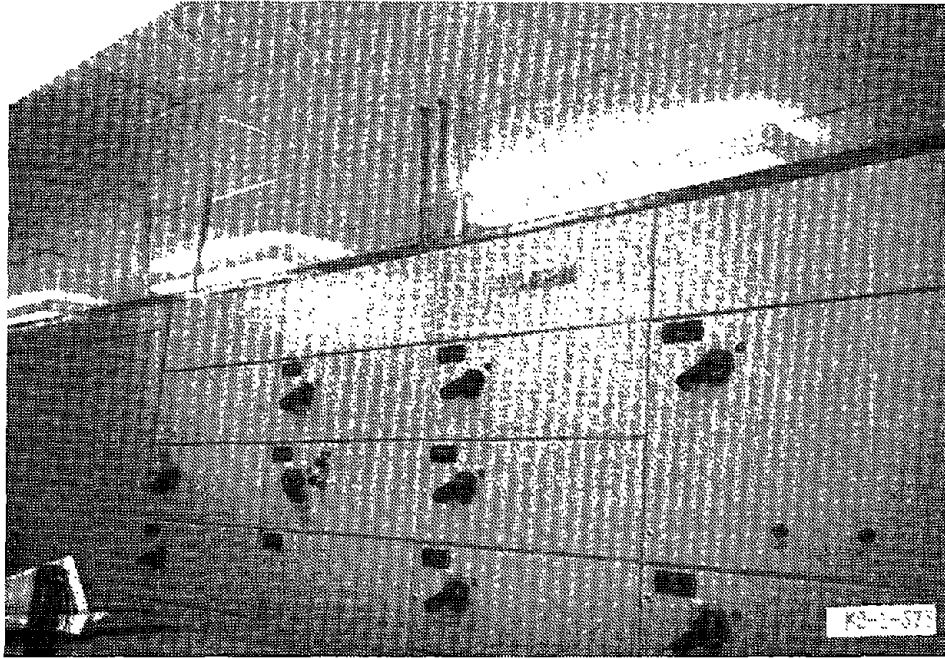
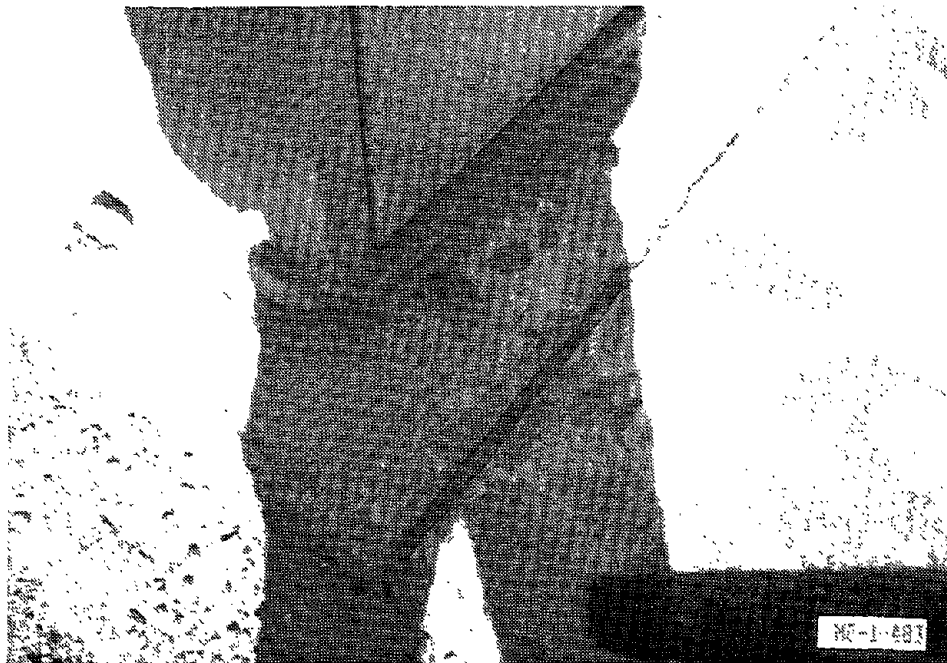
Figure 4-61: Two of the four MCCs at a pumping plant, affected by the 1983 sequence of earthquakes in Coalinga. All four MCCs were inadequately anchored and slid during the earthquake. Note the conduit in the upper photograph, which acted as an inadvertent restraint for the MCC, moved and damaged the ceiling.

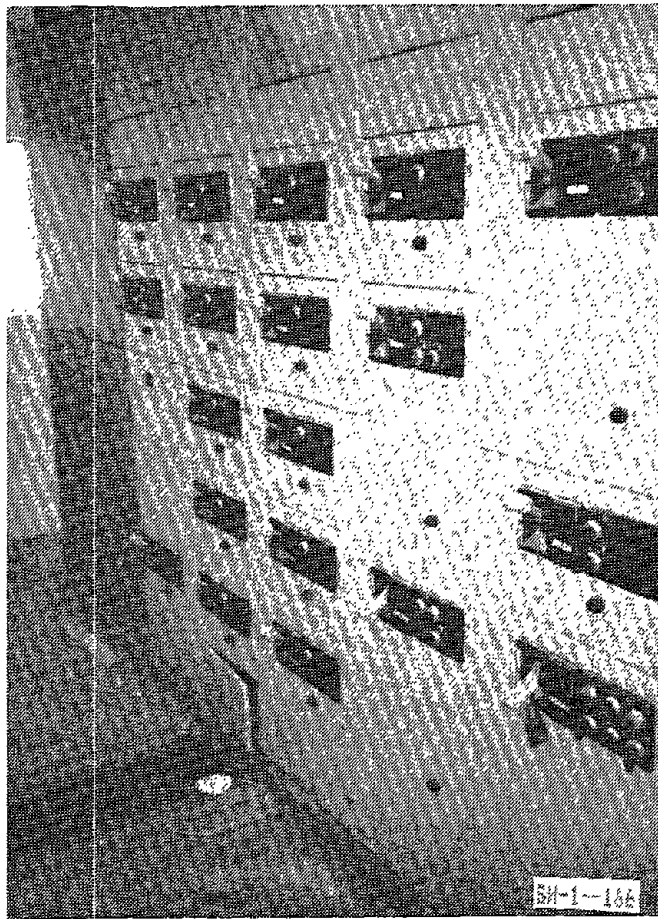
Figure 4-62: This MCC at a water treatment plant, affected by the 1983 sequence of earthquakes in Coalinga was inadequately anchored and slid during the earthquake. The motor controllers were undamaged.

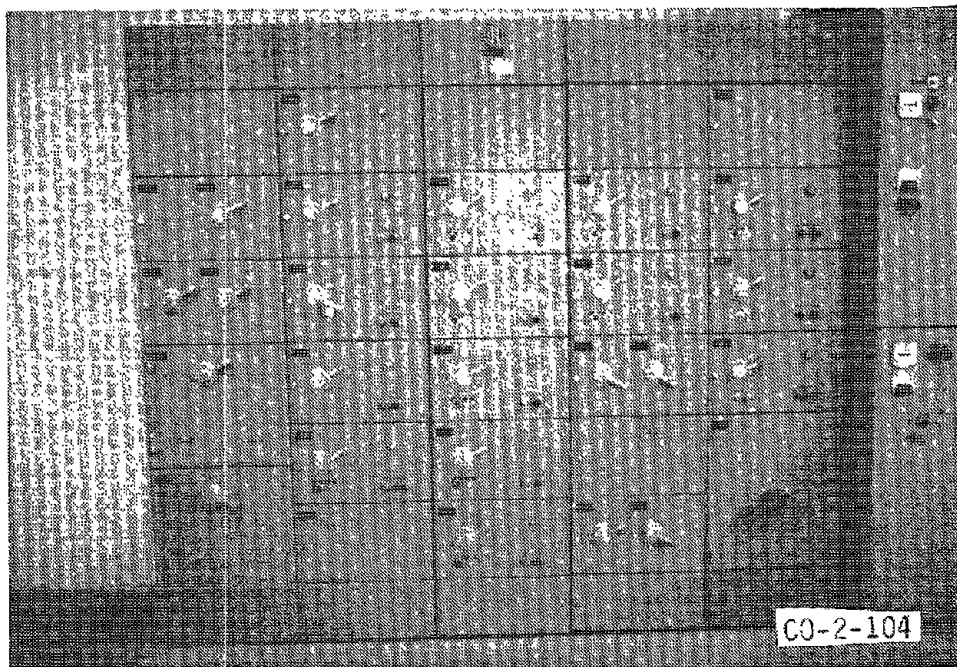
Figure 4-63: This unanchored MCC, at a water treatment plant slid approximately 3 inches during the 1983 sequence of earthquakes in Coalinga, but was not damaged.

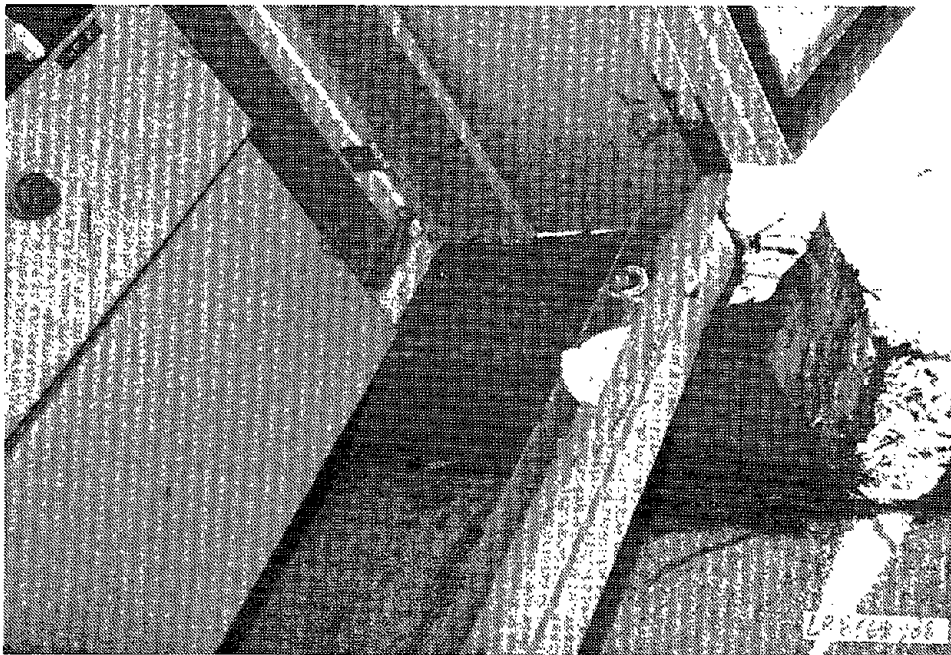
Figure 4-64: This roof-mounted MCC at a manufacturing facility, affected by the 1989 Loma Prieta Earthquake, pulled its anchorage. The anchorage design of the two-section unit used 3/8-inch lag bolts into wood.

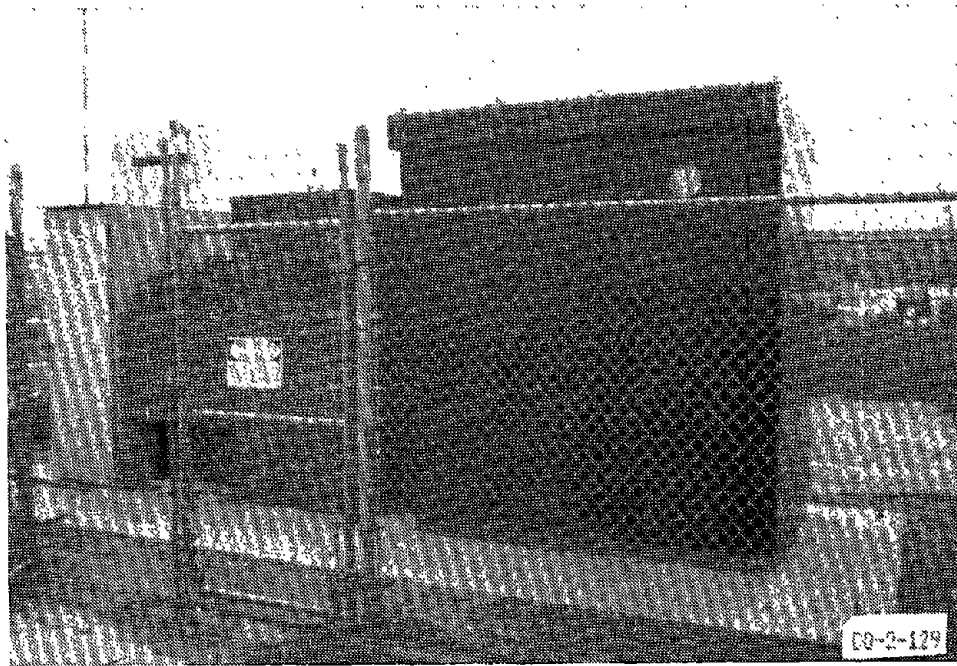
Figure 4-68: This assembly containing the substation transformer and attached 4.16 kV switchgear located at a water treatment plant, affected by the 1983 Coalinga Earthquake, slipped from its anchor clips and slid about two inches. This movement cracked a short section of plastic conduit running between the assembly and its concrete pad.

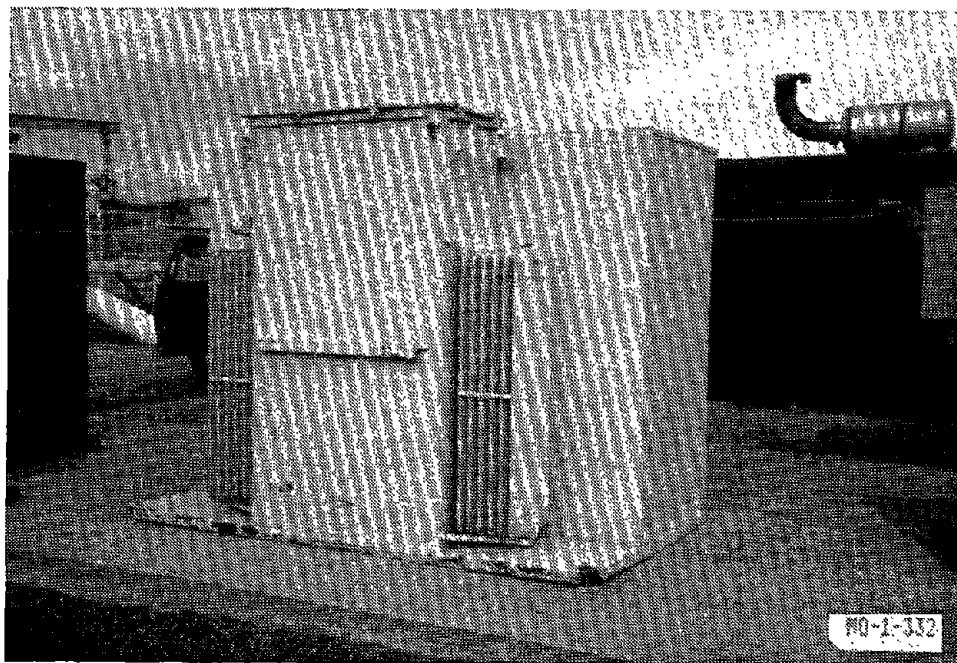
Figure 4-69: One of two transformers at a pumping plant that slid during the 1983 sequence of earthquakes in Coalinga.

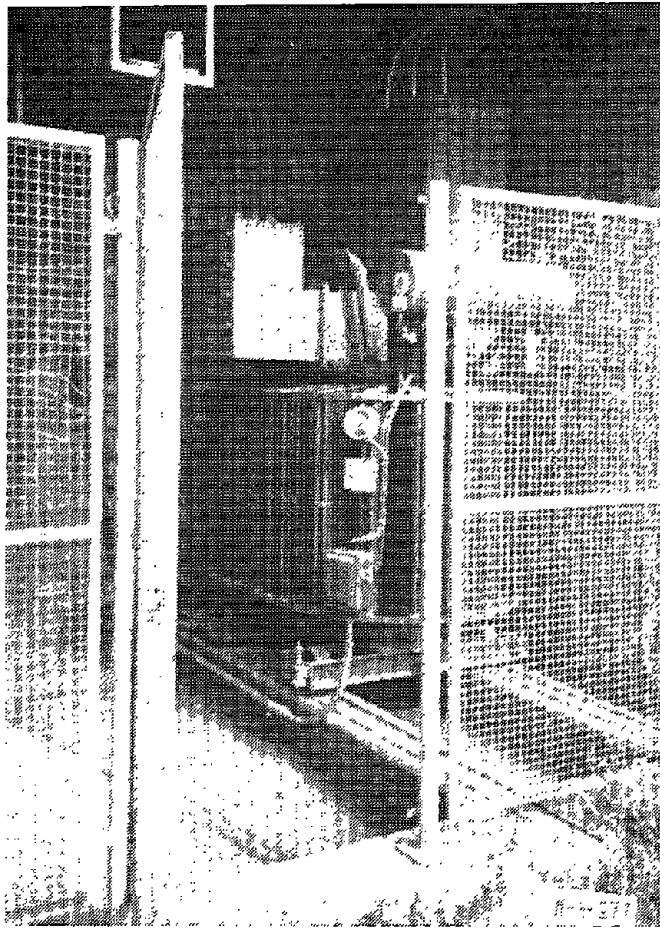
Figure 4-72: These rail-mounted unit substation transformers at a steel mill, affected by the 1985 Mexico Earthquake, fractured the bolts on their rail blocks and shifted during the earthquake.
