**Seismic Vulnerability of Equipment in Critical Facilities:
Life-Safety and Operational Consequences**

November 24, 1993

Technical Report NCEER-93-0022

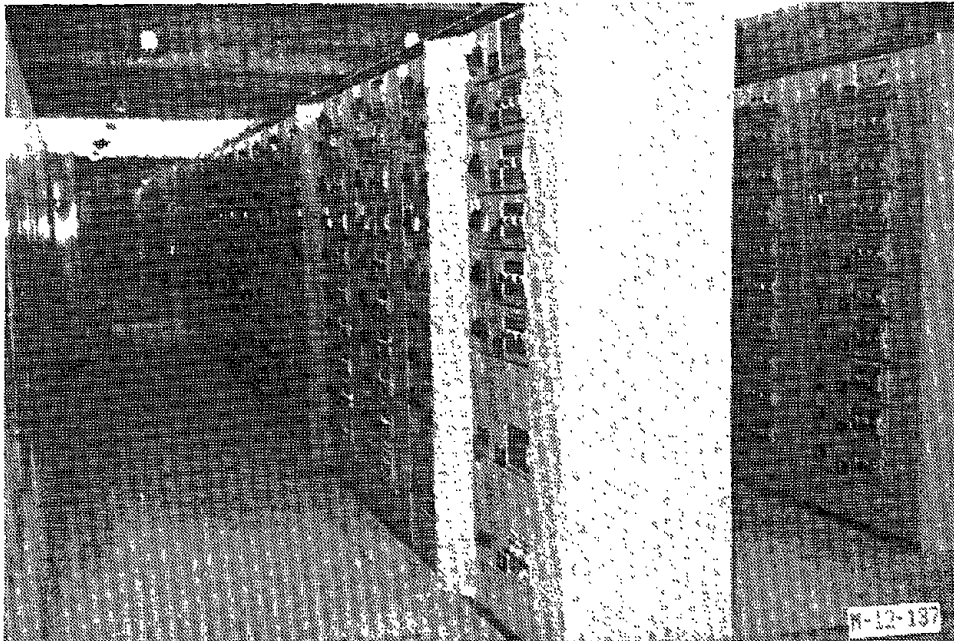
Figure 4-73: These MCCs at a chemical plant, affected by the 1985 Mexico Earthquake, sustained damage due both to inadequate anchorage and structural damage to the cabinet.

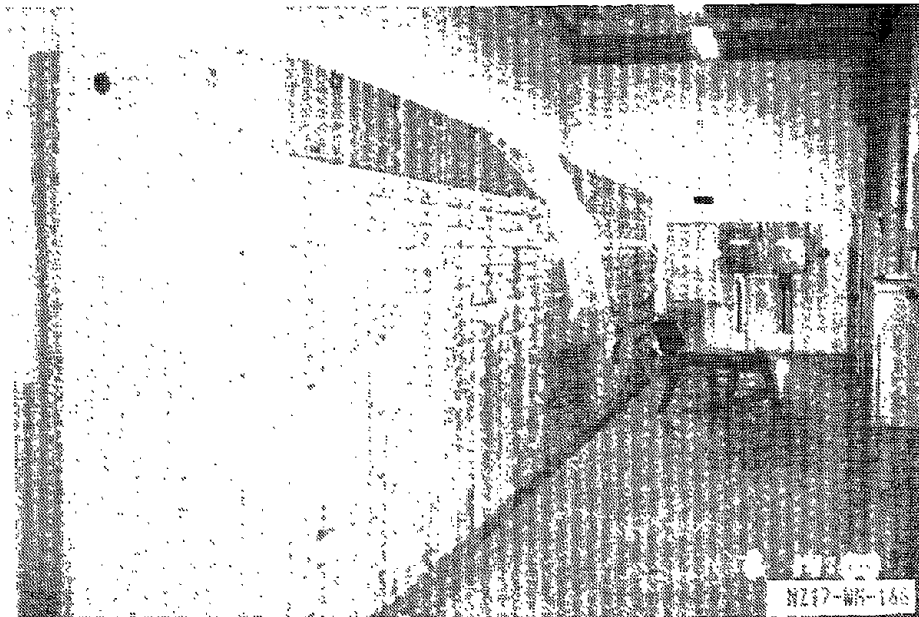
Figure 4-74: Several slide-mounted motor controllers in this MCC at a paper mill, affected by the 1987 New Zealand Earthquake slid forward from the front face of the MCC, but did not fall to the floor. When pushed back into position, the motor controllers remained functional.

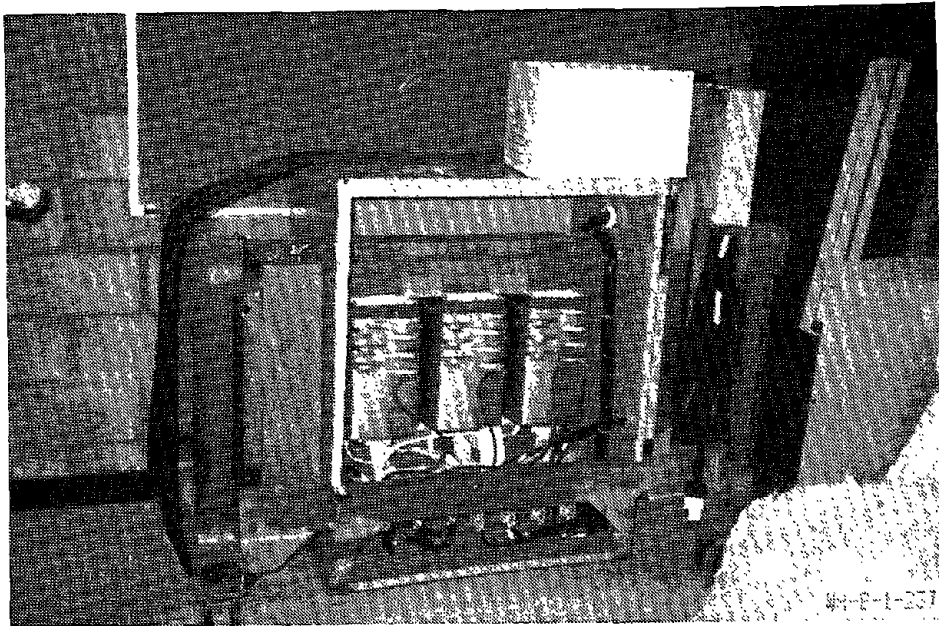
Figure 4-76: One of two dry-type distribution transformers located at a bank computer facility, which was damaged during the 1987 Whittier Earthquake. During the earthquake, the channel supporting the internal core-coil assembly deformed to the extent that the core-coil impacted and damaged the enclosure siding. Note that the frame shown in the photograph is a post-earthquake modification.

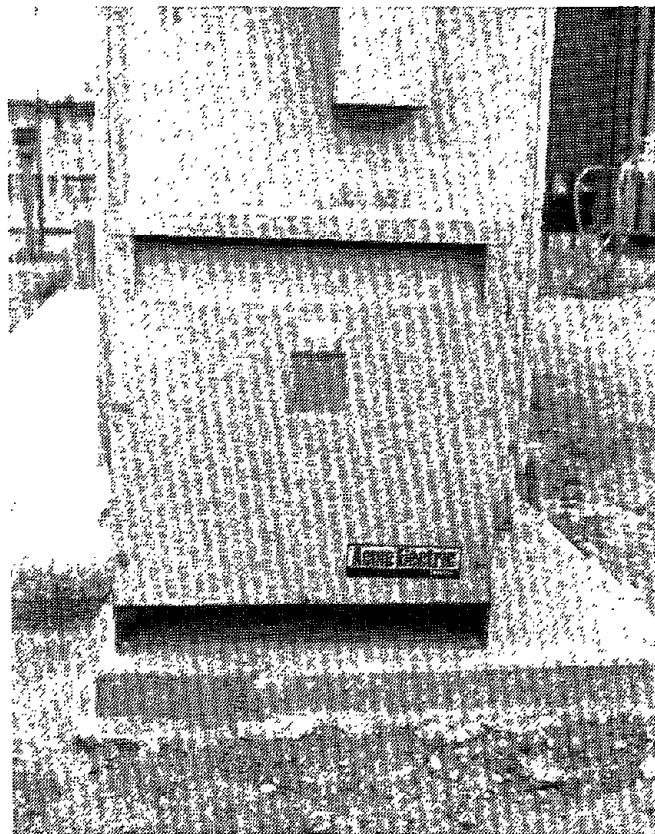
Figure 4-77: The foundation pad for this distribution transformer at a petrochemical facility, was damaged by the 1983 Coalinga Earthquake. An earthquake-induced crack broke the ground near the corner of the transformer's foundation pad.

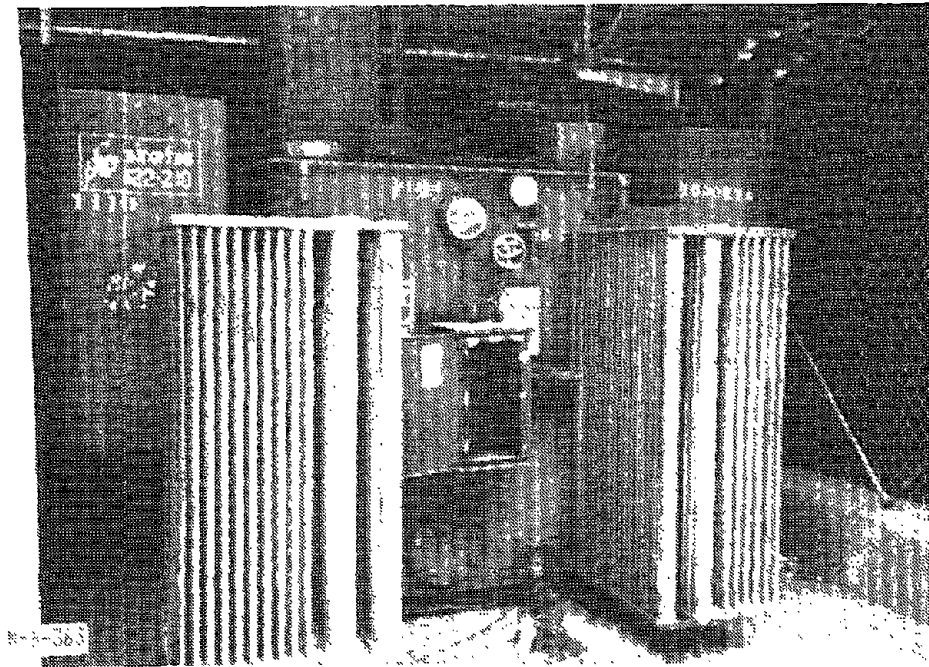
Figure 4-80: This unanchored, oil-filled transformer at a steel mill, suffered an internal short circuit during the 1985 Mexico Earthquake. Apparently, a ground fault occurred in an internal bus connection of the transformer, burning windings in one coil.

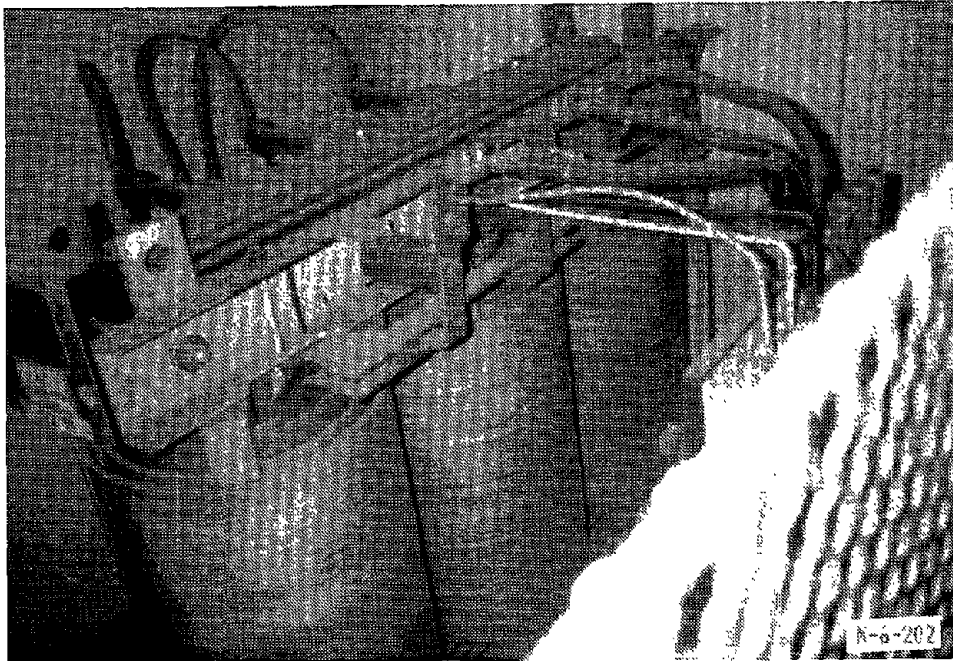
Figure 4-84: This unclad transformer at a steel mill, affected by the 1985 Mexico Earthquake, was hit by a light fixture. The transformer is enclosed in a mesh fence but is otherwise unclad to allow natural air cooling.
