TWR-63941

**Flight 20 (STS-45)
Polysulfide Gas Path Investigation
Final Report**

July 1992

Thiokol CORPORATION
SPACE OPERATIONS

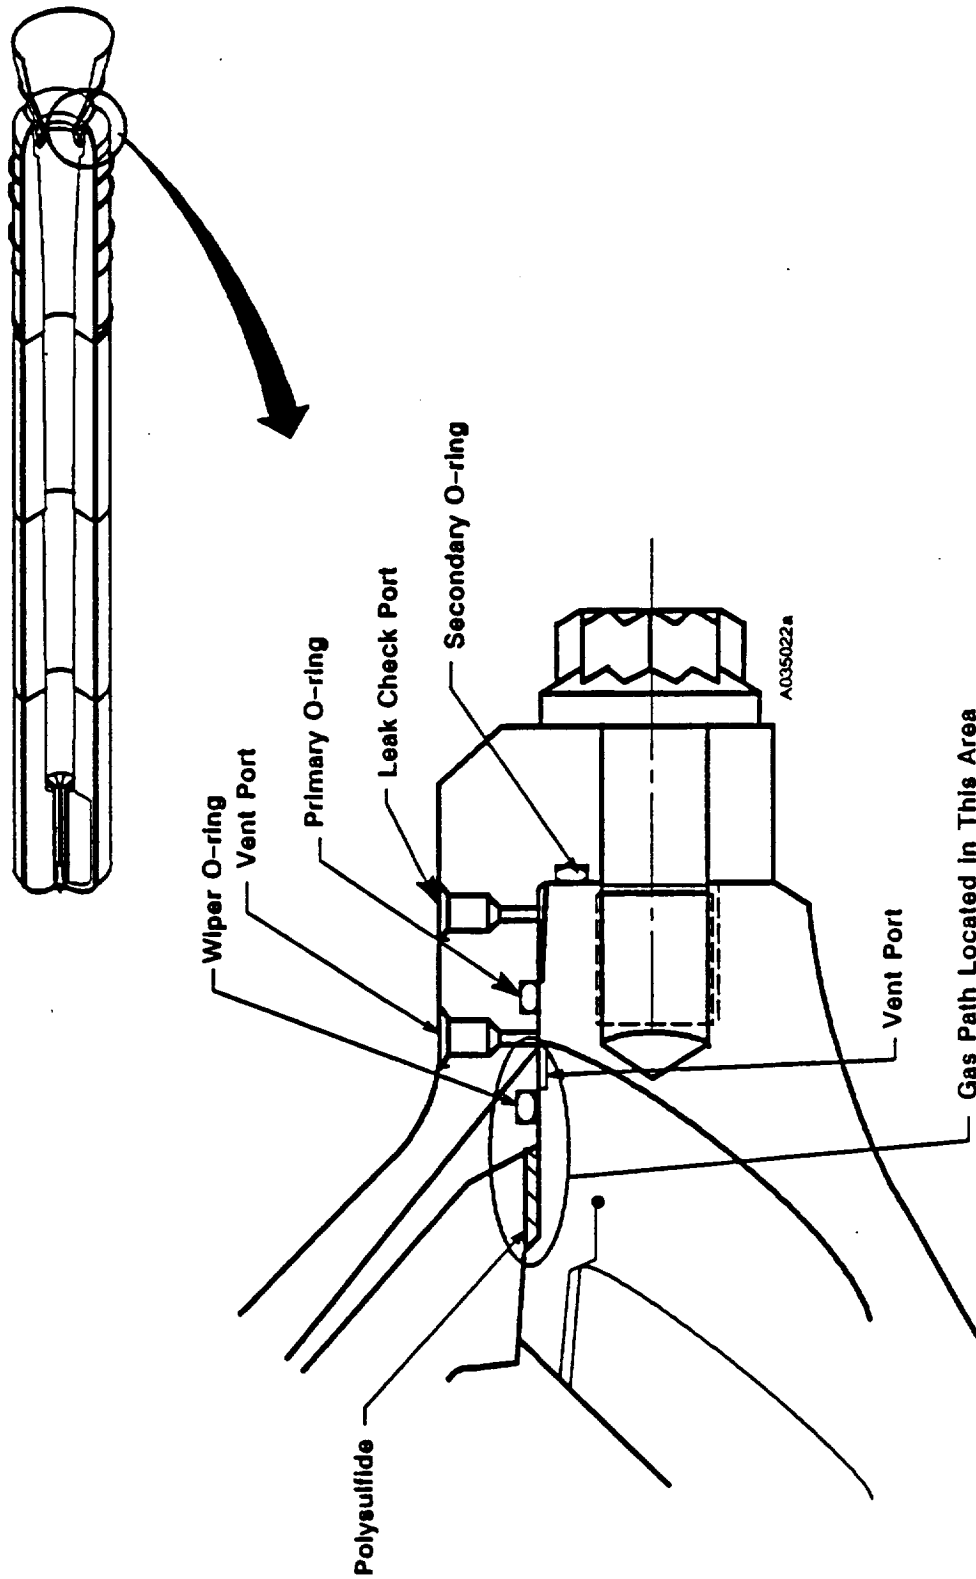
Figure 4-1. General Location of Gas Path

- a. The gas path within the nozzle-to-case joint polysulfide at 57.6 deg on the 20A, extending from the motor chamber to the wiper O-ring (see Figures 4-1 and 4-2).
- b. Evidence of combustion gas blow-by beyond the wiper O-ring with local heat damage to the wiper O-ring (see Figure 4-2).
- c. A gas path within the polysulfide at 247 deg on the 20B nozzle-to-case joint (see Figures 4-1 and 4-2).

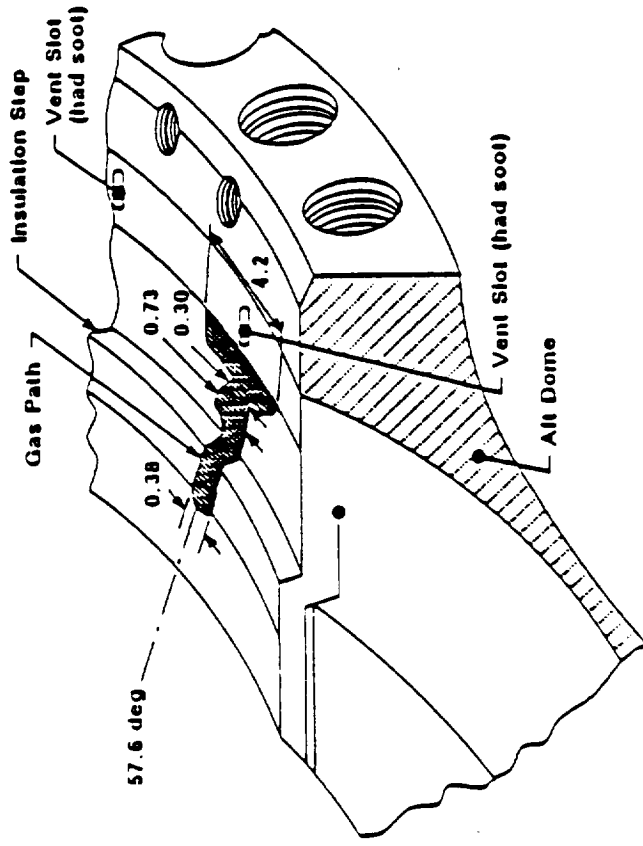
Figure B-1. Gas Path on RSRM-20A Aft Dome

- The polysulfide immediately in front of the wiper O-ring was heat affected full circumference as evidenced by a darker colored polysulfide.
- Soot was observed on the forward wall, aft wall and on the bottom of the wiper O-ring groove in the fixed housing intermittently between 50 and 79 degrees.

- Soot was observed past the wiper O-ring groove at the vent slot locations at 57.6 and 64.8 degrees. No soot was observed to the primary O-ring.
- Soot was not observed across the wiper O-ring footprint in the bottom of the groove, i.e., the blowby occurred on the NBR side of the wiper O-ring.

Gas Path at 57.6 Degrees
SIS-42 (3601020) LH (A)

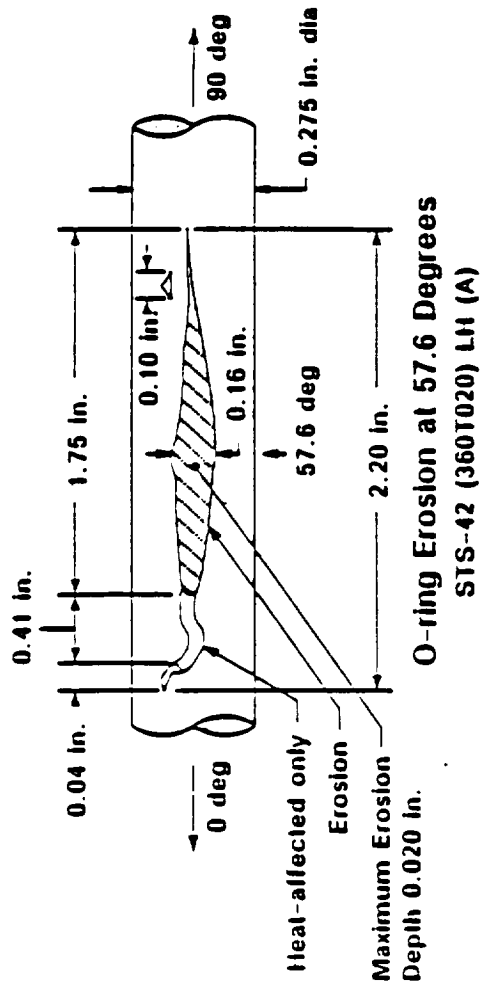
Figure B-2. RSRM-20A Wiper O-Ring

- Circumferential heat effect and erosion were observed on the wiper O-ring centered at 57.6 degrees and measured 2.2 inches long by 0.020 inch maximum depth, Figure B-2.

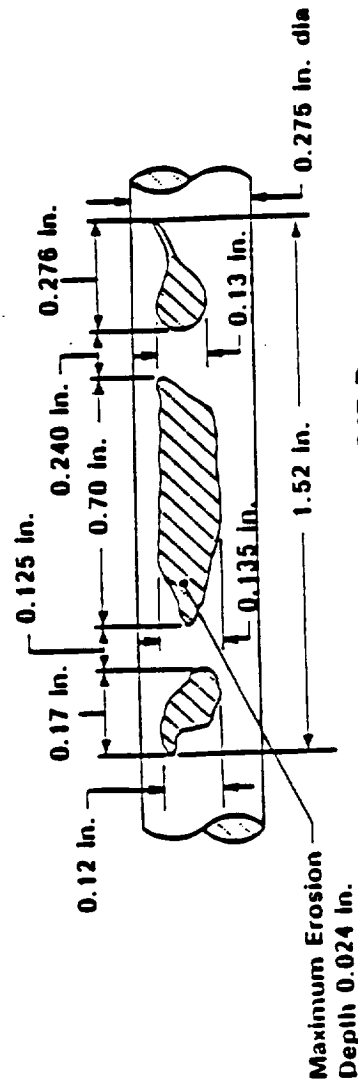
Figure B-4. RSRM-20B Wiper O-Ring

- Circumferential heat effect and erosion were observed on the wiper O-ring in three locations centered at 247 degrees and measured 1.52 inches long overall by 0.024 inch maximum depth, Figure B-4.

O-ring Erosion at 247 Degrees
STS-42 (360T020) RH (B)

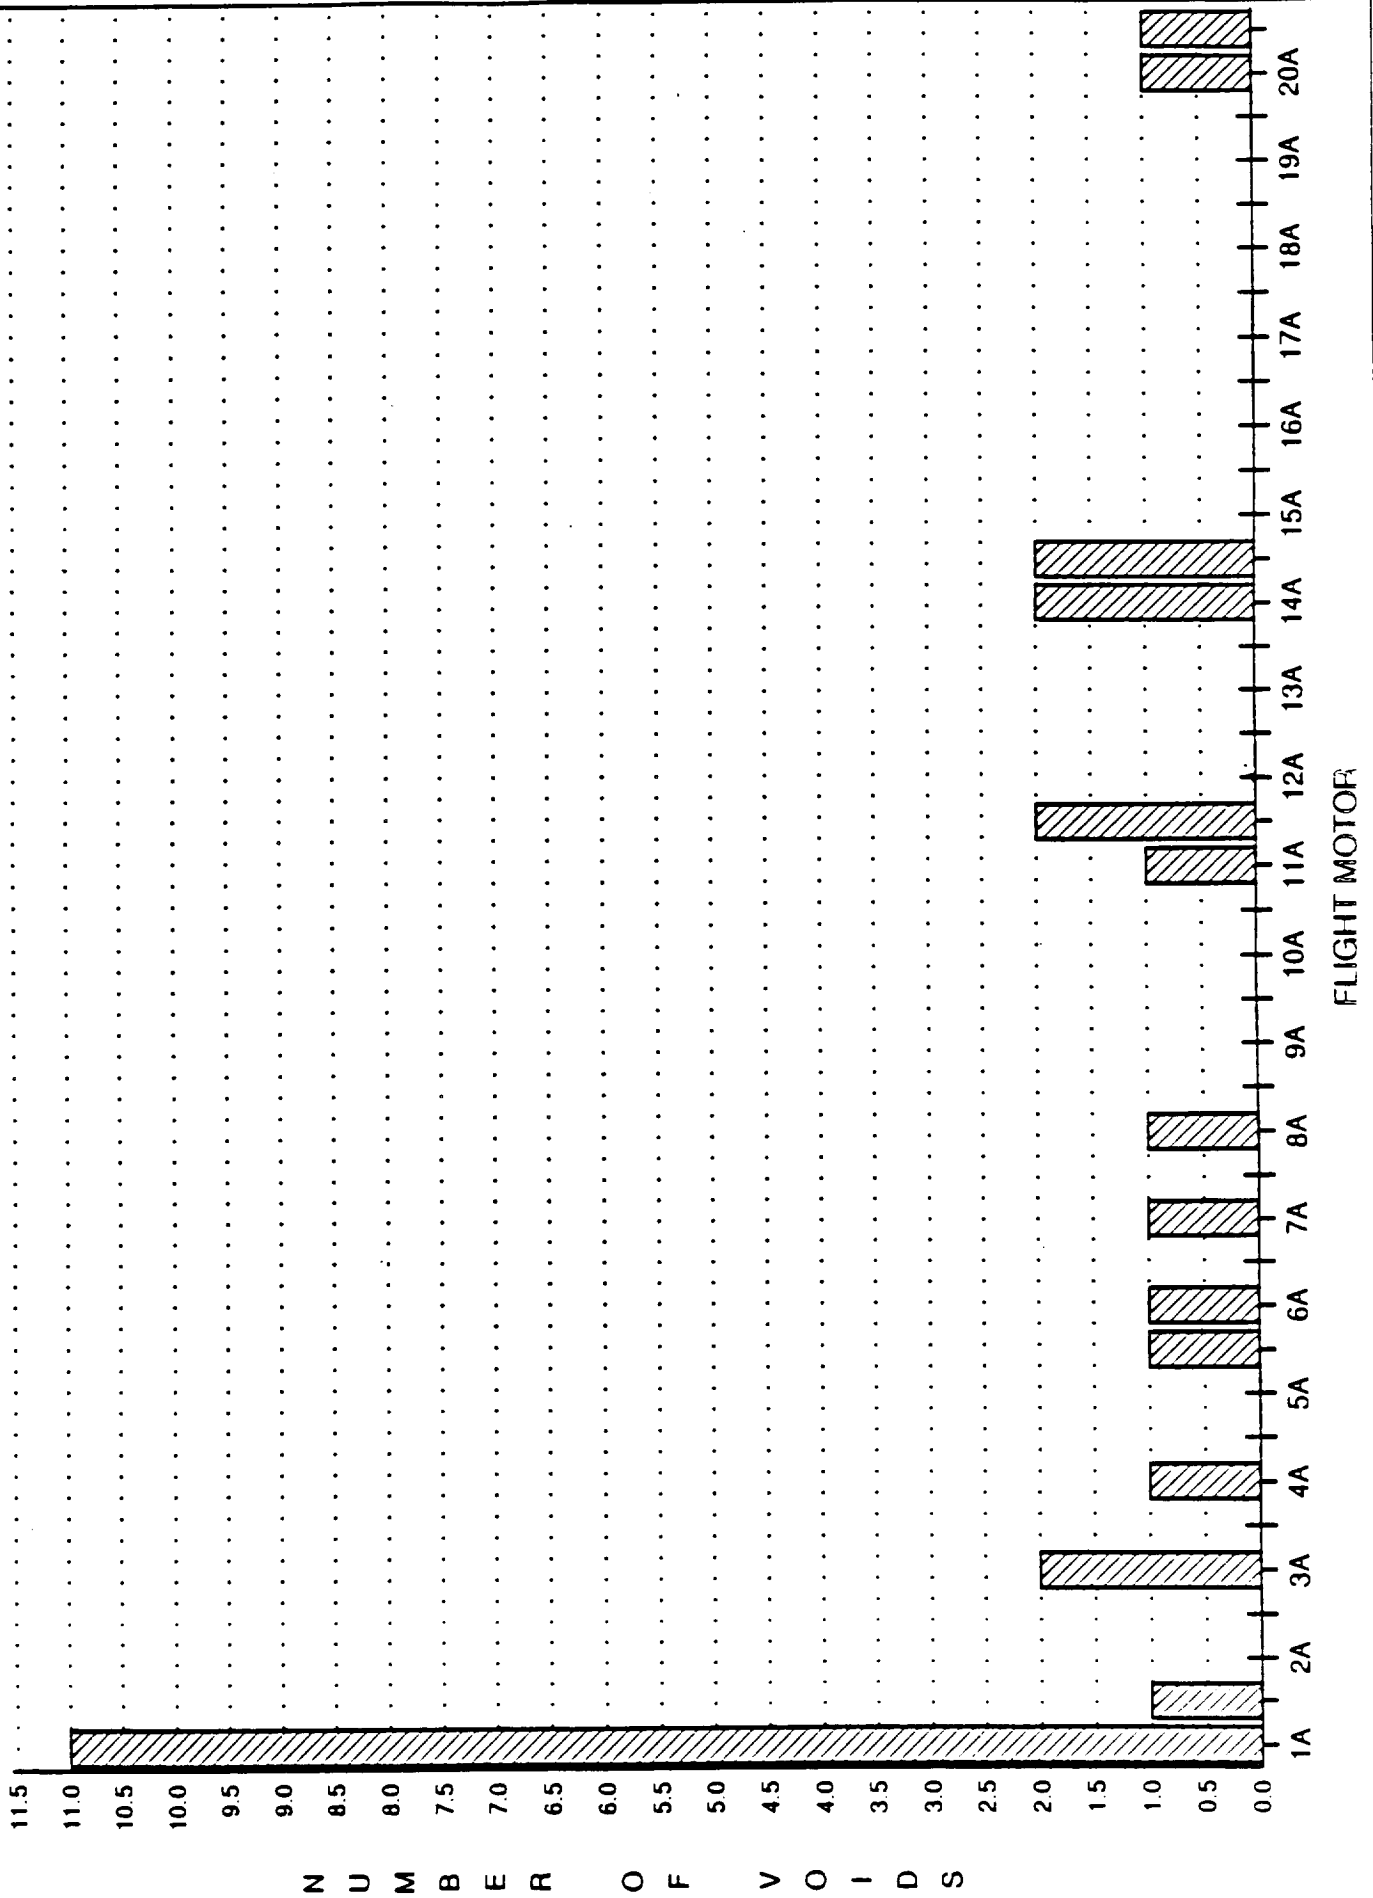
Figure B-5. Void Formation

Attached are plots of voids greater than 1.0-inch axial length and voids greater than 0.5-inch axial length for flight motors (Figures B-5 and B-6). The charts do not show an increase in the number of significant voids observed. Also plotted were the degree location of voids larger than

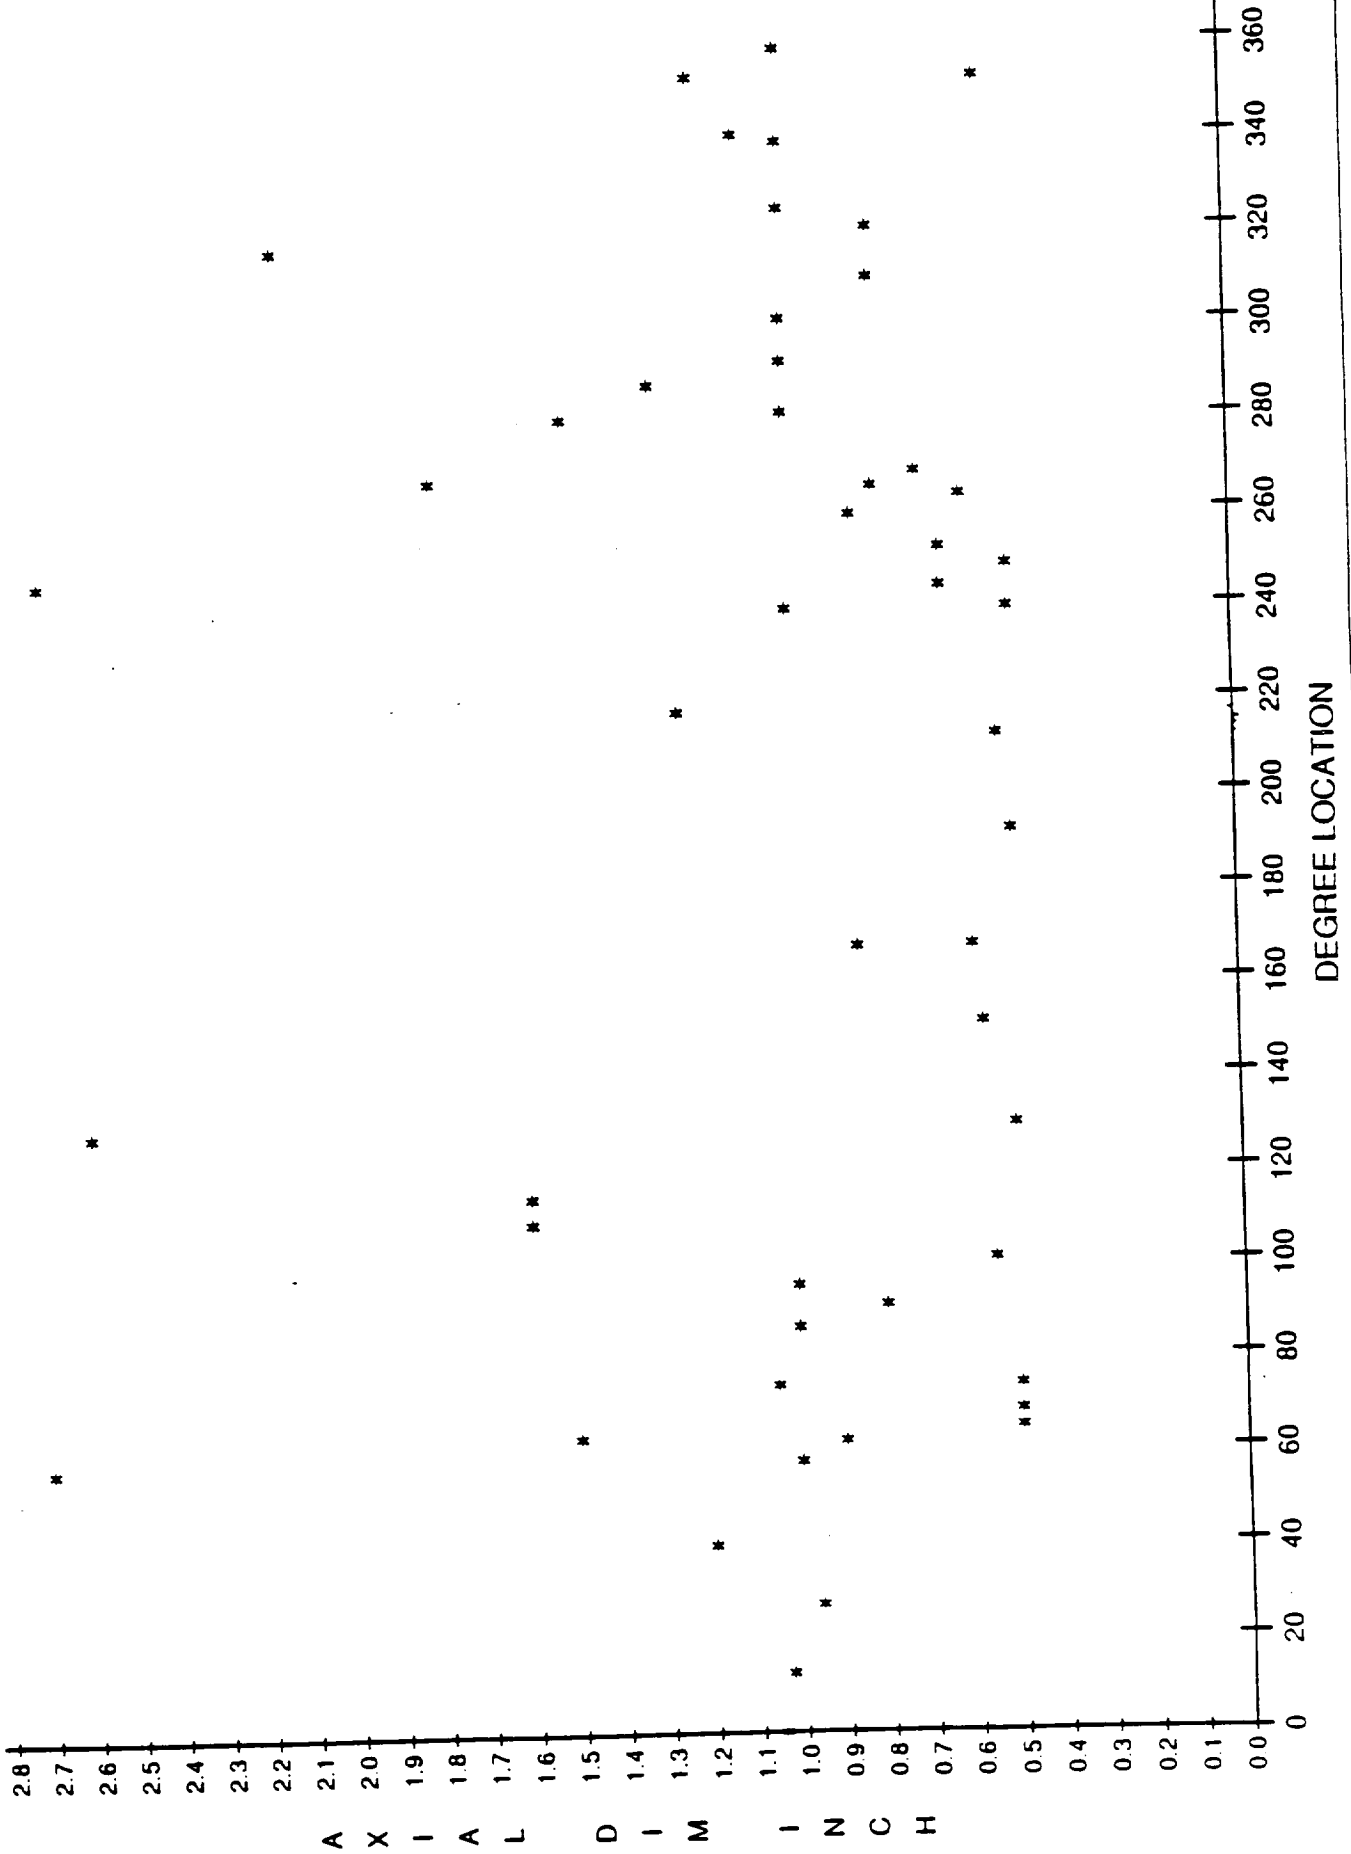
Figure R-7. Void Formation

0.5-inch axial length, Figure B-7. The voids do not appear to concentrate in any area.

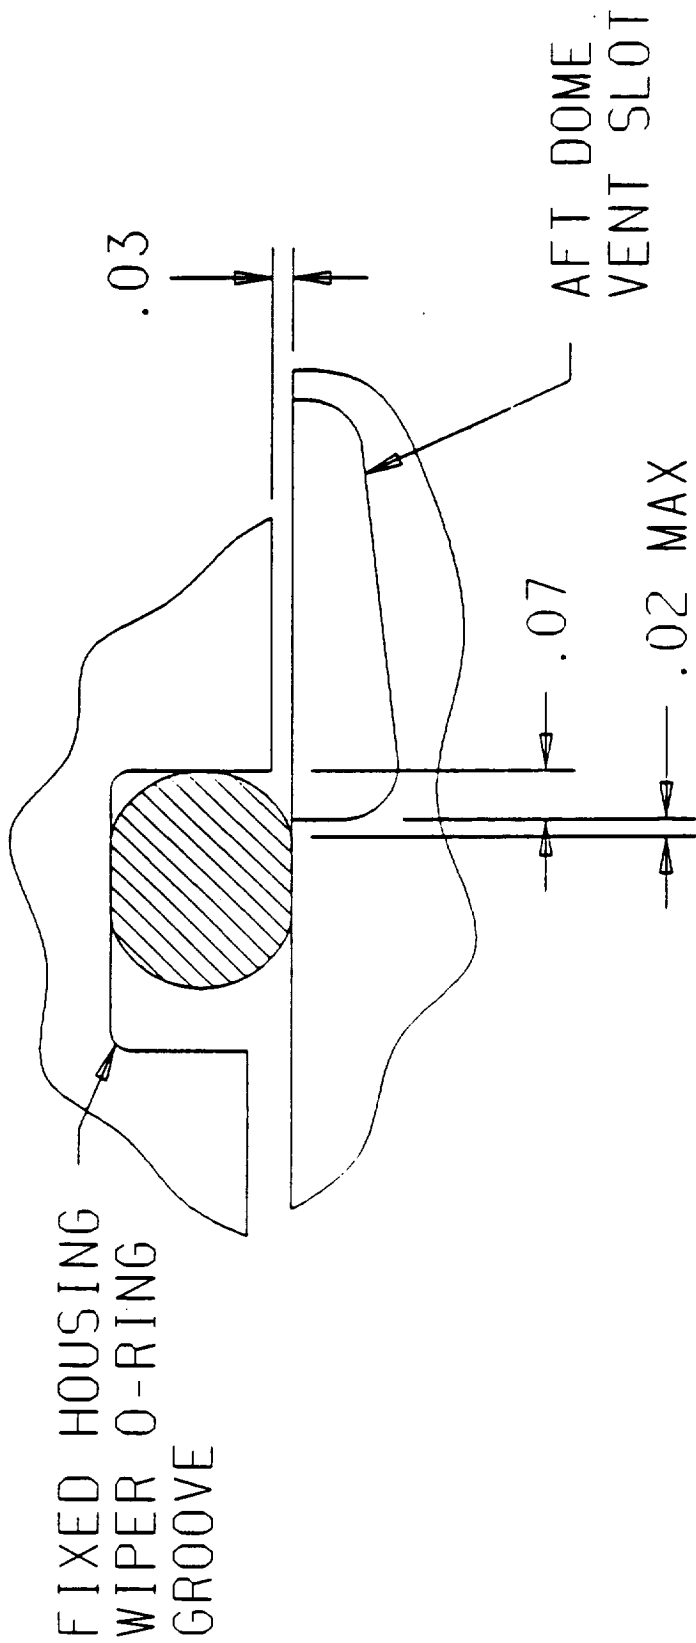
Figure B-17. Assembled Wiper O-Ring Configuration

RSRM 20A, ACTUAL WIPER O-RING CONFIGURATION AT 57.6° (

MAX O-RING GROOVE WIDTH: .381
 MAX O-RING GROOVE DEPTH, FROM F.H. METAL SURFACE: .201
 MIN O-RING DIAMETER: .2731
 O-RING DEFORMED LENGTH: .303 - .307
 O-RING FOOTPRINT: .130 - .134

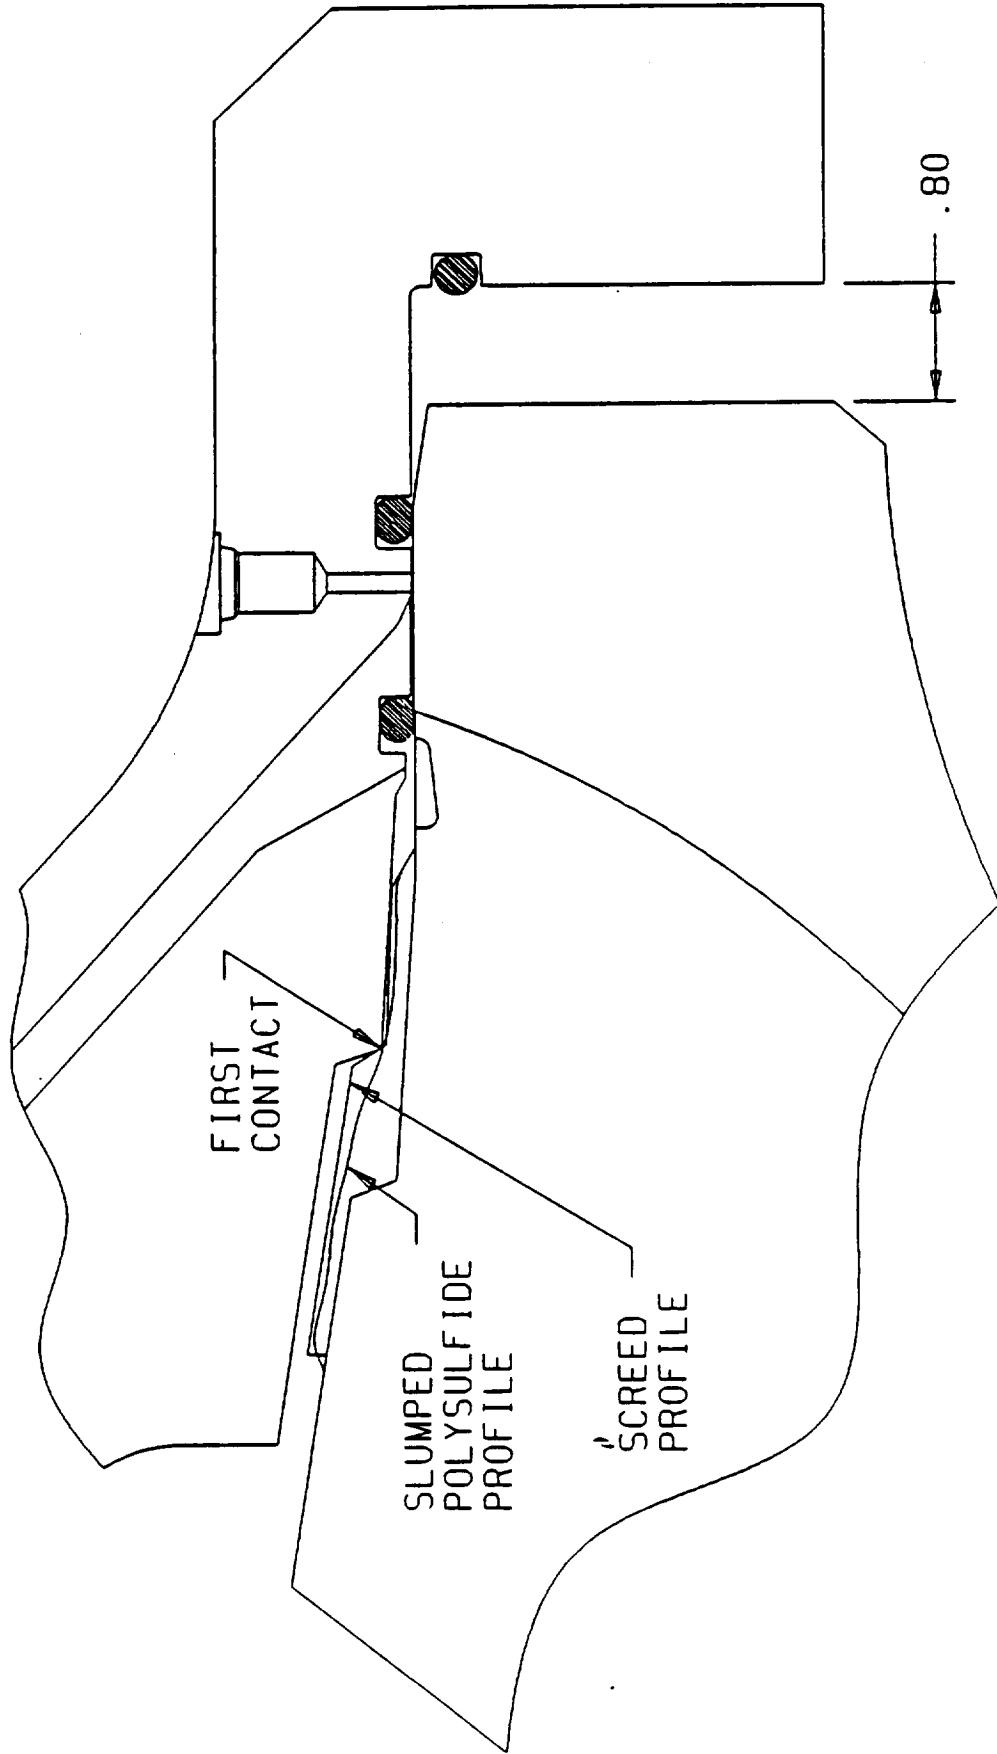
Figure B-26. Nozzle-to-Case Joint Assembly

remained the same shape as the screed, i.e. no slumping, then the fixed housing would first contact the bead at the same point in the assembly, Figure B-26. This demonstrates that the variation in slump commonly seen with the current polysulfide has little effect on when the fixed housing first contacts the adhesive bead, because the edge of the adhesive that is first contacted by the fixed housing does not slump significantly, due to the close proximity to the aft dome surface.)

JOINT GAP (.80) WHEN FIXED HOUSING FIRST CONTACTS POLYSULFIDE, IF POLYSULFIDE MAINTAINED THE PROFILE OF THE APPLICATION SCREED.
