2016 BRIDGE INSPECTION REPORT
March 18, 2016

BRIDGE NO. CE0079001
BREWSTER BRIDGE ROAD
OVER
BIG ELK CREEK

SABRA, WANG & ASSOCIATES, INC.

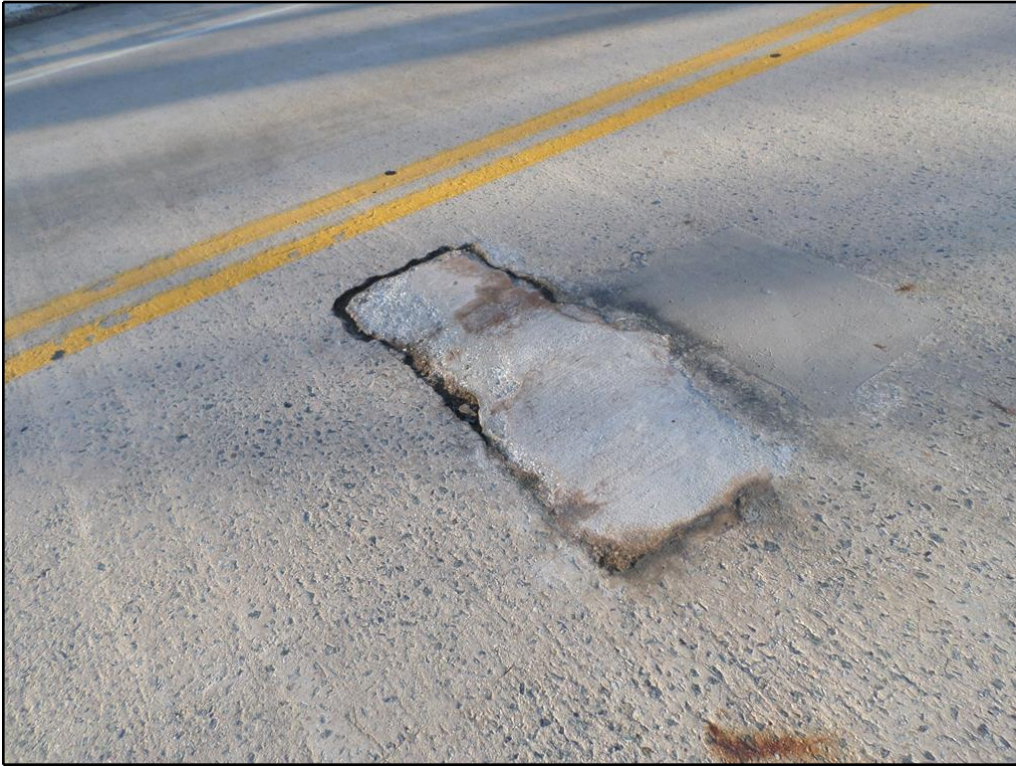
1. The deck is in overall satisfactory condition. There are multiple patches, hollow sounding areas and random cracking throughout the deck. There is a failing patch with up to 3/4" deep spalling in the westbound lane in Span No. 2 (see Photograph No. 7). The spall with exposed reinforcement in the westbound lane in Span No. 2 has been patched since the previous inspection (see Photograph No. 8). There is a 1'-0" diameter x 1/2" deep spall in the eastbound lane over Pier No. 2 (see Photograph No. 9).

7. Failing patch in westbound lane of Span No. 2

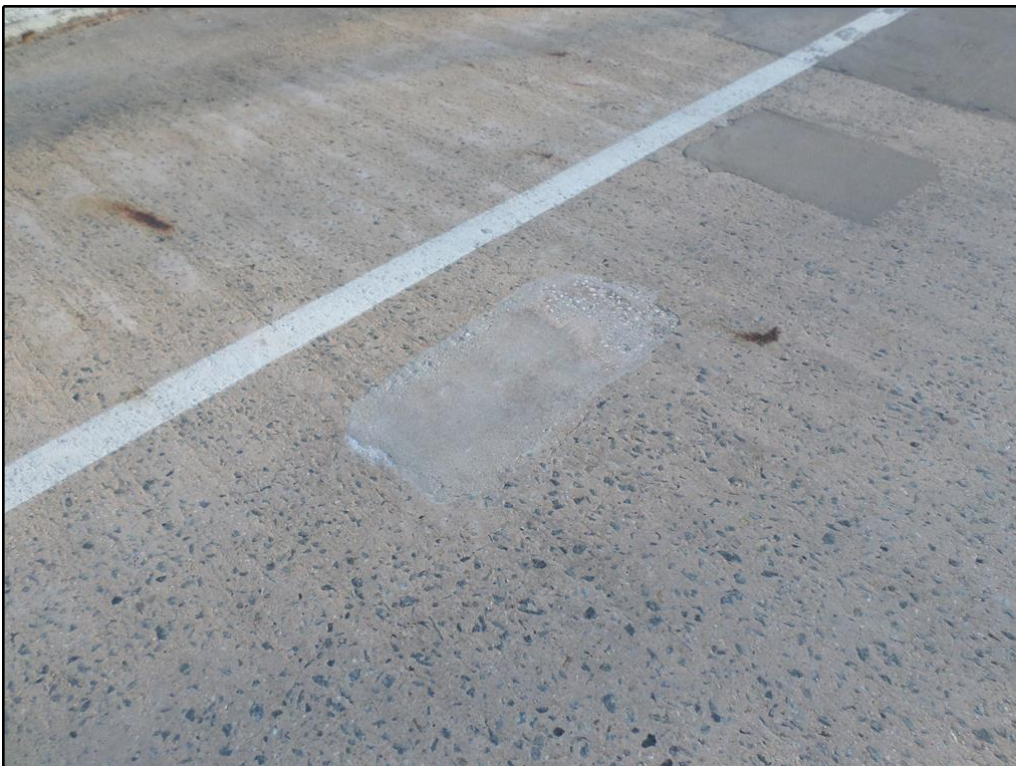
1. There are additional spalls and cracks in the concrete deck.
2. The spall with exposed reinforcement in the westbound lane in Span No. 2 has been patched since the previous inspection.

8. Patched spall in westbound lane of Span No. 2

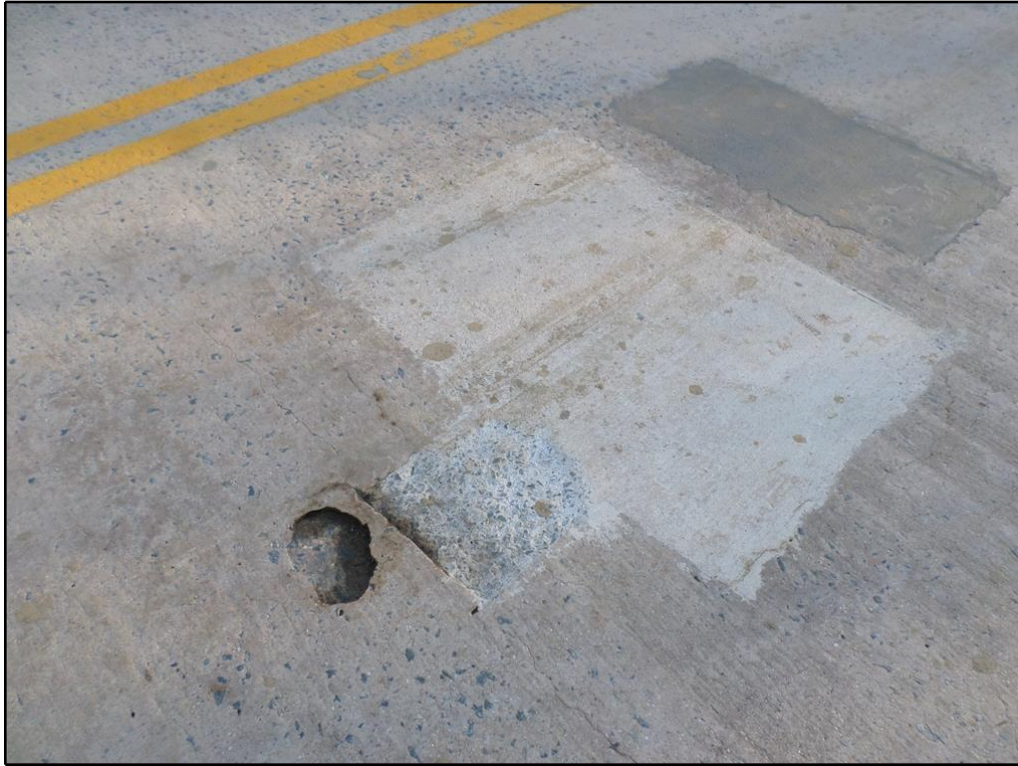
9. Spall in eastbound lane over Pier No. 2

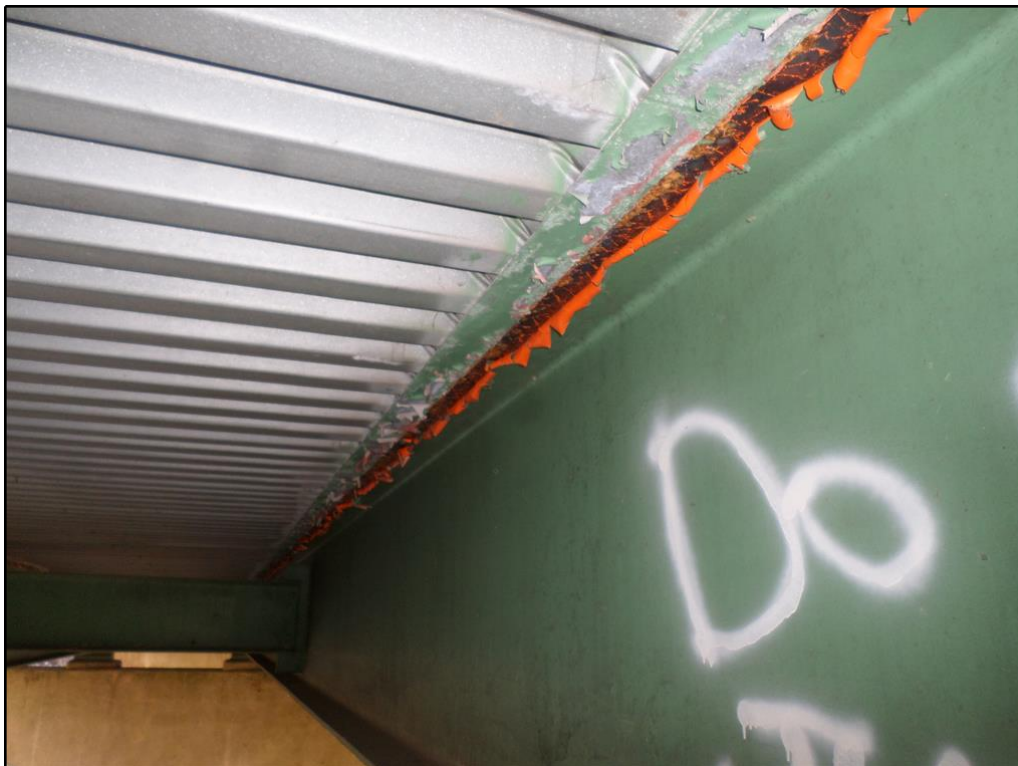
2. The painted steel beams are in satisfactory condition. The beams typically exhibit areas of paint failure along the edges of the top flange plates in all spans (see Photograph No. 10). There are random areas of flaking and peeling paint on the webs and bottom flanges throughout (see Photograph No. 11). There is graffiti on the beams in Span Nos. 1 and 3. There are random areas of minor web pitting on the exterior beam fascia in a few locations (see Photograph No. 12).

10. Typical peeling paint along the top flange (Beam No. 3, Span No. 1 shown)

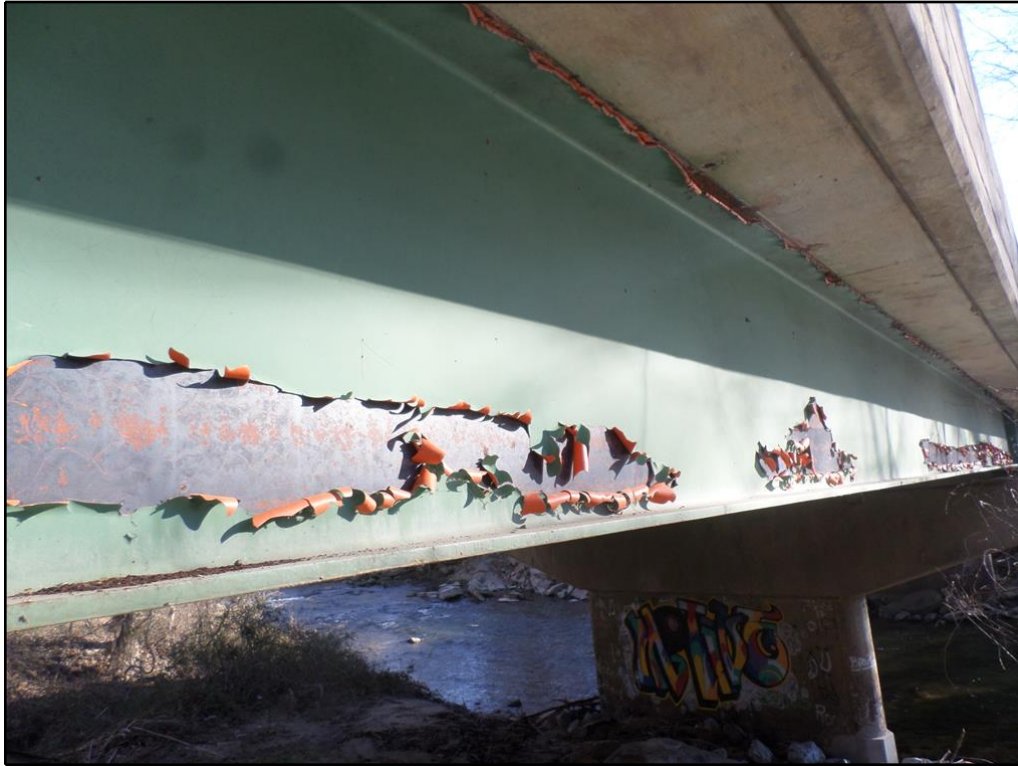
11. Typical flaking and peeling paint of beams (Beam No. 6, Span No. 1 shown)

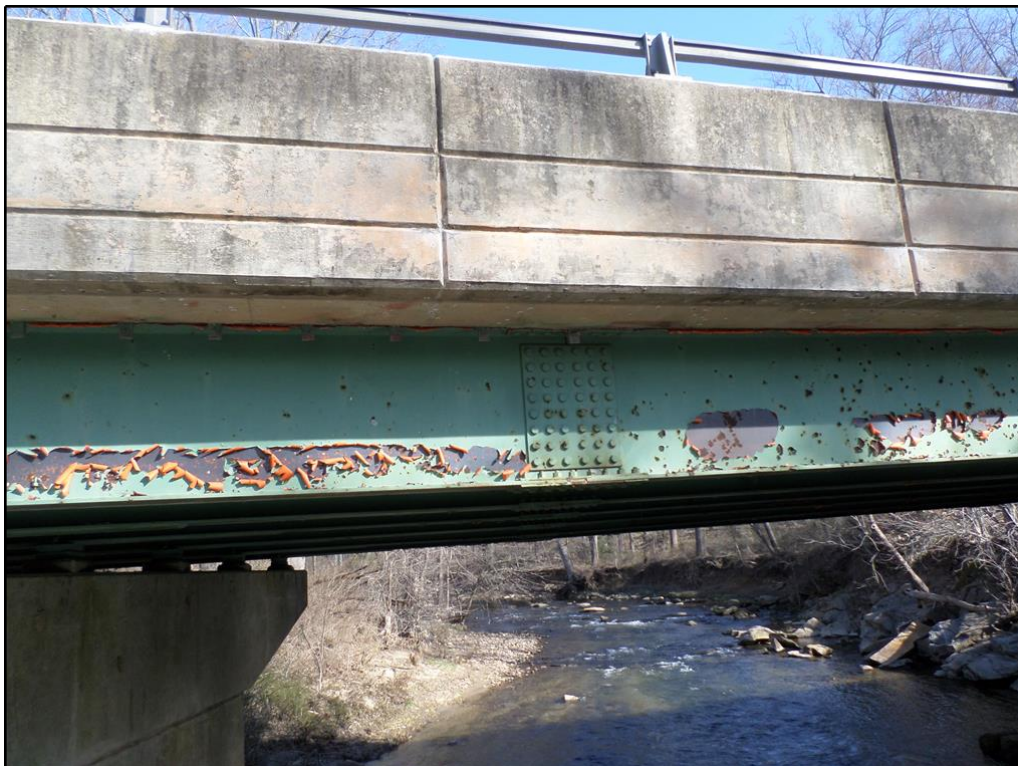
12. Typical peeling paint with minor corrosion on exterior fascia (Beam No. 6 shown)

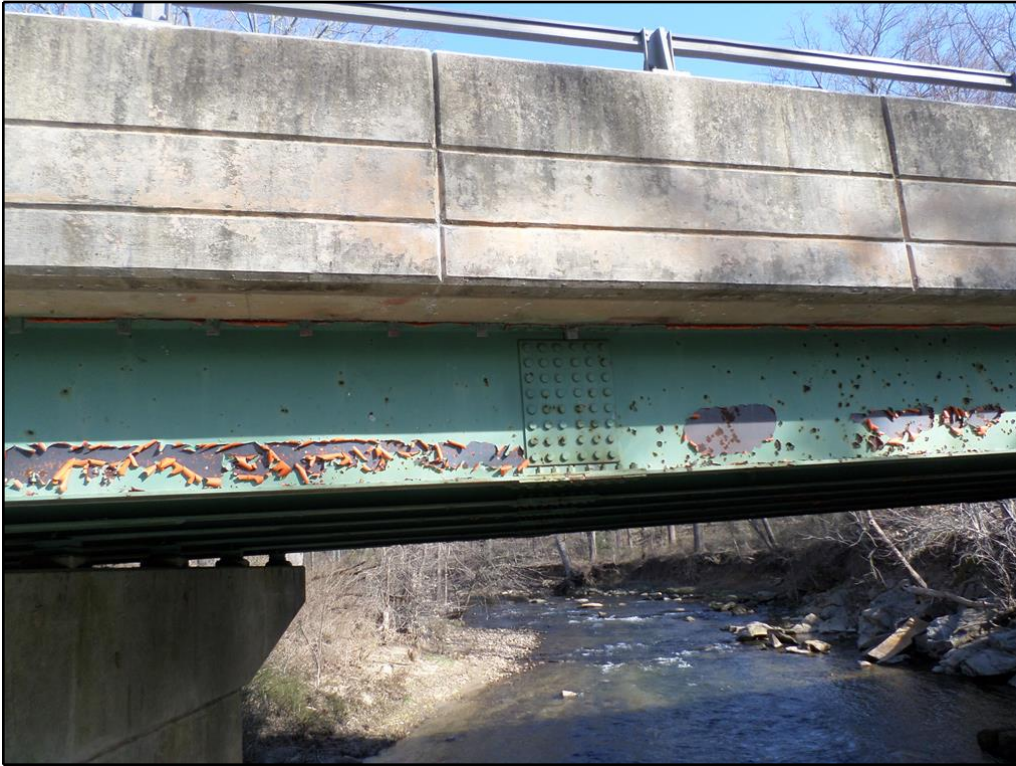
There is minor sag in Beam No. 1 at Splice No. 2 and in Beam No. 6 at Splice No. 1 in Span No. 2. There are random areas of paint failure on the splice plates throughout, resulting in minor surface corrosion. Beam No. 6 exhibits a 1/2" diameter hole in an area of painted over pitting at the west abutment.

13. Sag in Beam No. 6 at Span No. 2

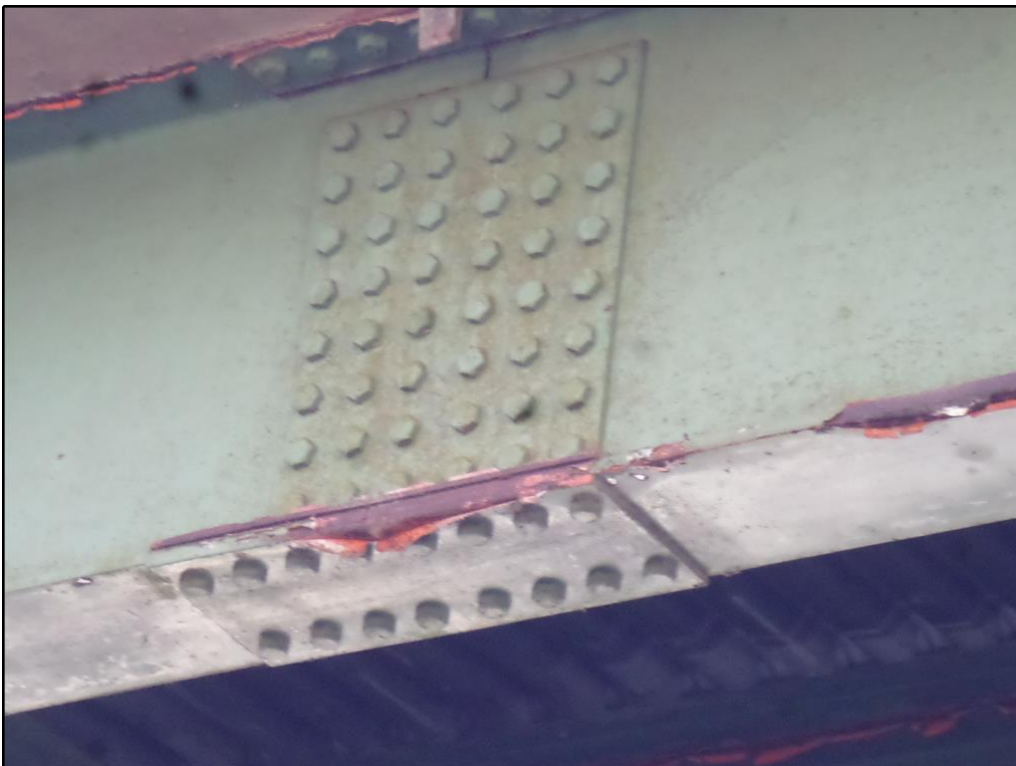
There are random areas of paint failure on the splice plates throughout, resulting in minor surface corrosion (see Photograph No. 14). There are a few missing nuts and/or bolts at the diaphragm connections.

14. Typical minor corrosion and pack rust at beam splices (Beam No. 1, Splice No. 1 shown)

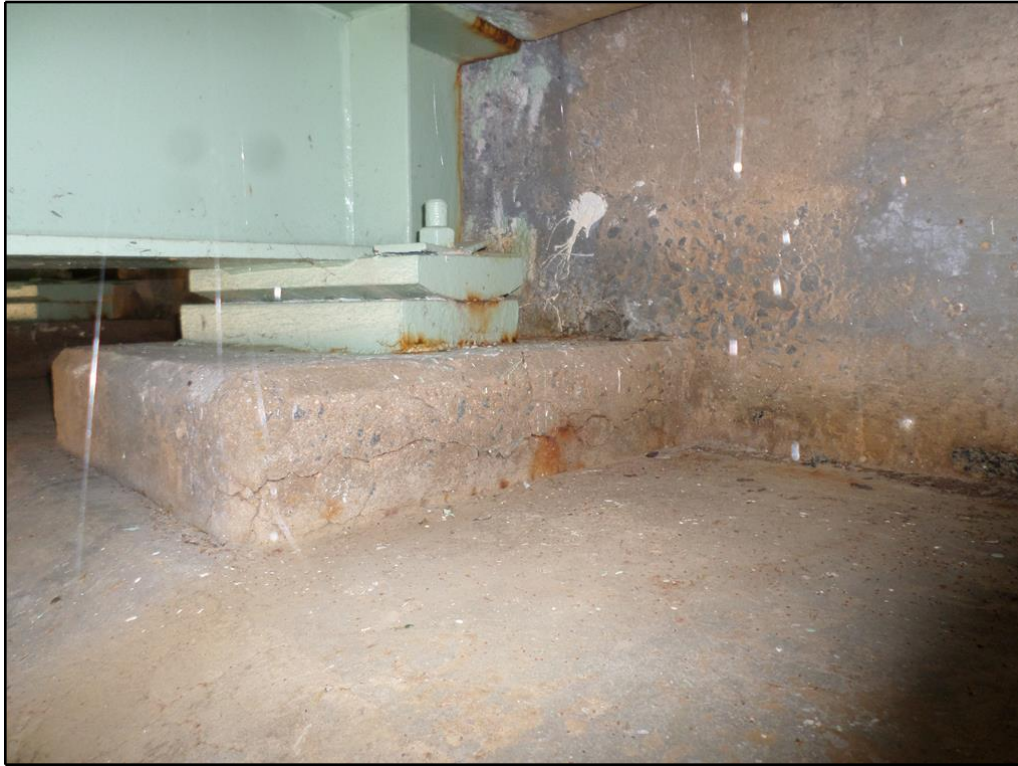
4. The concrete abutments are in good condition. The abutment stems exhibit random up to 1/16" wide cracks. At the east abutment, there is a 1/16" wide horizontal crack and a 1/16" wide vertical crack with rust staining in the south face of Pedestal Nos. 3 and 4 (see Photograph No. 15).

15. Cracking at Pedestal No. 4 of the east abutment

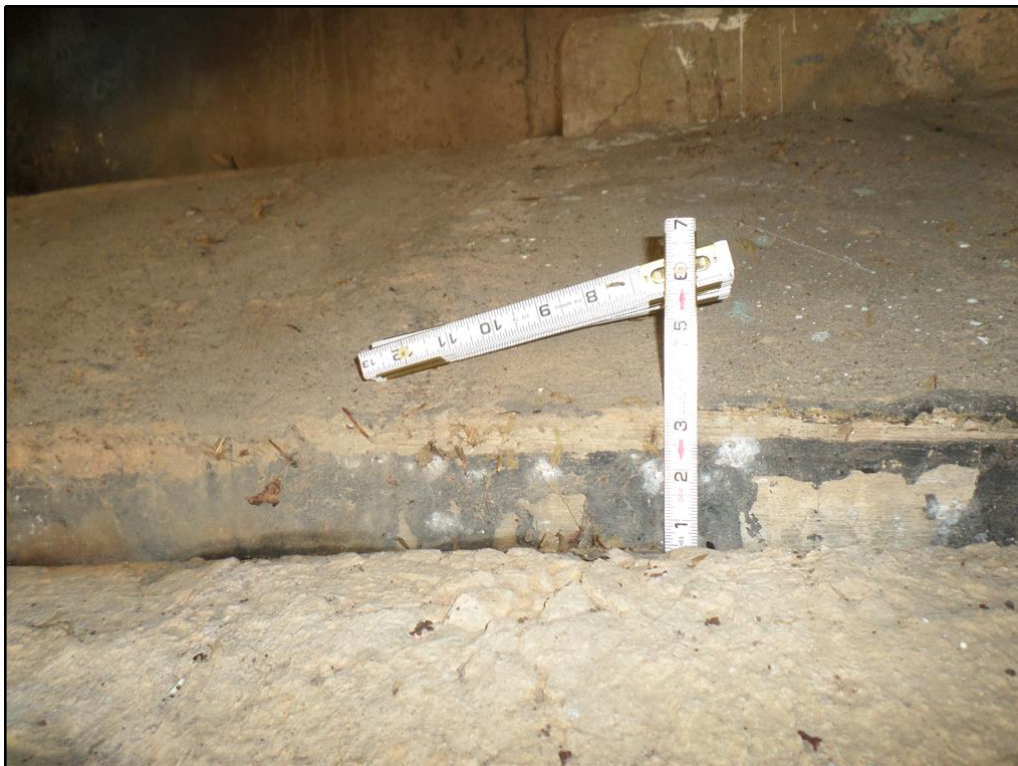
5. The concrete slope protection slabs are in fair condition. There is typical vegetation growth in the joints between the concrete panels. Both slope protections exhibit up to 4" of settlement with adjacent panels, particularly adjacent to the abutments (see Photograph No. 16). There are up to 1/4" wide cracks and spalling throughout both slope protections (see Photograph No. 17).

16. Typical settlement of the concrete slope protection (east slope protection shown)

Monitor the concrete slab settlement of the east and west protected slopes.	8260		0		\$0
Subtotal for Routine Repairs =					\$0
Total for Maintenance Repairs =					\$44,000

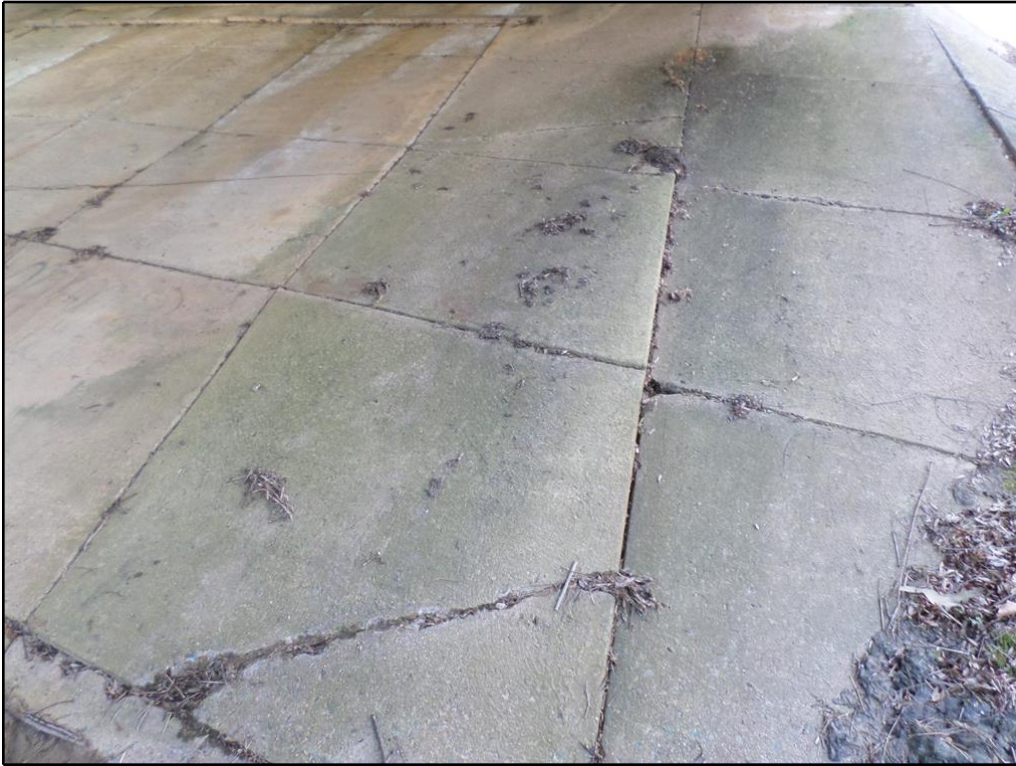
17. Typical cracks and spalls in slope protection (west slope protection shown)

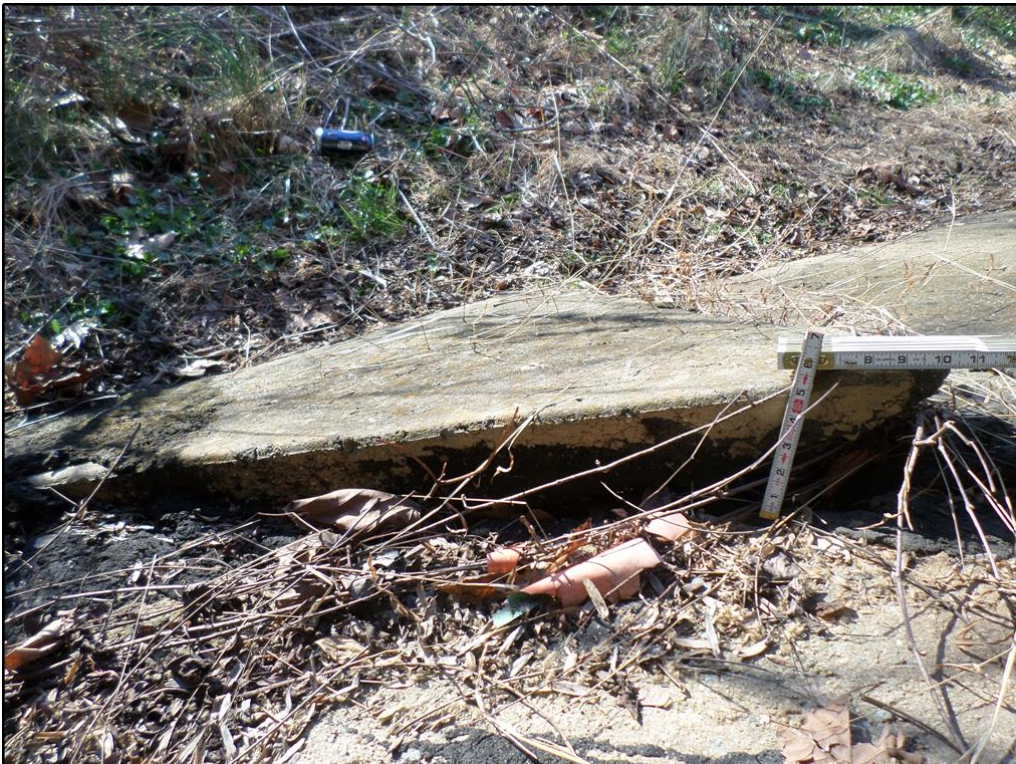
The bottom panel where the slope protection for the west abutment and southwest embankment meet has heaved up to 5" out of alignment (see Photograph No. 18). Adjacent to the northeast wing wall, the slope protection is cracked up to 1/2" wide, undermined, and there are hollow sounding areas at the lower edge of the slope protection adjacent to the wing wall (see Photograph No. 19). The east abutment slope protection exhibits a 2'-0" wide x 1'-6" high imminent spall at the top of the south embankment (see Photograph No. 20).

18. West slope protection heaved at the southwest embankment

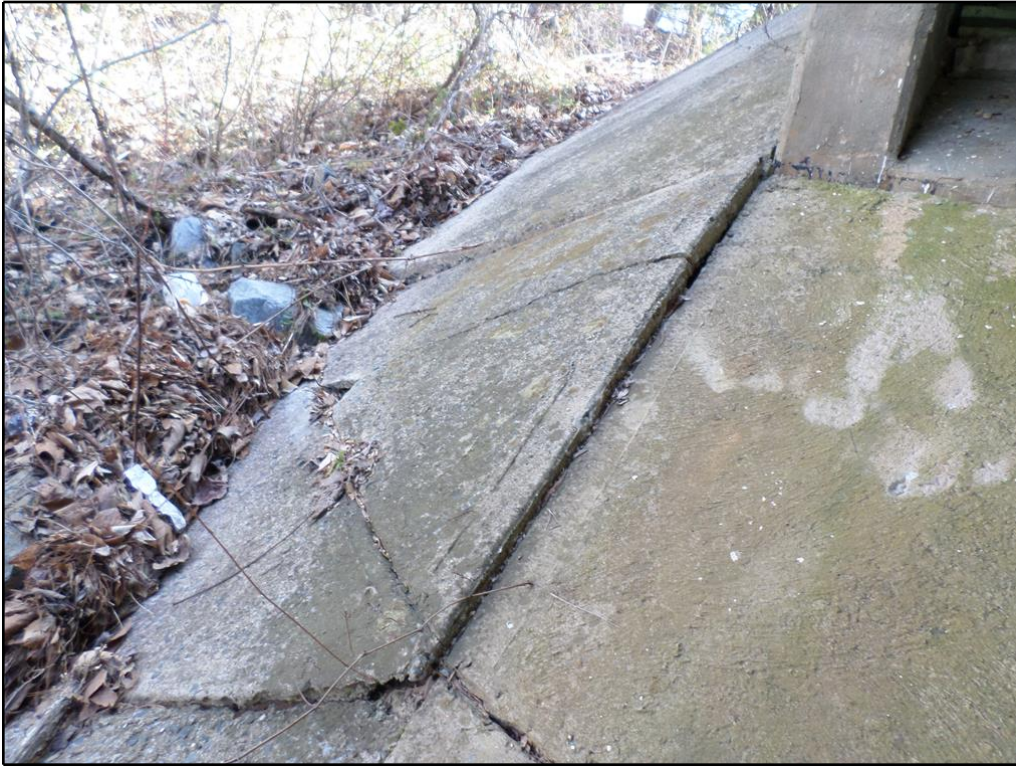
19. Cracked and undermined slope protection at the northeast wing wall

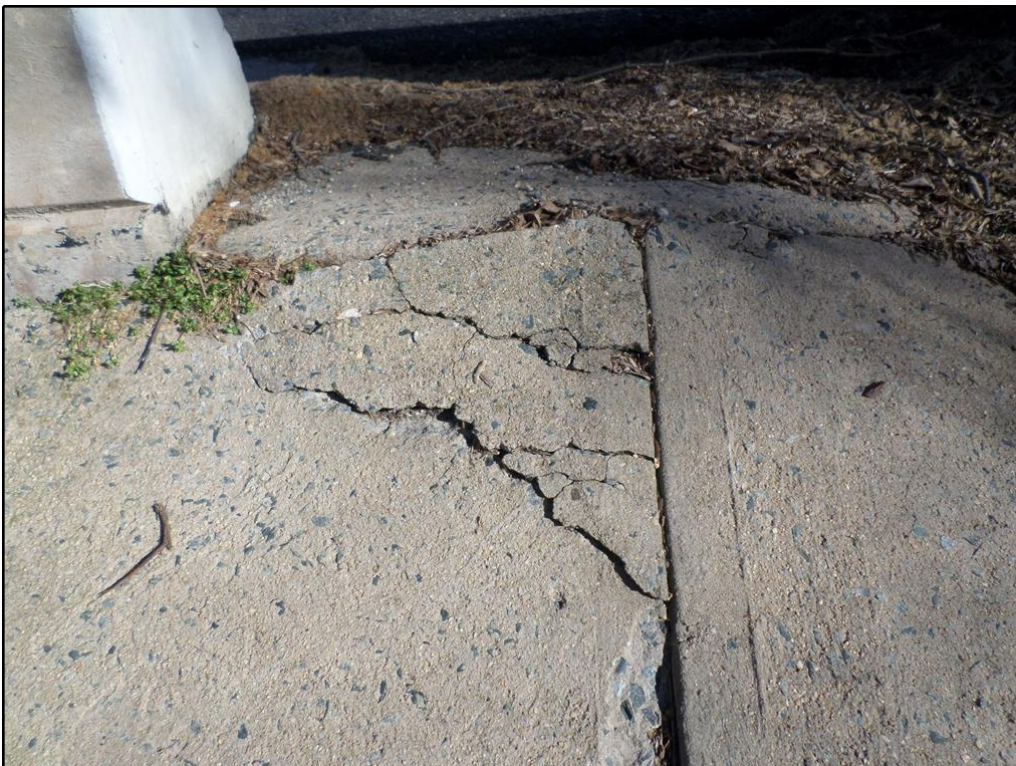
20. Imminent spall at the top of the southeast embankment slope protection

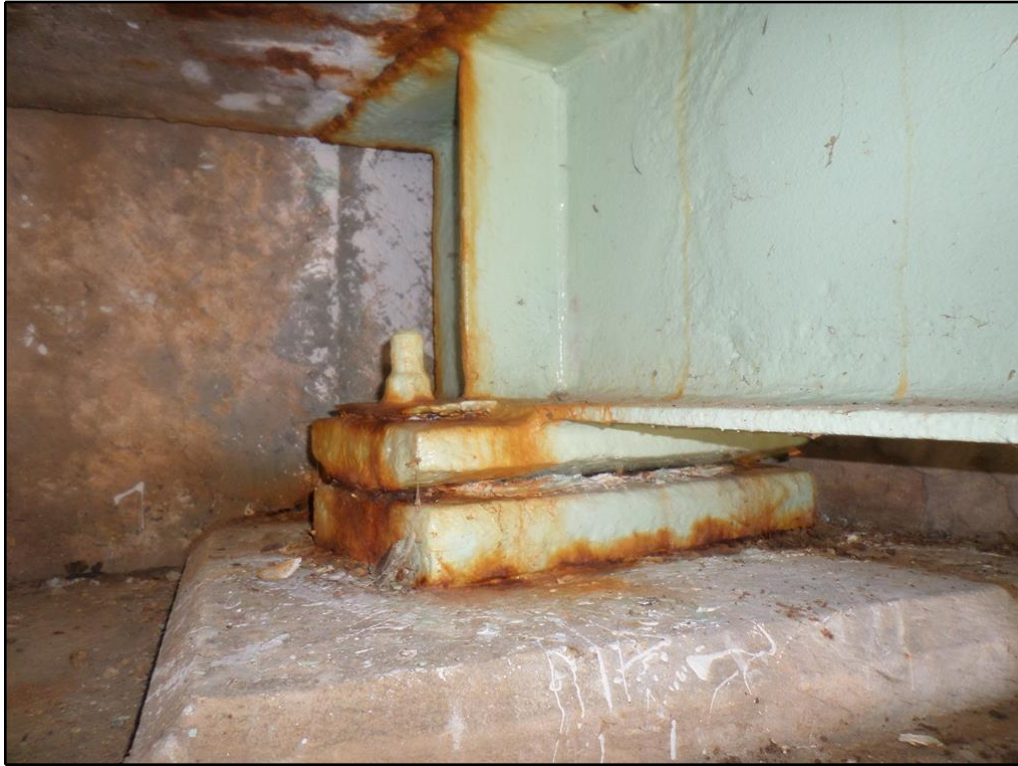
6. The bearings at the abutments are in good condition. Bearing No. 6 at the east abutment exhibits minor to moderate corrosion (see Photograph No. 21). The bearings at Pier 1 are in satisfactory condition. A few bearing components at Pier No.

21. Corrosion of Bearing No. 6 at the east abutment

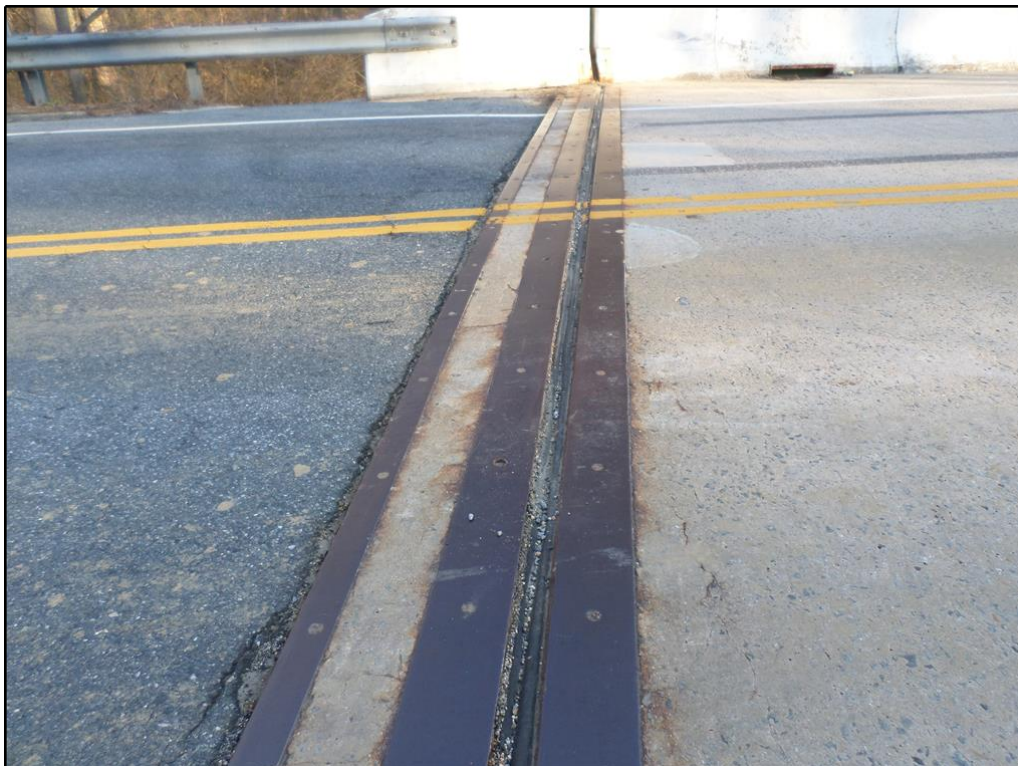
7. The compression joints are in good condition. Both joint seals exhibit minor areas of up to 1/2" depression (see Photograph No. 22).

22. Typical roadway joint (east joint shown)

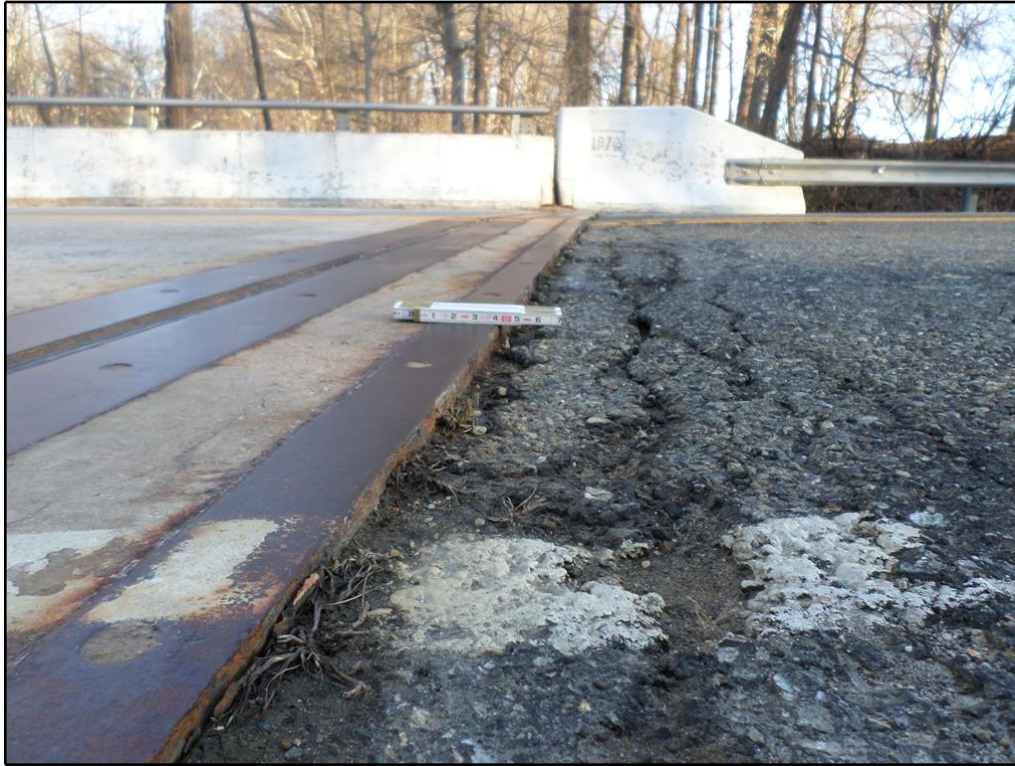
7. The roadway approach transitions are in satisfactory condition. Both transitions have settled up to 1" and exhibit up to 1/2" wide cracking (see Photograph No. 23). Both approach roadways exhibit up to 1/4" wide map cracks (see Photograph No. 24).

23. East approach transition settlement and adjacent cracking

Mill and repave both roadway approaches.	8322	TON	30	\$450	\$13,500
Subtotal for Long Term Repairs =					\$24,500
Routine Repairs					
Monitor the waterway channel widening and deepening trend.	8365		0		\$0

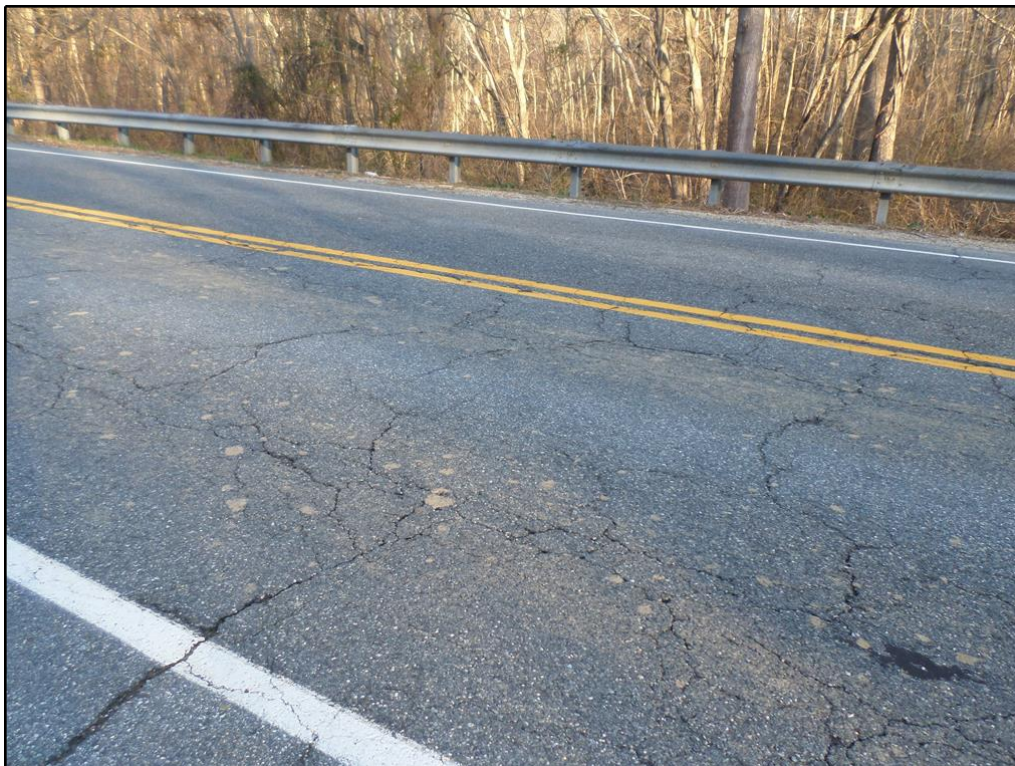
24. Cracking in the west approach roadway

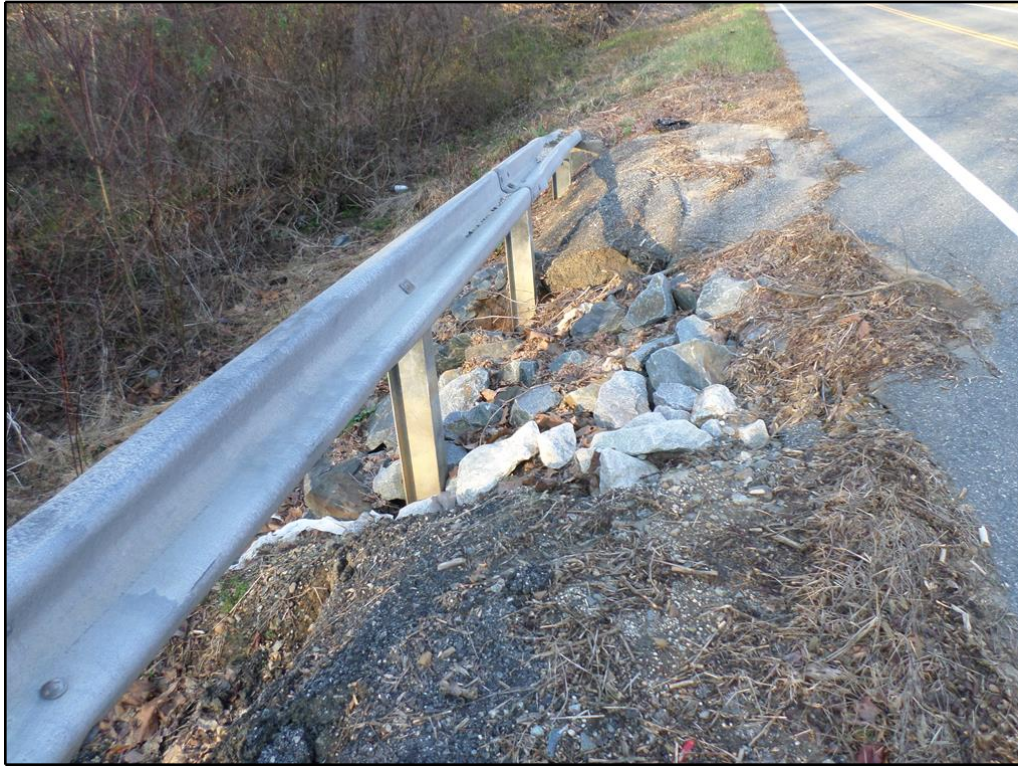
25. Erosion filled with rip rap at the southwest approach embankment

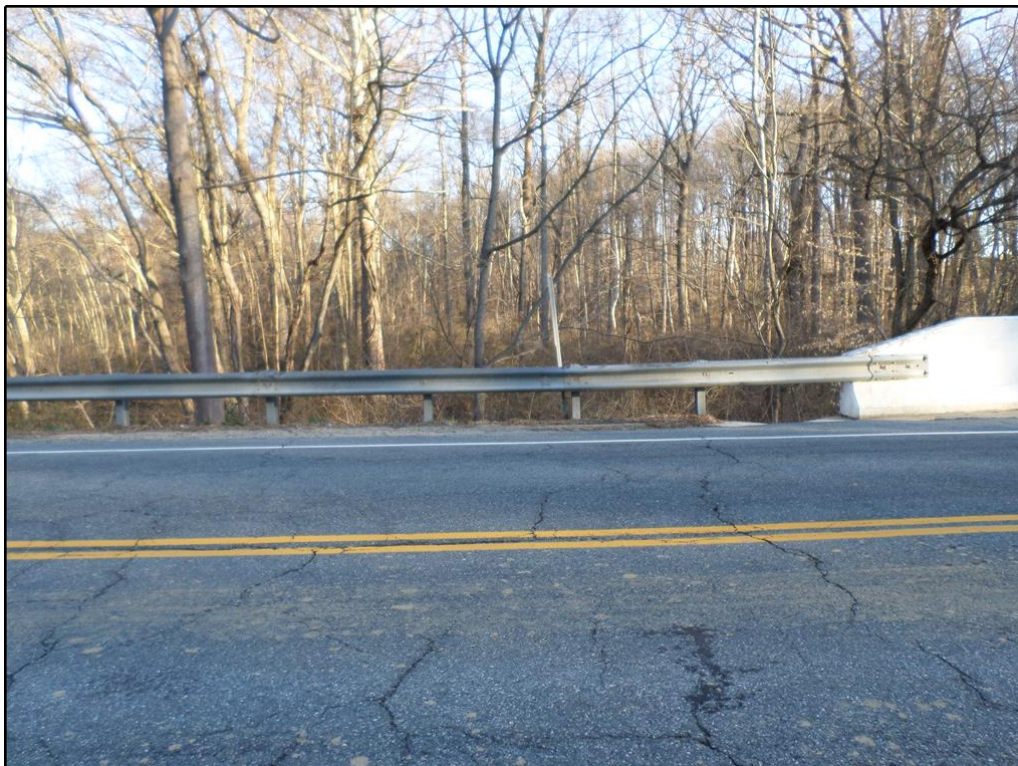
26. Inadequately stiffened approach traffic barrier transition (northwest approach shown)

DESCRIPTION	PONTIS ITEM	UNITS	QUANTITY	UNIT COST	TOTAL COST
Immediate Repairs					
Replace/reinstall the traffic barrier transitions in accordance with SHA standards.	8322	EA	4	\$2600	\$10,400
Install MDSHA Type C approach W-beam end treatments at the northeast and southwest approaches.	8322	EA	2	\$2800	\$5,600
Repair spalls and failed repair patches on the deck riding surface.	12	LS	1	\$1000	\$1,000
Subtotal for Immediate Repairs =					\$17,000
Short Term Repairs					
Patch the spalls and seal the cracks at least 1/16" wide in the substructure units.	210	LS	1	\$2500	\$2,500
Subtotal for Short Term Repairs =					\$2,500
Long Term Repairs					
Repair the cracked and undermined concrete slope protection slabs around abutments and wing walls.	8260	LS	1	\$8000	\$8,000
Install adequate erosion countermeasures around Pier No. 2.	8365	LS	1	\$2000	\$2,000
Zone paint areas of paint failure at the beam splices.	107	LS	1	\$1000	\$1,000

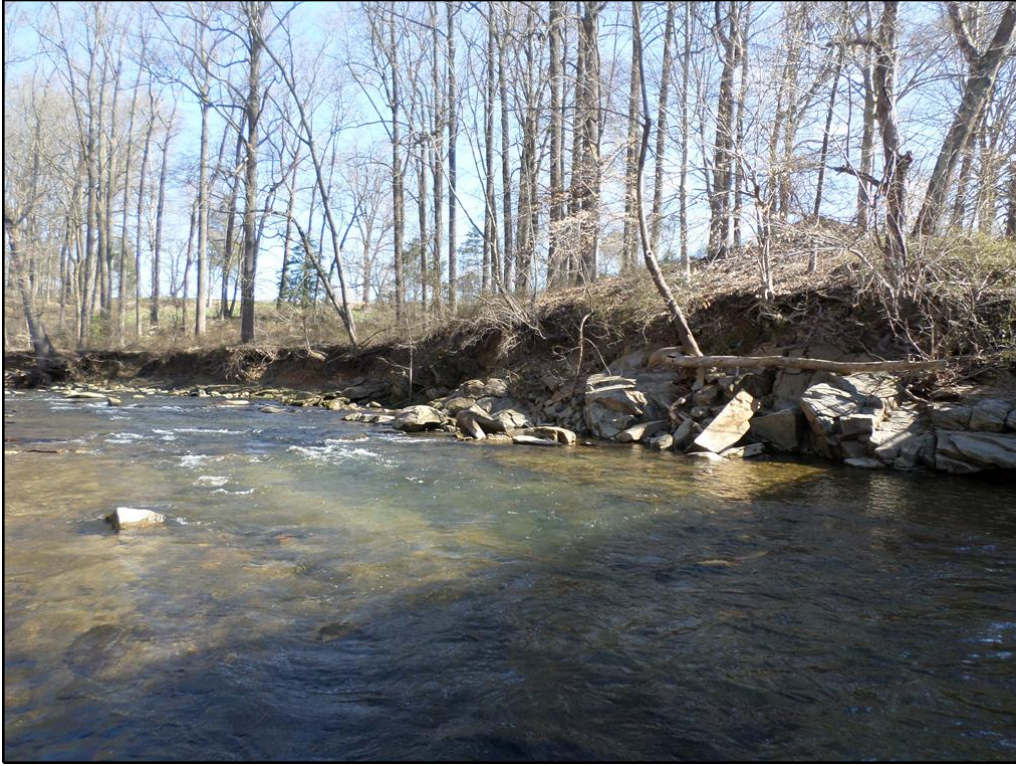
11. The stream channel is in satisfactory condition. At the east bank, about 100' upstream, there is a vertical cut up to 10'-0" high with exposed tree roots (see Photograph No. 27). The east slope behind Pier No. 2 exhibits heavy ongoing erosion. Rip rap is partially displaced and coverage is not adequate.

27. Northeast embankment erosion
