EA11-012

HONDA

4/20/2012

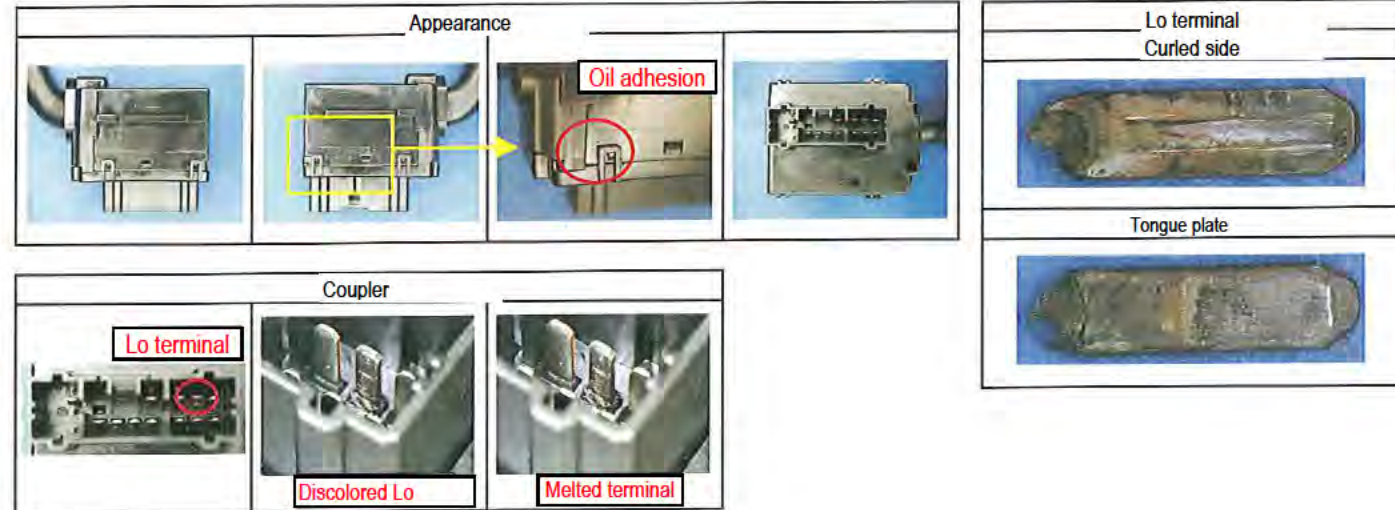
- As a result of continuity check of each circuit (except for Lo circuit), no abnormality such as continuity failure was found.
- 2. disassembly results
- Local discoloration of the terminal was confirmed for both curled side and tongue plate side when checked its appearance by cutting the Lo terminal.

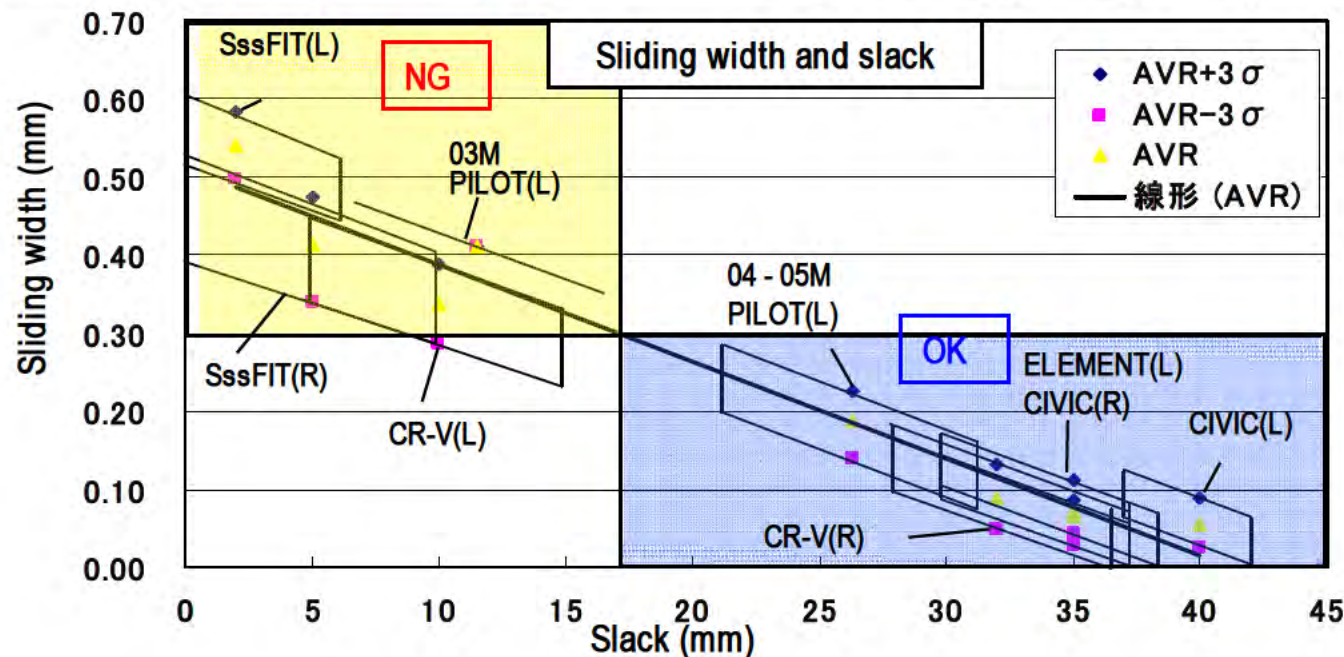
The result from 02 - 04M CR-V(L), and 03M PILOT is judged as NG since sliding width exceeds 0.3mm.

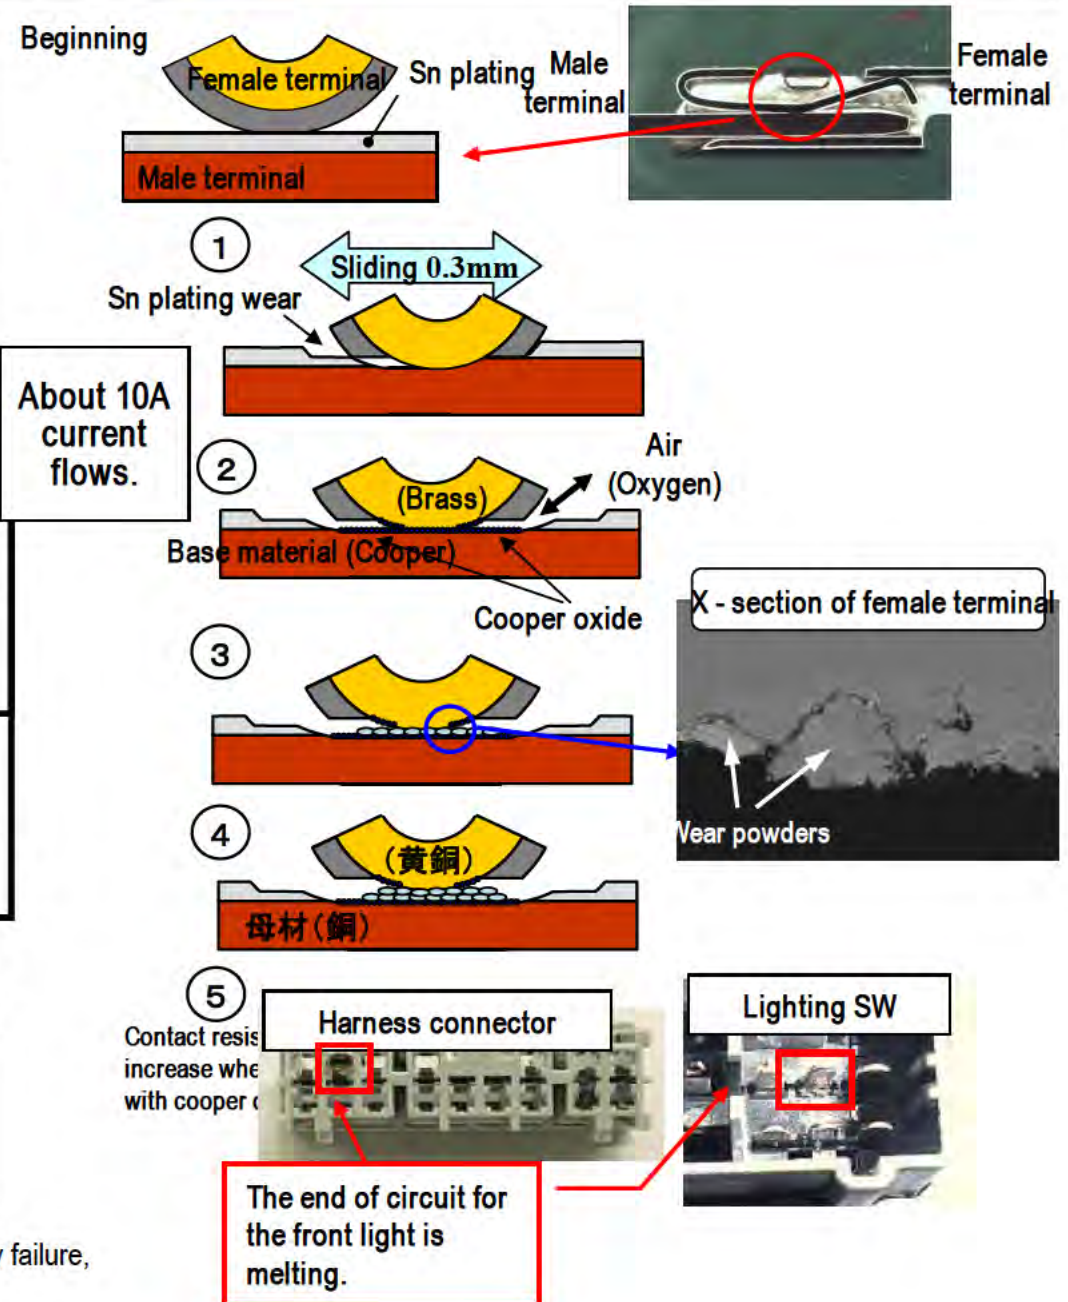
- 1 Terminal fitting area of low beam excessively slides by SW lever operation. (more than 0.3mm)
- 2 As the terminal fitting area slides, Sn plating wears, and base material becomes exposed. Cooper oxidizes on the contact surface, and wears, accumulating wear powders on the sliding area.
- 3 As the terminal contacts with accumulated cooper oxide, contact resistance increases, causing the terminal fitting area to excessively heat when the front light illuminates.
- 4 Heat reduces stress application to the fitting area, causing more wear powders to accumulate on the fitting area, and also terminal to heat further.
- 5 After this condition continues, plastic of the coupler is melting, and flowing into the terminal fitting area, causing the low beam to fail to illuminate due to conductivity failure.

\*Surrounding parts are not burning since current doesn't flow due to conductivity failure, which is caused by melted plastic flowing into the fitting area.

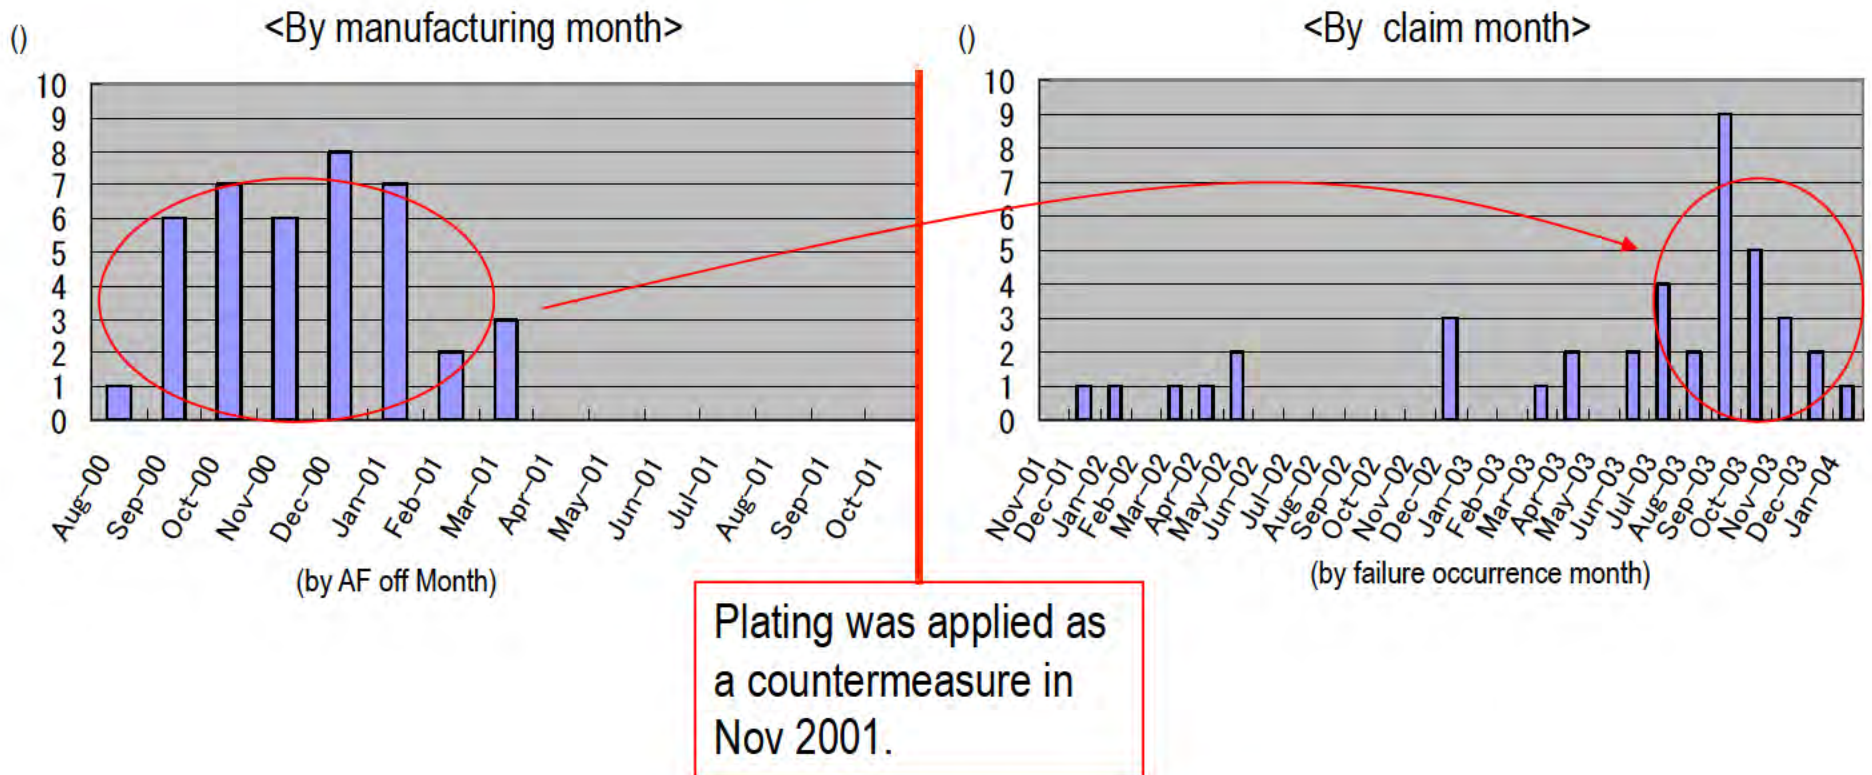
# CIVIC with melted terminals Confirmation results (Japanese market)

- This failure tends to increase from CIVIC in the Japanese market that had been manufactured in the early stage of production.
- Recently, failure occurrence has increased.

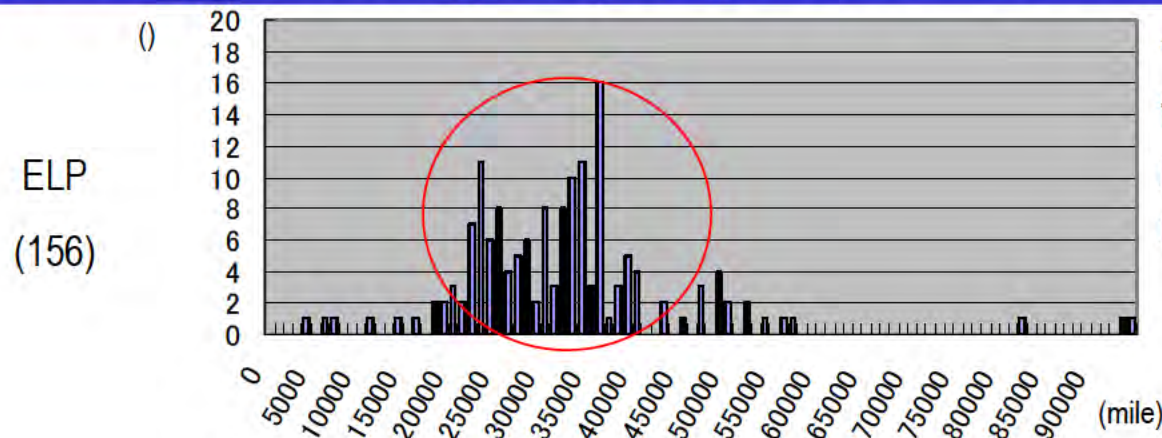
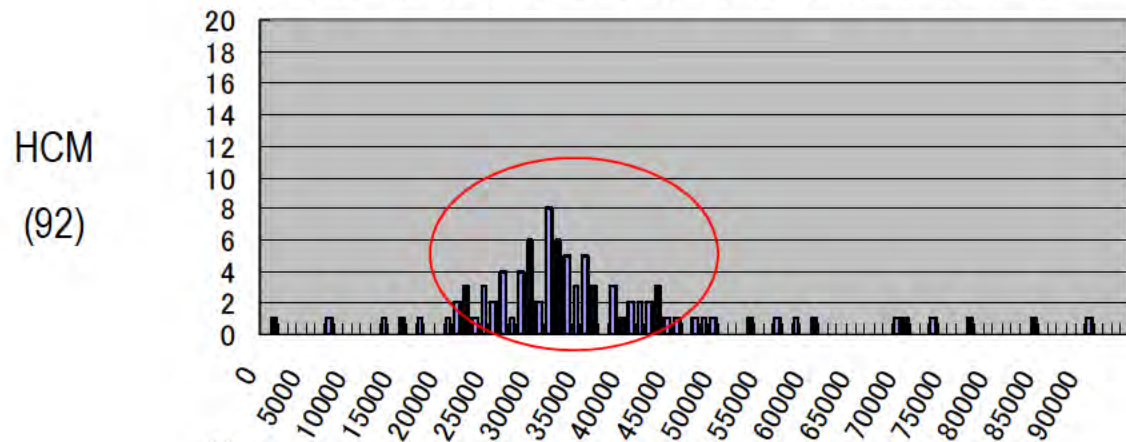
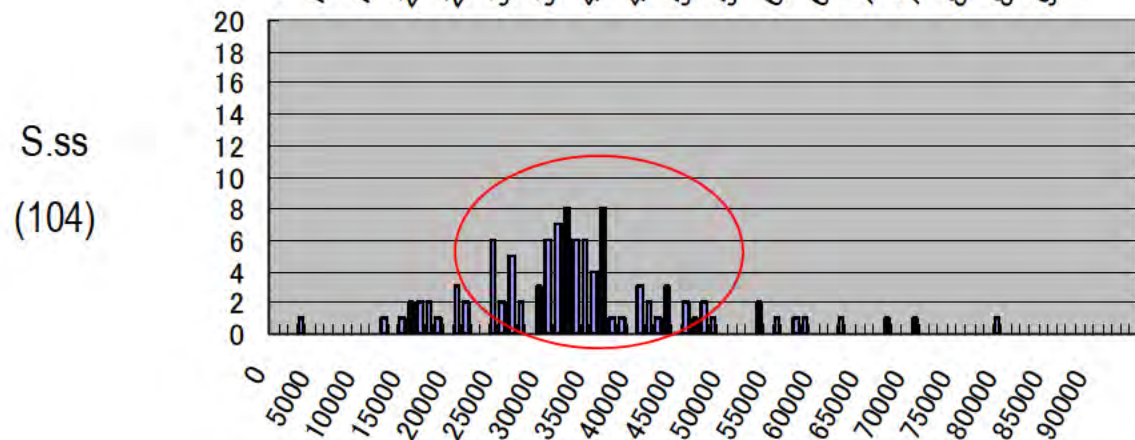
\*Those three graphs show claims from smoke, melting, and wire replacement related to head light by mileage, and factory.

This failure from each factory tends to occur around 25,000 to 50,000 miles., and also has a similar tendency.

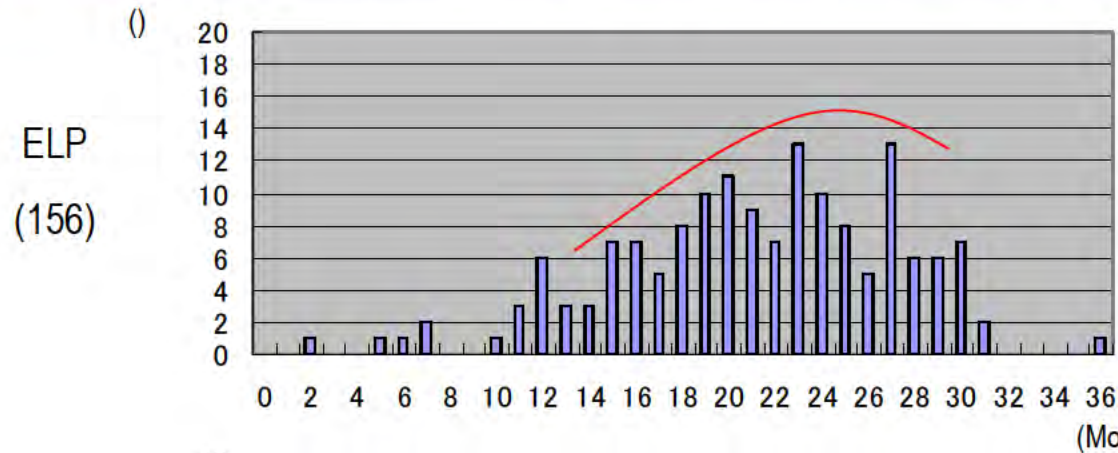
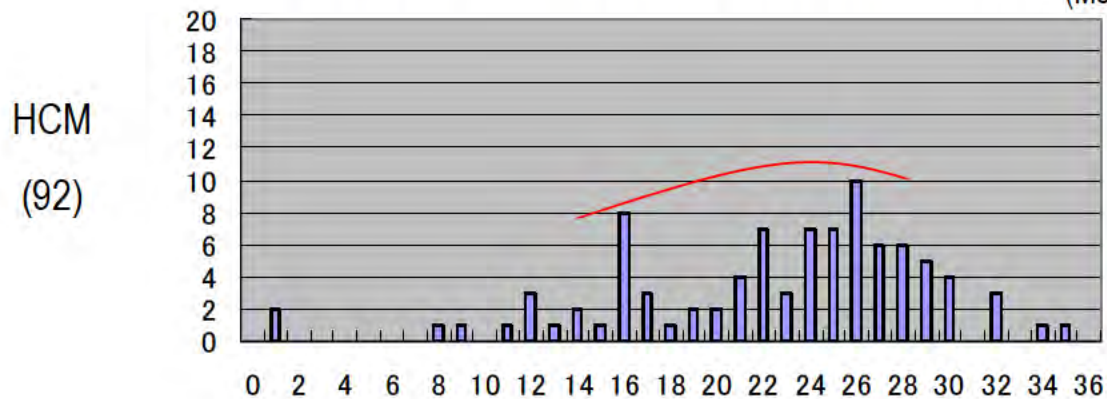
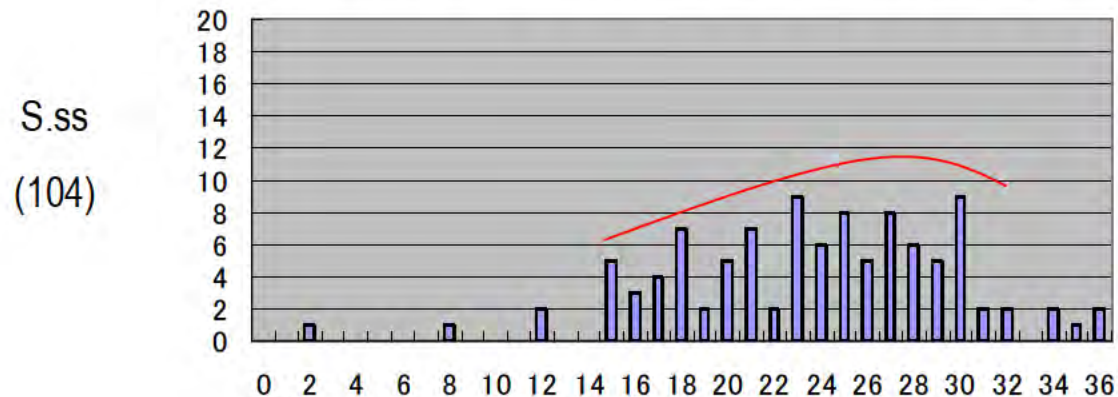
\*Those three graphs show claims due to smoke, melting, and wire replacement related to head light by month to fail, and factory.

This failure from each factory tends to significantly occur in 15 months from, and has a similar tendency.

This failure from each factory is durability deterioration judging from faire situation, and shows a similar tendency.

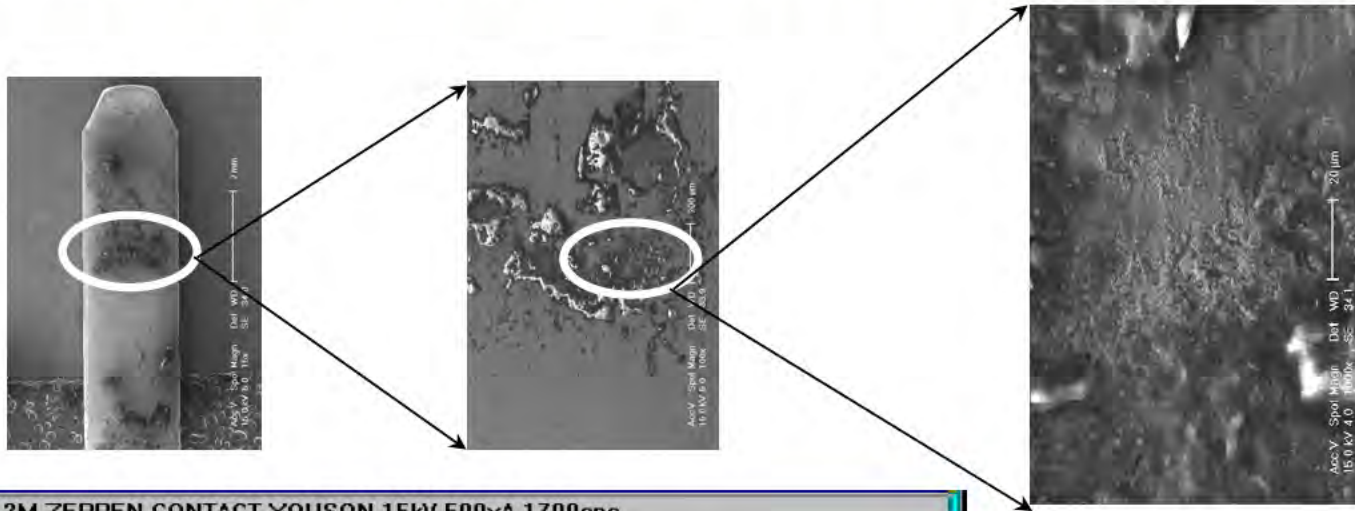
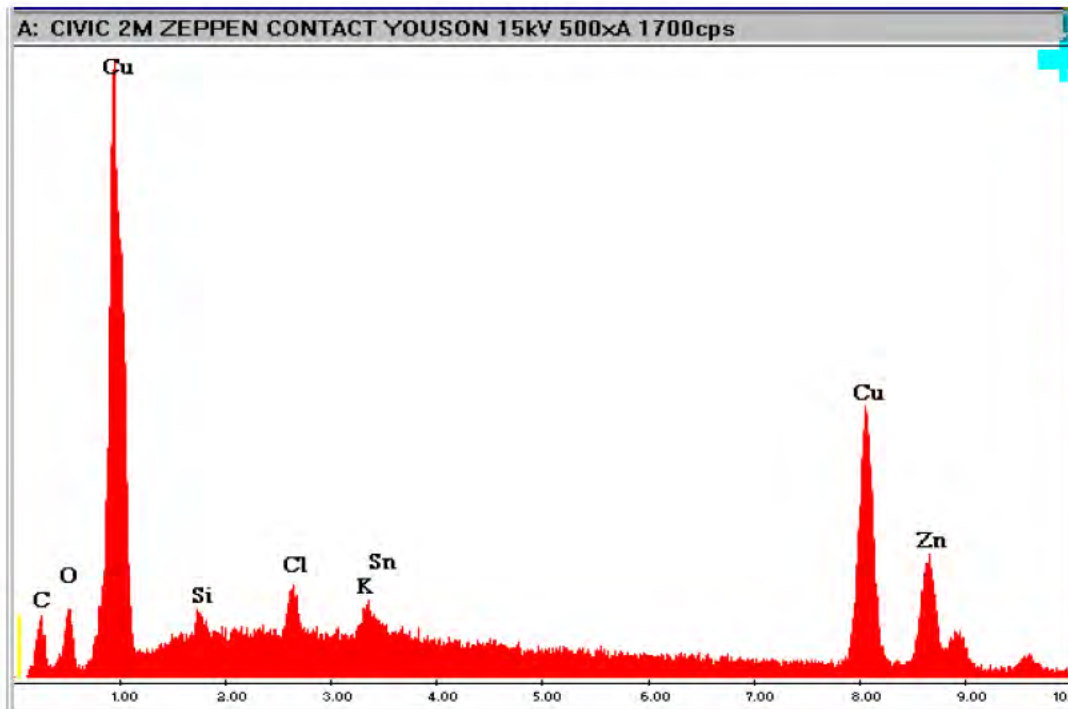
Those pictures show that wear powders adhere around the contact area on the surface of tongue plate.

Oxidized cooper is seen on the rub area on the affected part.

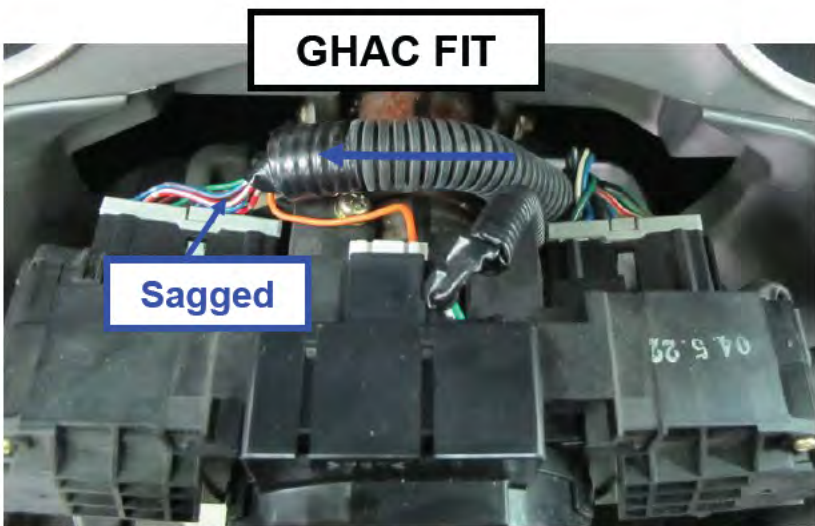
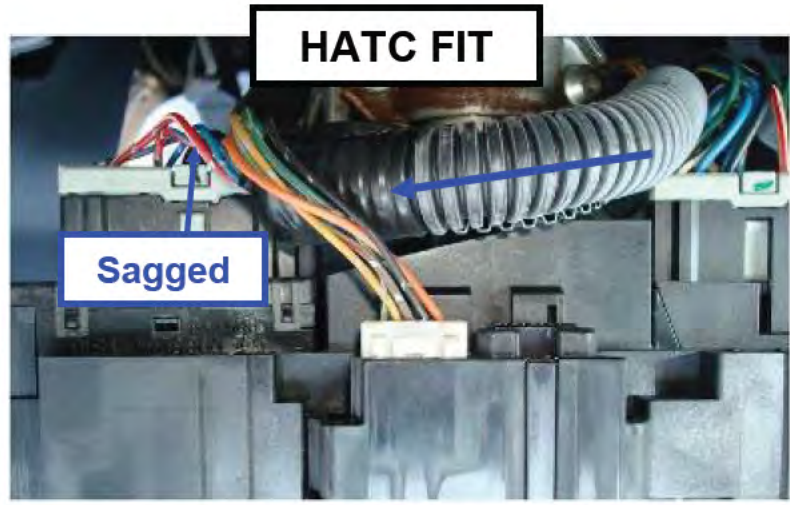
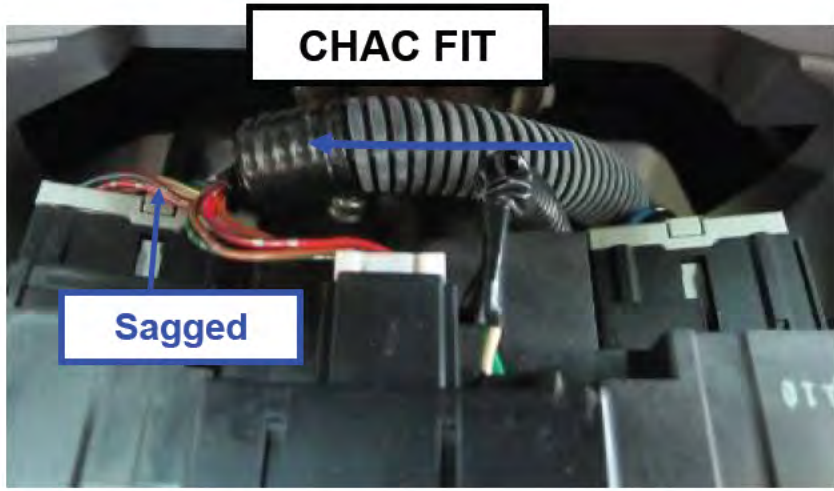
Difference in sagging amount of Lo terminal wiring is caused by harness layout.

Only Sss FIT has a layout pulled condition of Lo terminal wiring occurs.

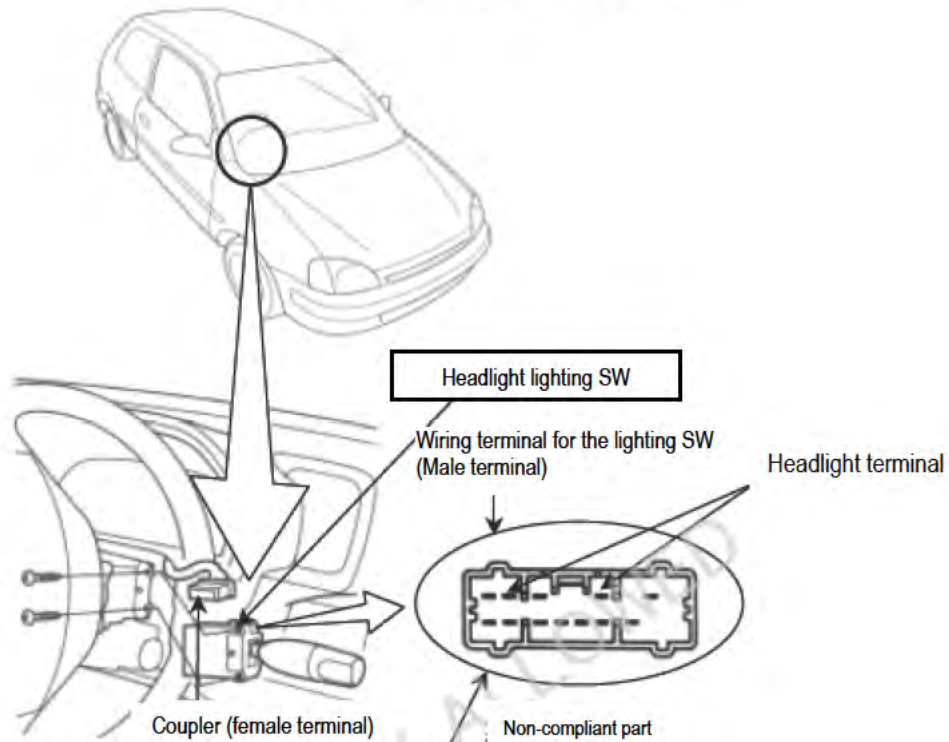
### Illustrative Drawing of Modified Part

Due to inappropriate surface treatment for a headlight SW terminal of the lighting system, the coupler joint moves and increases contact resistance when switching operation of the headlight is performed. As a top event, the coupler joint melts and leads to a continuity failure, possibly causing the headlight failure.

Corrective action details: In all units, replace the headlight lighting SW with a non-defective part.

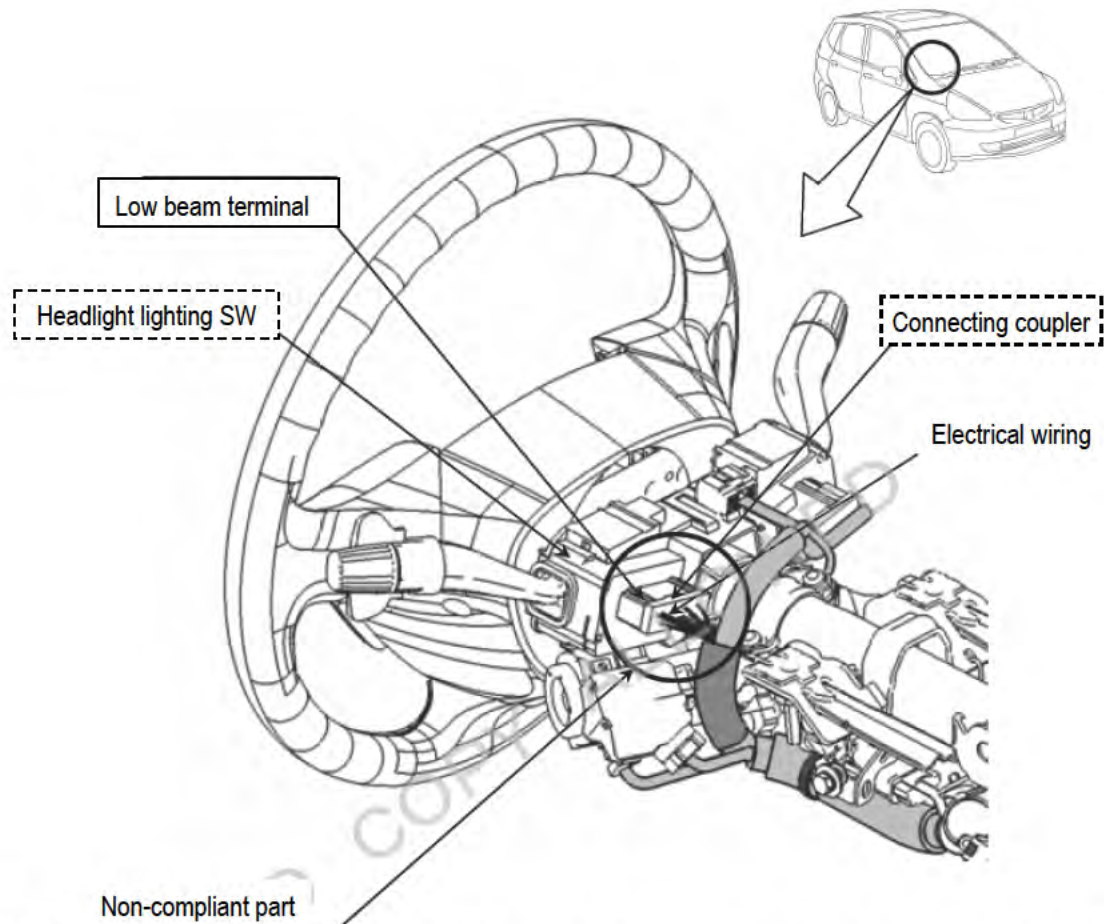
Since the wire harness connected to the lighting switch does not have sufficient reserve length, it gets stretched by coupler connecting operation. This causes the terminal joint to slide when switch lever is operated repeatedly, increasing the contact resistance and generating heat to melt the coupler. Consequently, the headlight low beam does not come on.
