Revised February 2018

Dealer Service Instructions for:

# Safety Recall T79 / NHTSA 17V-821 Brake Transmission Shift Interlock

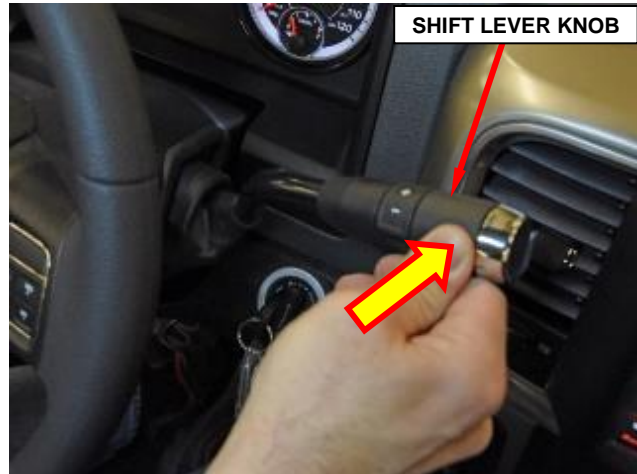
**Figure 1 – Push Lightly On Shift Lever Knob Toward Instrument Panel To Feel BTSI Solenoid Pin Movement**

5. Place your hand on the shift lever knob and push lightly on the shift lever toward the instrument panel. This will allow you to feel a click sensation from BTSI solenoid pin movement when the brake pedal is applied and released (Figure 1).

9. After five seconds of holding the brake pedal down, release the brake pedal while both listening and feeling for the click of the BTSI pin movement. The sound and feel of the BTSI pin movement should occur immediately within 0-2 seconds upon release of the brake pedal.

➤ If the BTSI pin could be heard and felt moving within 0-2 seconds, then the BTSI inspection process is complete and the gearshift bracket / BTSI assembly does not need to be replaced. Place the ignition switch in the “OFF” position then proceed to **Section C. Reprogram Body Control Module (BCM)**.

➤ If the BTSI pin could **not** be heard and felt moving within 0-2 seconds, then continue with **Step 10**.
