Safety Recall

Code: 74D9

Subject Passenger Occupant Detection System (PODS)

Release Date August 27, 2019

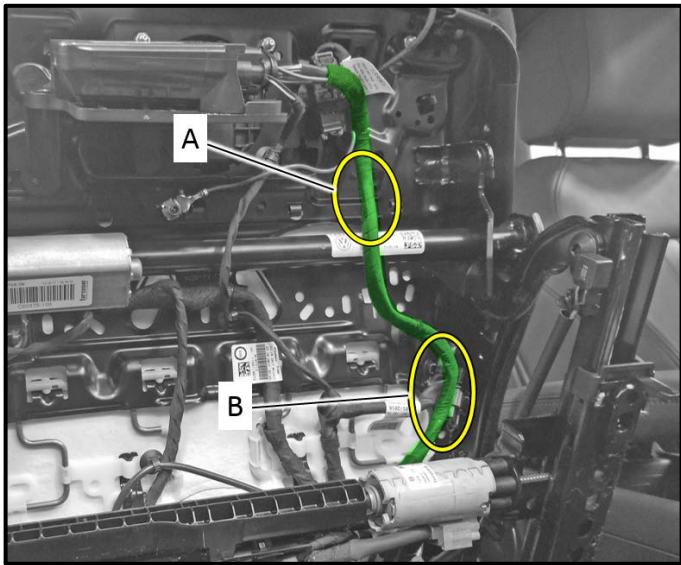
Problem Description In certain cases, the aluminum shielding on the PODS harness under the seat may not be fitted tight enough to the harness which may allow partial surface corrosion in that area which causes a mostly sporadic error code to occur. As designed, the passenger occupant detection system (PODS) switches off the passenger airbag if a malfunction is detected. In the event of a crash there would be an increased risk of injury to the occupant seated in the front passenger seat if the passenger airbag is switched off/not working.

- Install cable ties on PODS control module wiring harness.
