Transmission ECU Compatibility VAH, VHD, VN, VT

FSB 432-014, Transmission ECU Compatibility

(October 2014)

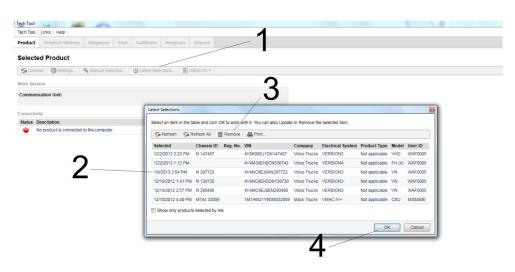
W2093745

1	Pick Latest Selections
2	Select the chassis
3	Click Remove
4	Click OK

1 Turn ignition OFF, select Finish Work on the product screen and delete the chassis number from PTT.
