Field campaign

Topic	Bentayga - Battery Energy Control Module 2 software update (ASW 09.03) (SC16/27)
Market area	Bentley: worldwide (2WBE),Hongkong-Macau (5HK)
Brand	Bentley
Transaction No.	2046108/1
Campaign number	EA65
Note	
Type	Service Campaign
US code

Error in software during shut down – module 21 not visible in diagnostic log

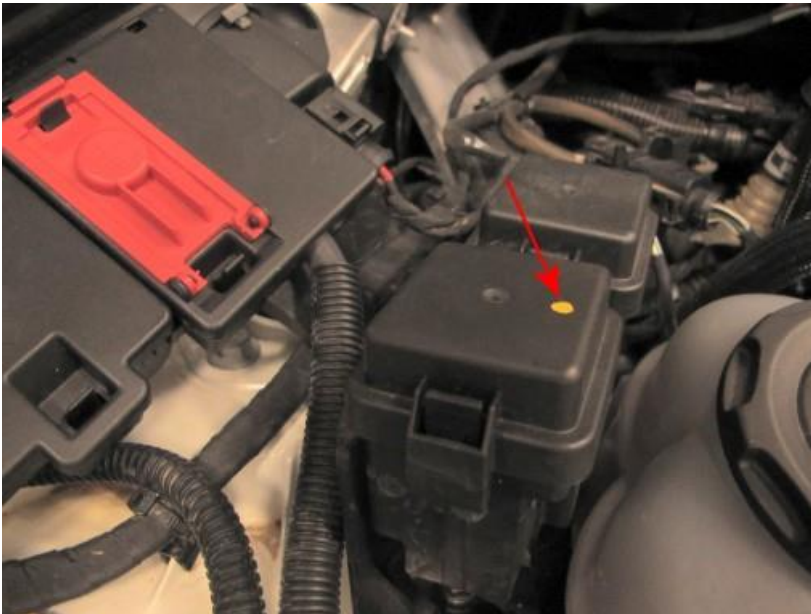
Figure 7

If the vehicle is not already listed as repaired in the "Repair history" (in Elsa Pro), check for the presence of a yellow campaign completion mark on the top of the relay box adjacent to the right hand bonnet hinge (see Figure 7) should neither be evident carry out the required work in accordance with these instructions

17. Select Done/Continue at successfully complete to finalise the update (see Figure 6)
18. Select *Guided fault finding* to check and clear the vehicle of any fault codes generated as a result of performing this campaign. Note: When requested to *Make a Target/Actual comparison* this action should be performed, select YES
19. On completion apply a yellow campaign completion mark to the top of the relay box adjacent to the right hand bonnet hinge (see Figure 7)
