Technical Service Bulletin

42 Rattle noise from rear suspension

42 18 38 2038689/3 June 20, 2018. Supersedes Technical Service Bulletin Group 42 number 17-37 dated April 18, 2017 for reasons listed below.

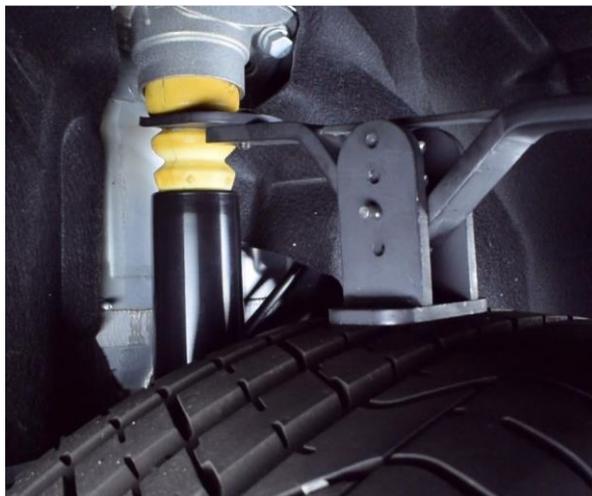
Figure 2. The SET900 tool being used to install a rear bump stop.

1. Clean the top of the rear bump stops and coat with tire mounting paste.
 2. Use the SET900 special tool to fully press the rear bump stops in to the upper shock mounts (Figure 2).
- The purpose of the tool is to properly seat the rear bump stops in the rear shock mounts (Figure 3), which will prevent them from dropping out of the rear upper shock mounts and causing noise.

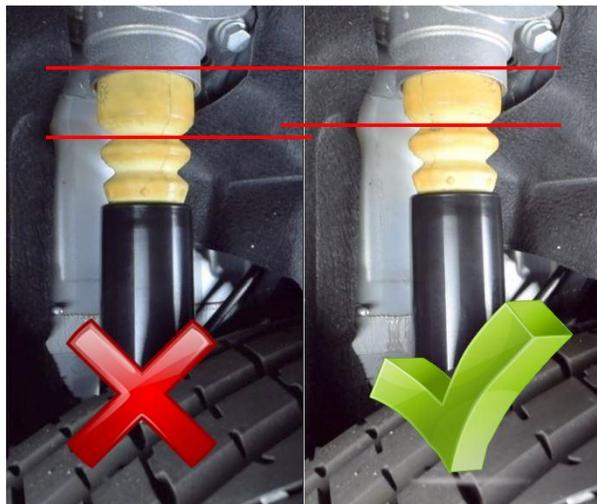
These noises can be caused by an improperly seated rear bump stop (which occurs when the rear bump stop was not fully inserted into the rear shock absorber mounting during PDI).

Figure 3. Comparison between rear bump stop installation without and with the SET900 tool.
