**Replacement of (LPS) Low Pressure Sensor and fuel line P5**

<b>REF NO:</b> TJ 33794.2.0	<b>ISSUING DEPARTMENT:</b> Technical Service	<b>CAR MARKET:</b> United States and Canada	
<b>PARTNER:</b> 3 US 7510 Volvo Car USA		<b>ISSUE DATE:</b> 2018-07-09	<b>STATUS DATE:</b> 2018-07-11
<b>FUNC GROUP:</b> 2346	<b>FUNC DESC:</b> Fuel line	Page 1 of 3

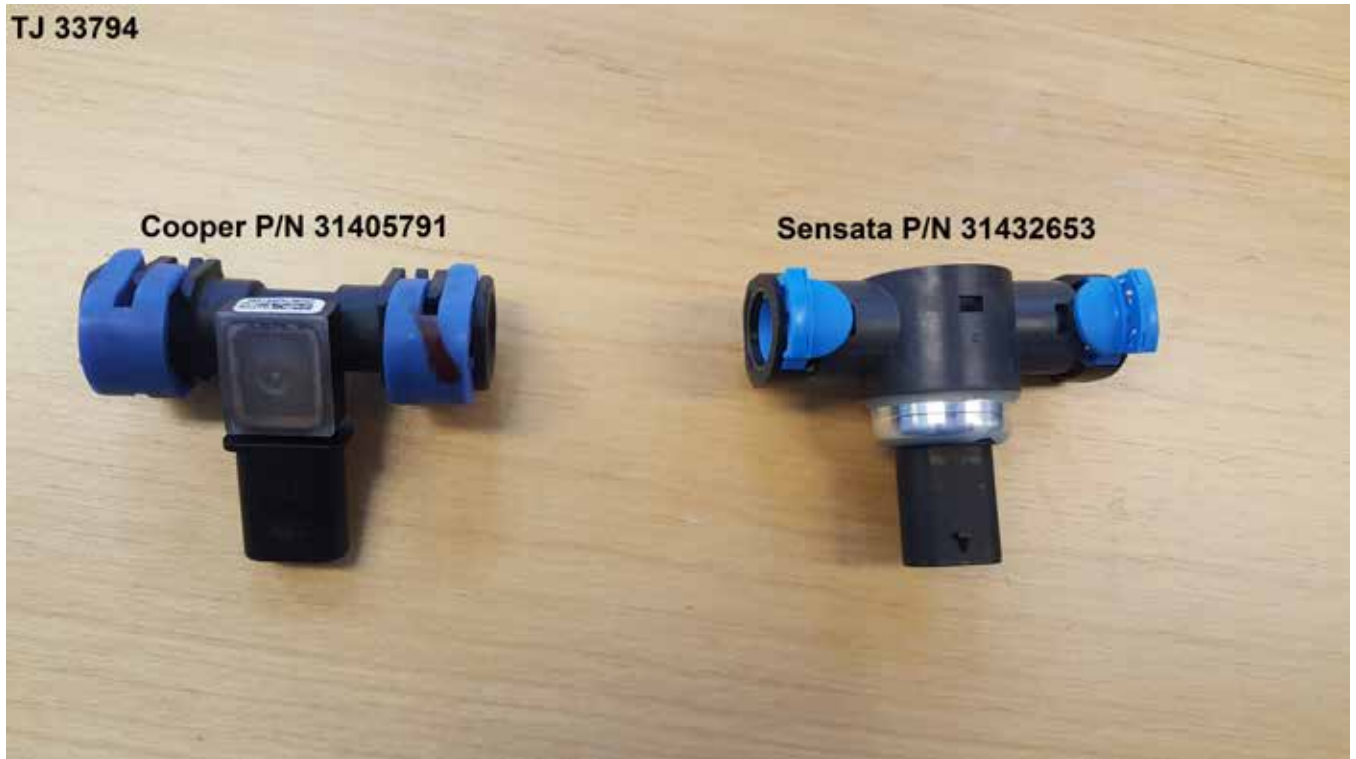
TJ 33794

Cooper P/N 31405791

Sensata P/N 31432653

If the car is equipped with a Cooper LPS P/N **31478293/31405791**, replace it with a new Sensata sensor P/N **31432653** that is included in a kit P/N **32242869** together with the appropriate feed line packed in a plastic bag. All required parts are included in the kit. Follow the instructions on how to replace the involved parts in VIDA VCC-412342-12.

- Please notice that the feed line P/N **31669066** included in the kit always needs to be replaced when a replacement of the LPS is needed.
