Fault message "SRS - Service Required" displayed in instrument cluster and SRS lamp active

Topic number	LI54.18-P-069309
Version	3
Function group	54.18 Cable harnesses
Date	02-19-2019
Validity	Model series 177, model series 118, model series 247, model series 167
Reason for change	Model series validity adapted
Reason for block

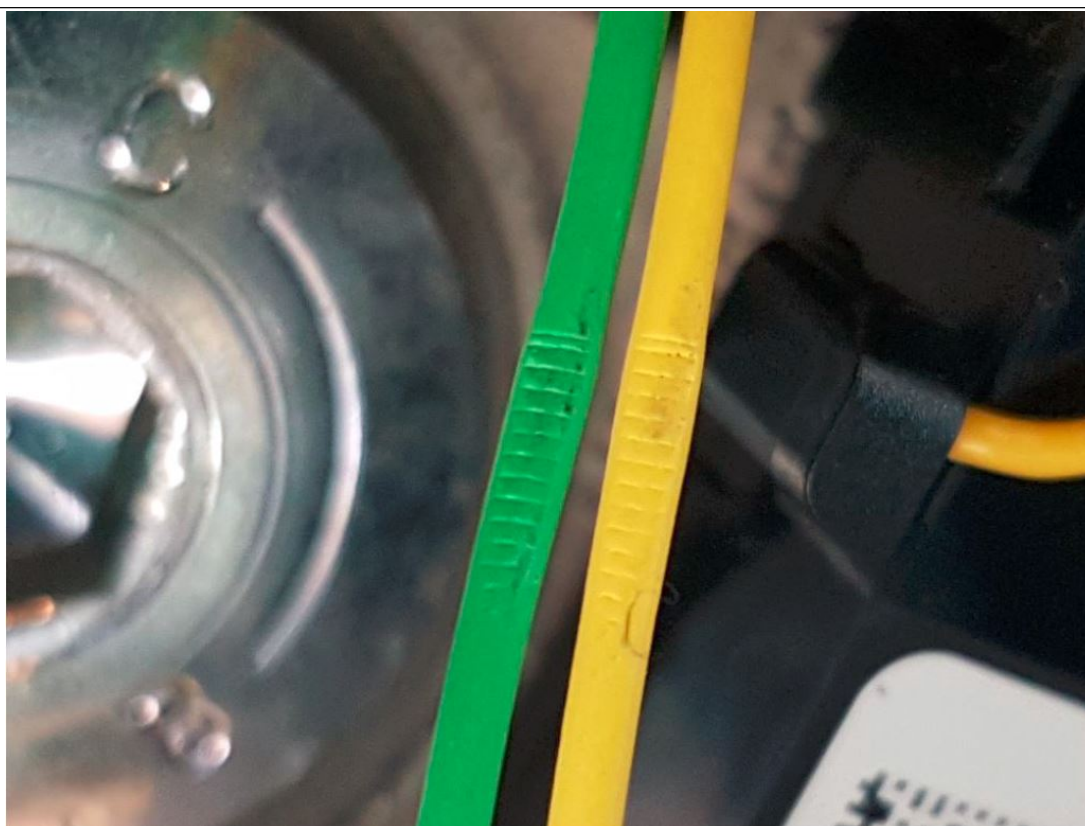
AirbagModul.JPG:

Some vehicles may have marks on the insulation of the electrical line at the K/Z airbag module, which are production-related tool locating marks.

The locating marks have no influence on the functioning. (See attachment)

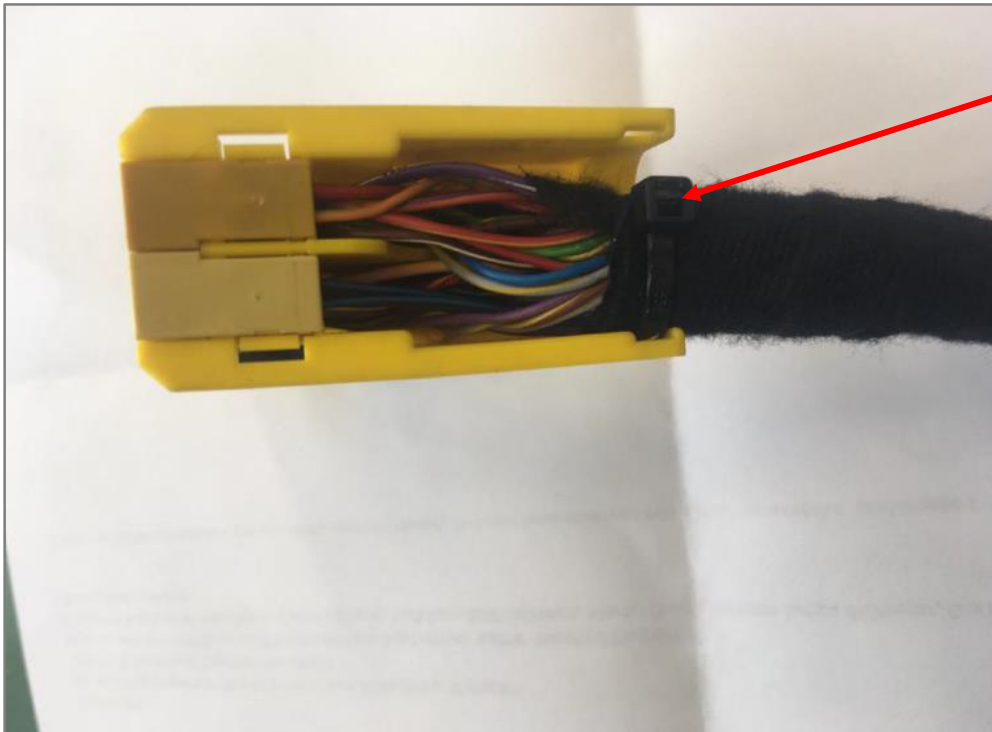
Current Verbaustatus

Wrapping Airbag SG u Cable Ties all MFA2 LL and RL

- All wraps should be wrapped between 1mm/ 5mm under the cable tie.
- cable ties

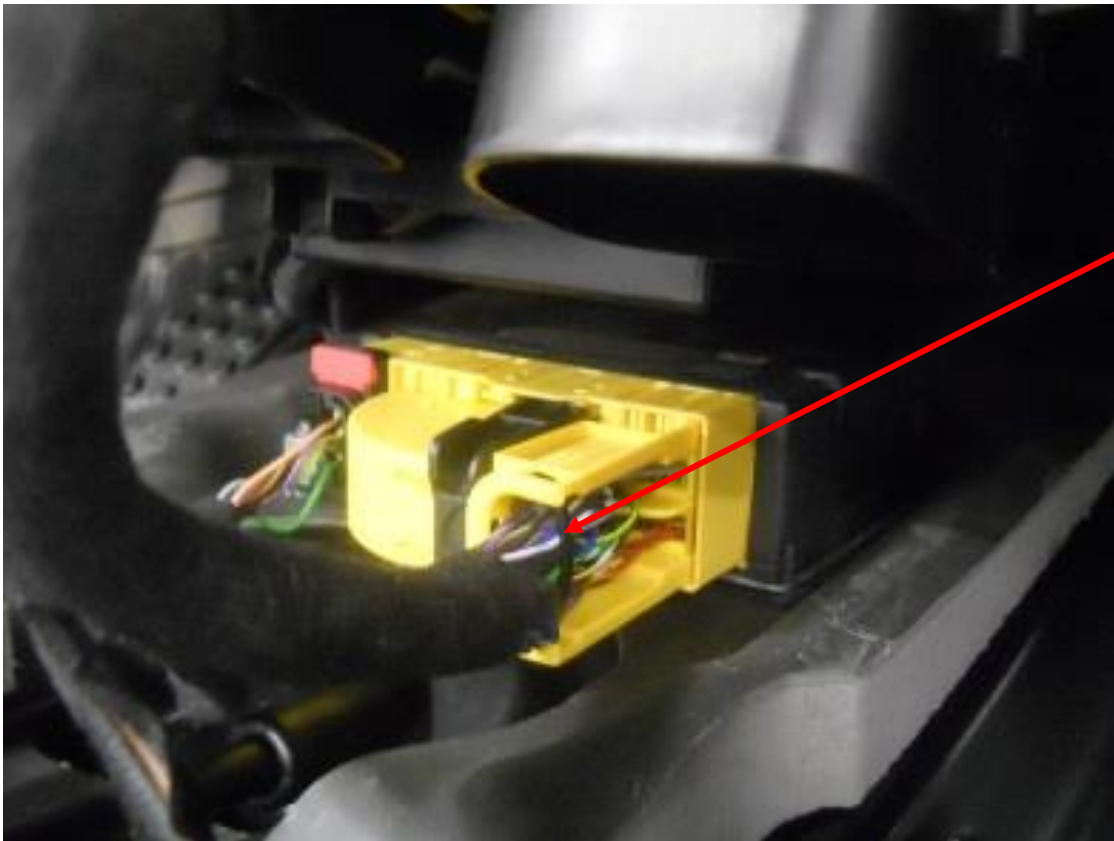
New Construction Execution

All BR LL and RL on the N2 / 5 control unit Airbag Full

- Wrapping ends 30mm before the start of the housing as shown in (Fig. 1)
- Cable tie (used for cable guidance.)
