Service Bulletin

Bulletin No.: 19-NA-066

Subject: Missing Oil Filter Adapter Insert Causing Noise, Engine Failure After Oil Filter Was Changed, Malfunction Indicator Lamp (MIL) Illuminated

Brand:	Model:	Model Year:		VIN:		Engine:	Transmission:
		from	to	from	to		
Chevrolet	Colorado	2017	2019	All	All	3.6L LGZ	All
GMC	Canyon

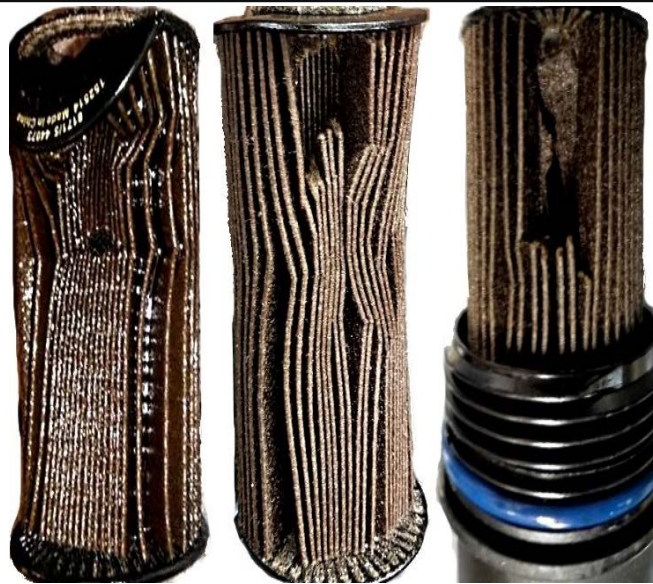
5297946

Note: Upon inspection, the technician may notice that the oil filter has been damaged or material from the oil filter may have been pushed into the oil galleries causing an upper engine noise.

If no mechanical damage has been found, inspect the oil filter for damage.

- ⇒ If there is paper debris, codes, and/or cam actuator noises, that does not require engine replacement, repair and/or replace the affected components and clean the engine thoroughly.
- ⇒ Order and install the oil filter adapter insert/bypass valve.
