PIT5487E Service Park Assist/Camera/Cruise/ and/or Front Park/Turn/Cornering Light Inop Blown Fuses (Front Fascia/Bumper Harness Chaffing)

Brand:	Model:	Model Years:	VIN:		Engine:	Transmissions:
			from	to		
Cadillac	Escalade Models	2015 - 2019	All	All	All	All

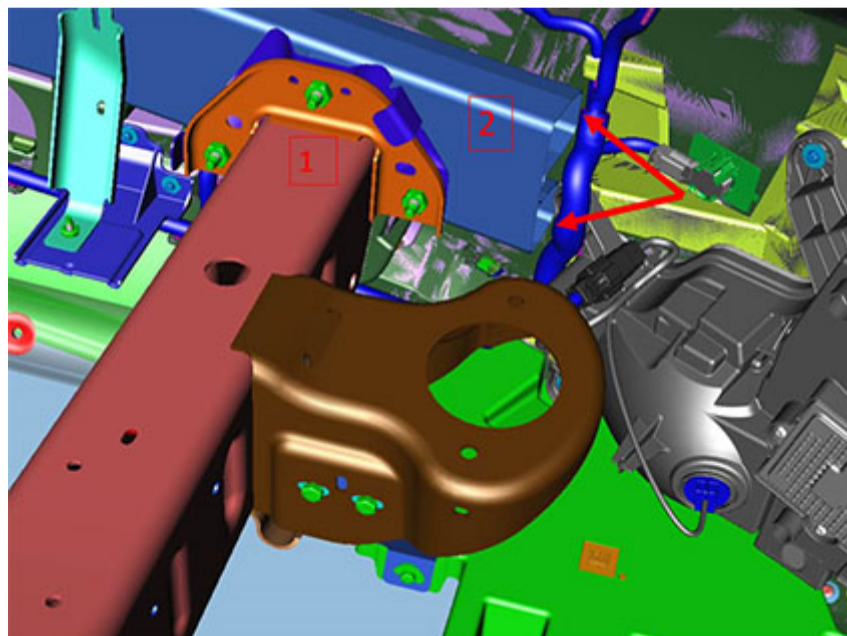
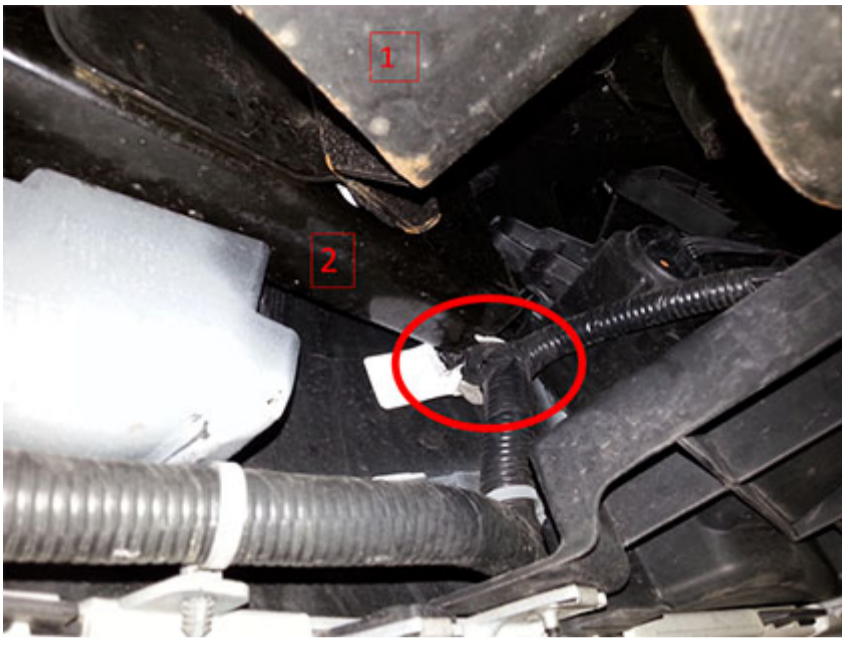
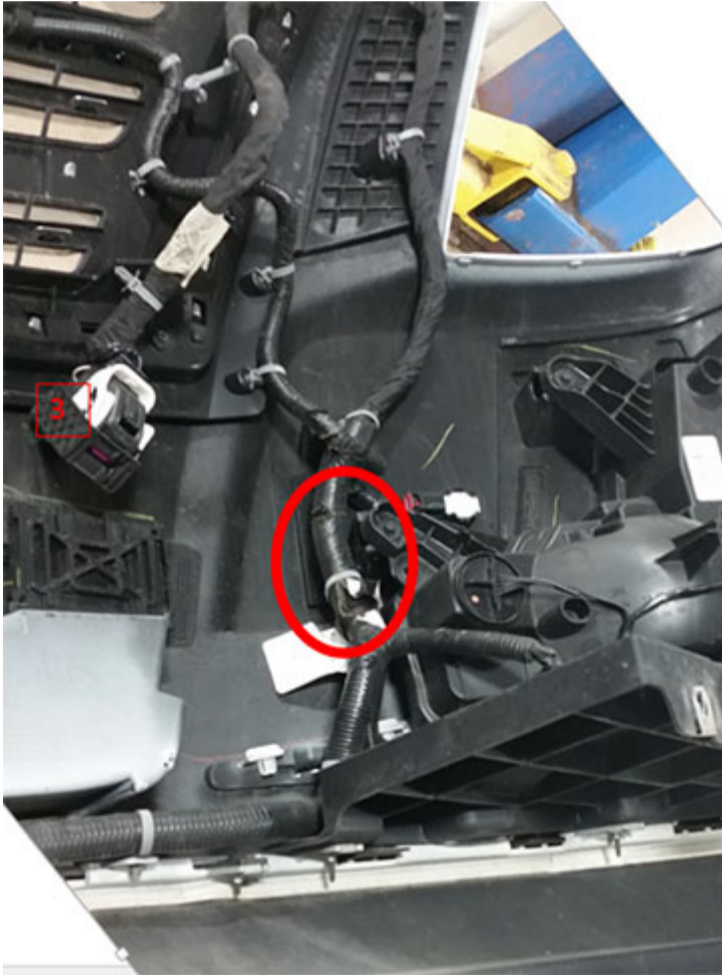
1. Right front frame rail
2. Right side of front bumper bar
3. X100 inline connector

These concerns could be caused by the front fascia/bumper harness shorted at the end of the right front bumper bar (2), as shown below.

The front fascia may need to be removed to make repairs to the wiring harness if any damage is found. After repairing any damaged circuits, reinstall the front fascia and pay close attention to reroute the wiring harness behind the front bumper bar and secure with a zip tie to the fascia, as shown below. This will prevent it from damage again in the future.
