Campaign code:
L636-A.08.19.

Campaign Name:
Gateway ECU connectivity configuration.

Model:
Urus.

Network information notice.

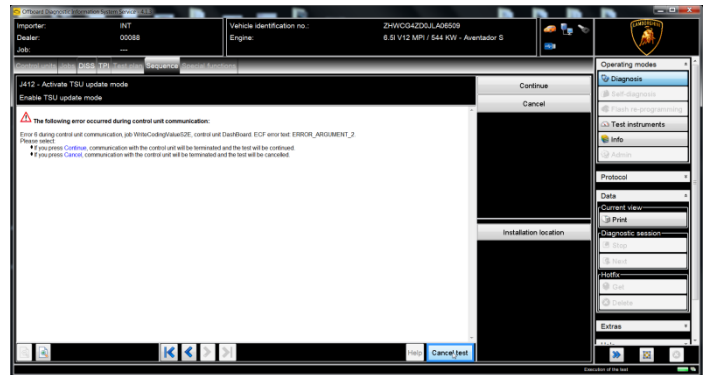
- i. If the following error screen is displayed, abort the guided function by clicking on “Cancel Test” and contact Technical Support.

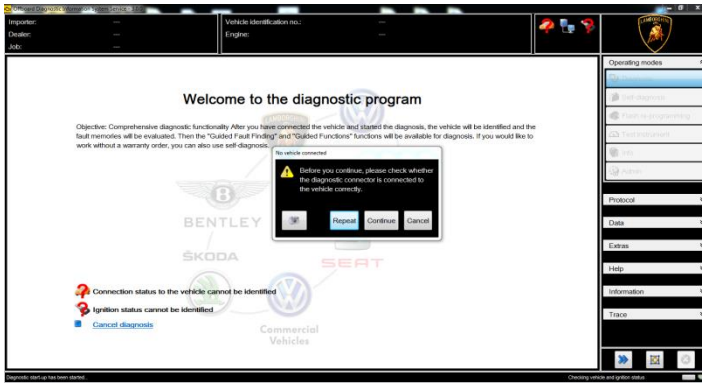
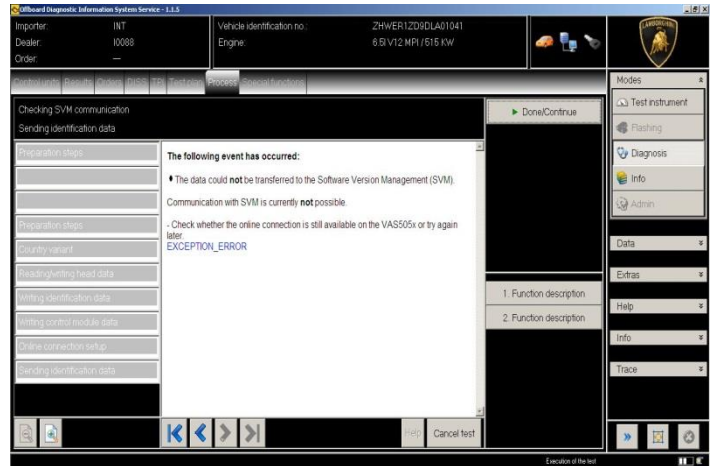
- ii. If an error is displayed that regards the hardware interface, and the "connection to vehicle" and "key state" icons appear as shown in the figure below:

- Click “Cancel”
- Repeat installation of the interface VAS5054/6154/6154A per the instructions in procedure (*) “VCI Manager v2.0”, selecting the right-hand “Extras” menu in ODIS and clicking on the “Diagnostic interface” button.

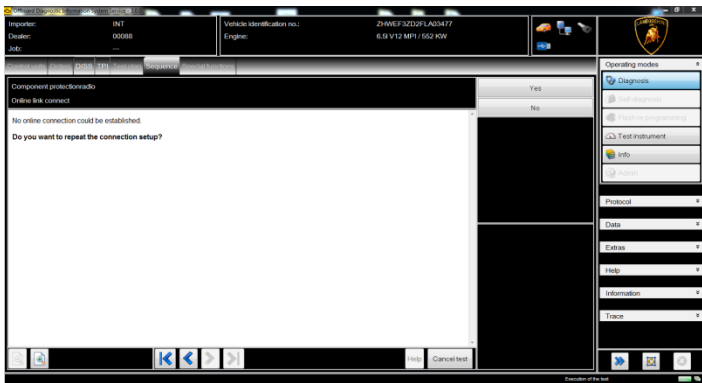
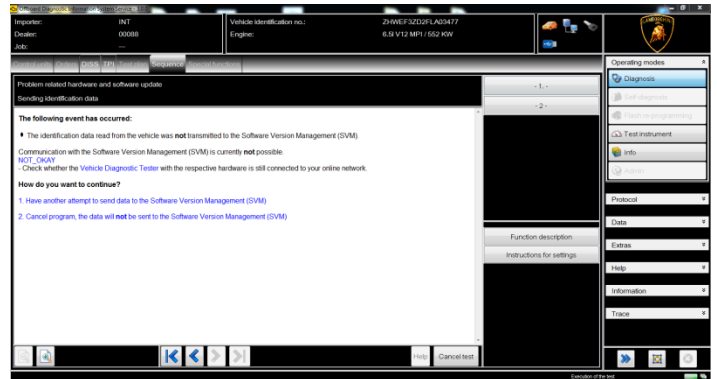
iii. If one of the following connection errors is displayed like in the following example screenshots:

- It is not possible to connect to the central server; check that your laptop is correctly connected to the Internet and retry by clicking on “1”.

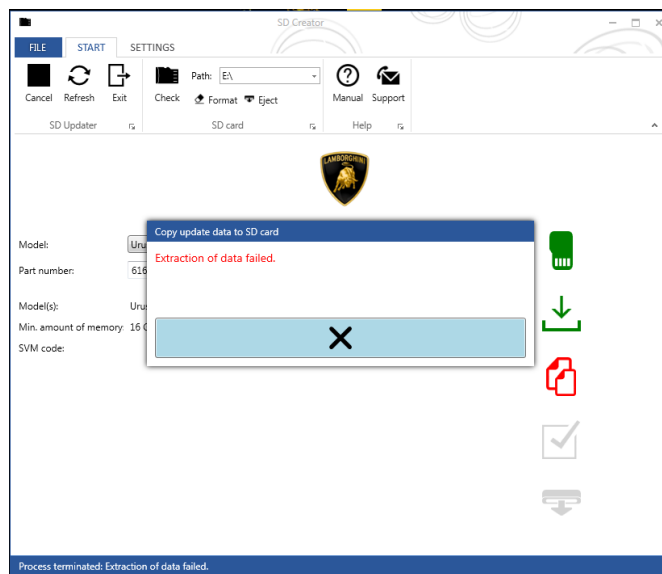
viii. If the following error should occur, it is necessary to follow the instructions given in **BI.25.18 (Rev.02)**, which can be downloaded on the Lamborghini HUB portal:
