CAMPAIGN BULLETIN

Transverse Link

Reference: PC726
Date: December 19, 2019

PC726 - 2019 – LEAF TRANSVERSE LINK

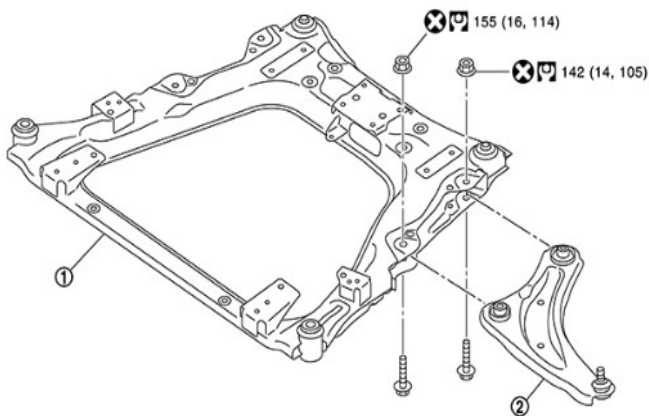
Figure 3

Nissan is conducting a quality action on thirty-two (32) specific MY2019 LEAF (ZE1) vehicles in dealer inventory and identified in Service Comm to torque the transverse link bolts and nuts to specification. Due to a manufacturing assembly issue, that has since been corrected, the transverse link fasteners may not have been torqued to specification.

3. Torque all 4 Transverse Link Bolts while holding suitable wrench on top nut (Figure 3).
