Countries: CANADA, UNITED STATES **Document ID:** IK1600257
Availability: ISIS, FleetISIS, Body Builder, IsSIR **Revision:** 2
Major System: ELECTRICAL SYSTEM **Created:** 1/15/2020
Current Language: English **Last Modified:** 3/4/2020
Other Languages: NONE **Author:** Erik Wass
Viewed: 268

Title: HX Cluster Gauges not Zeroing at key-off

Applies To: HX, 4093442C9*, 4093443C9*, 4093444C9*

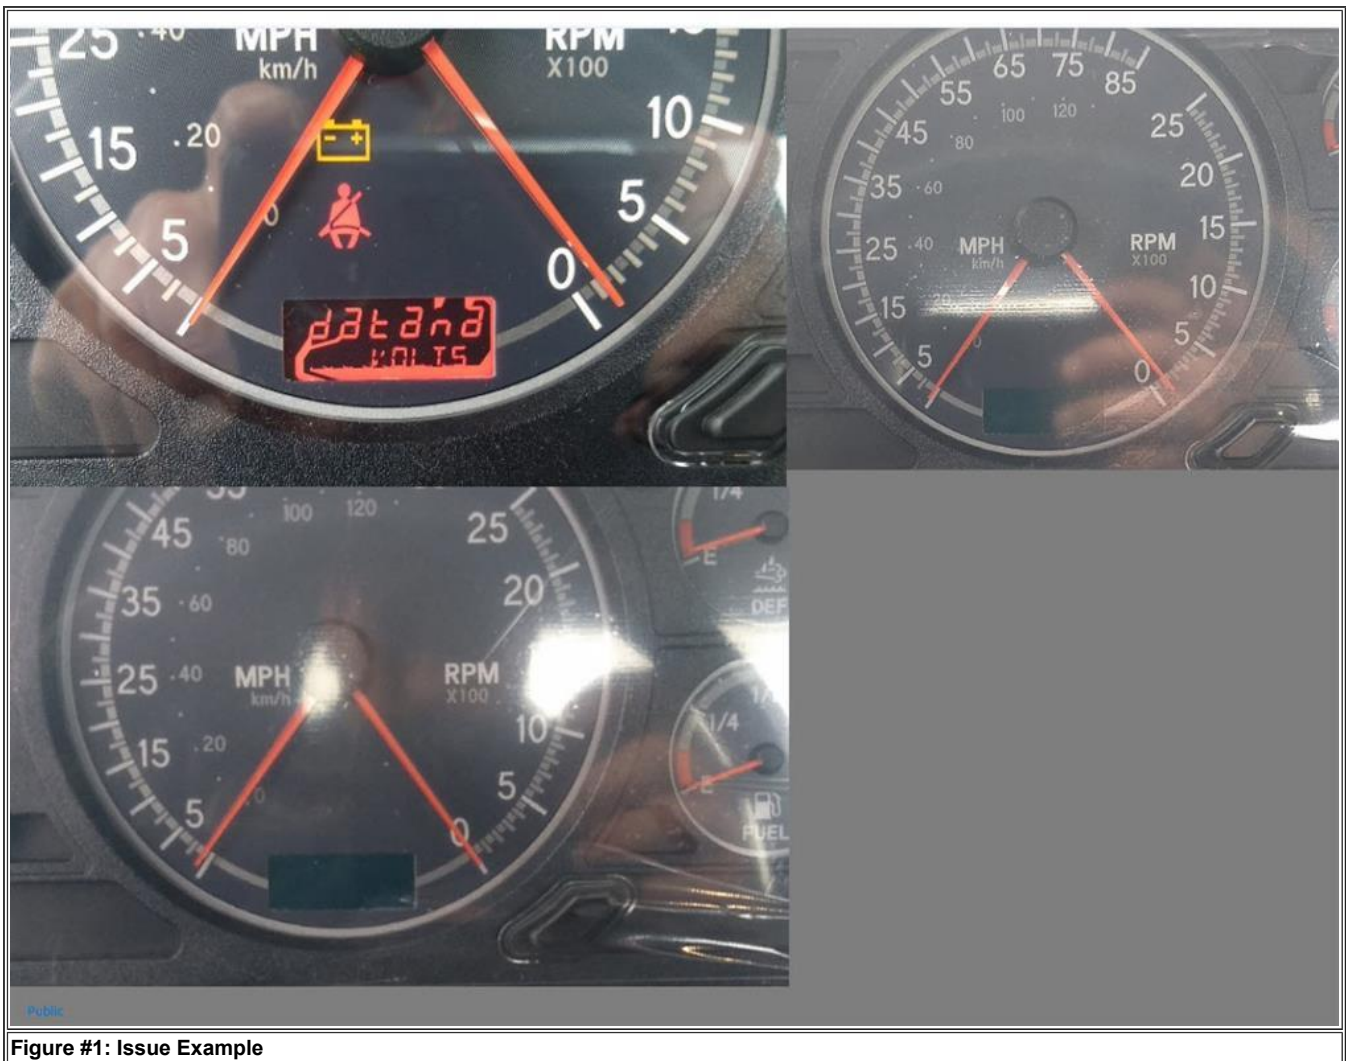
Gauges in the instrument cluster do not return to a full 'zero' position (or below) after shutting off the ignition (key-off position).

Verify the customer complaint of instrument cluster gauges not resetting to zero after a key-off event. **NOTE:** Applies to both metric and standard versions of the cluster (4093442C9*, 4093443C9*, 4093444C9*). See **Figure #1** for examples of the tachometer and/or speedometer not at zero.
