Disc Brake Rotor, Replacement
VAH, VHD, VN, VNE**FSB 511-010, Disc Brake Rotor, Replacement****(July 2021)**

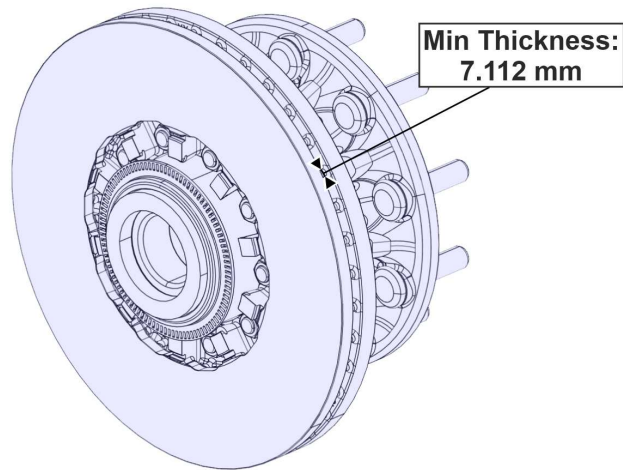
T5167190

Before 11/16/2020 (to be paired with high copper content brake pads):

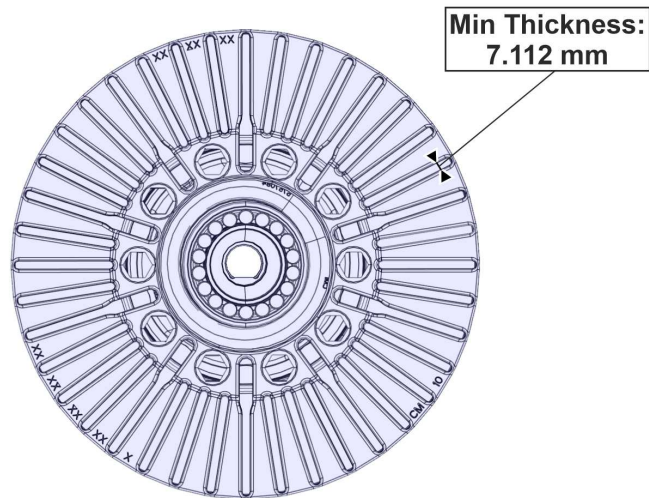
T5167191

Sectioned View:

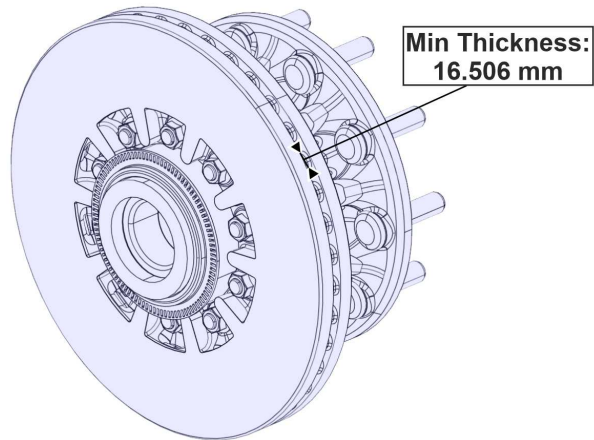
T5167192

11/16/2020 and after (to be paired with low/no copper content pads):

IMPORTANT: When replacing the disc brake rotor, the thicker rotor requires longer mounting studs. Longer mounting stud part number: 24019860.

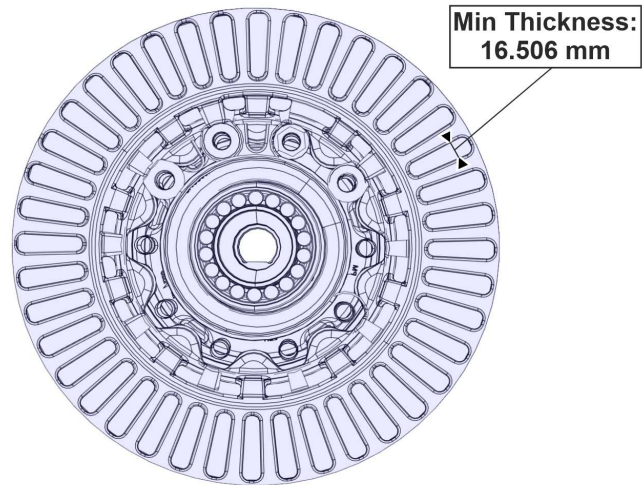
T5167193

Sectioned View:
