### PIP5810 Transfer Case Input Seal Installation

Brand:	Model:	Model Years:	VIN:		Engine:	Transmissions:
			from	to		
Chevrolet	Silverado 2500 HD/3500 HD	2020 - 2021	All	All	All	MGM, MGU
GMC	Sierra 2500 HD/3500 HD	2020 - 2021	All	All	All	MGM, MGU

<b>Involved Region or Country</b>	<b>North America</b>
<b>Additional Options (RPO)</b>	<b>NGF, NQH</b>
<b>Condition</b>	<b>Transfer case input seal installation tool will not install seal to correct depth.</b>
<b>Cause</b>	<b>New tool being developed.</b>

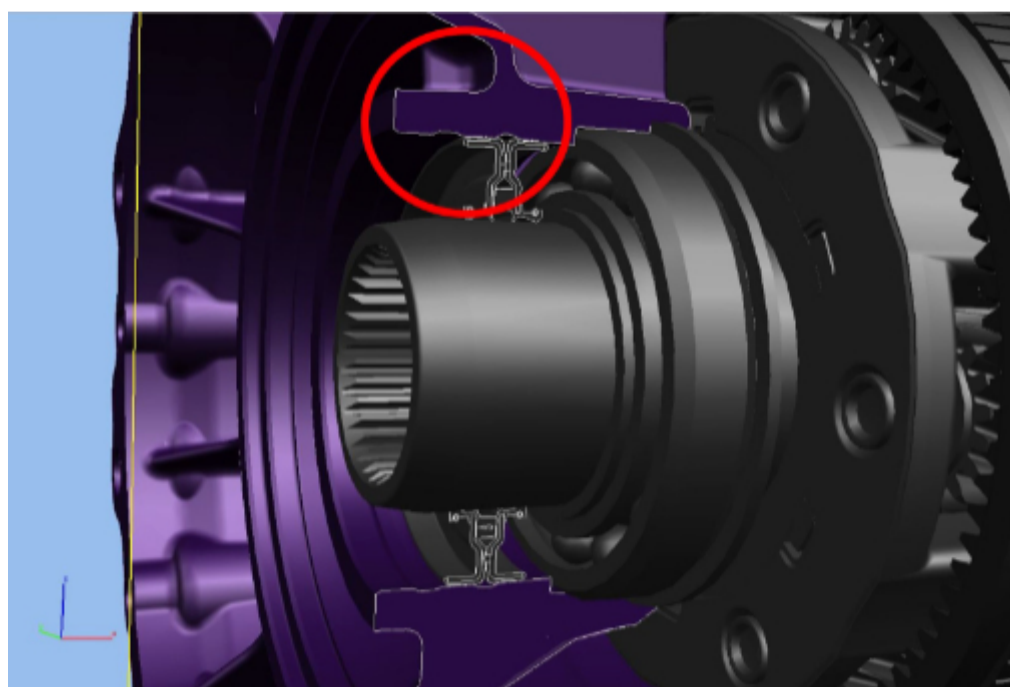
Seal installation depth is critical when replacing the transfer case input seal. There is a gap around the outer portion of the seal that needs to be centered over a weep hole in the case. Weep hole is drilled in the center of a groove machined into the case. Tool # DT-50648-A Seal Installer will not work for these applications.

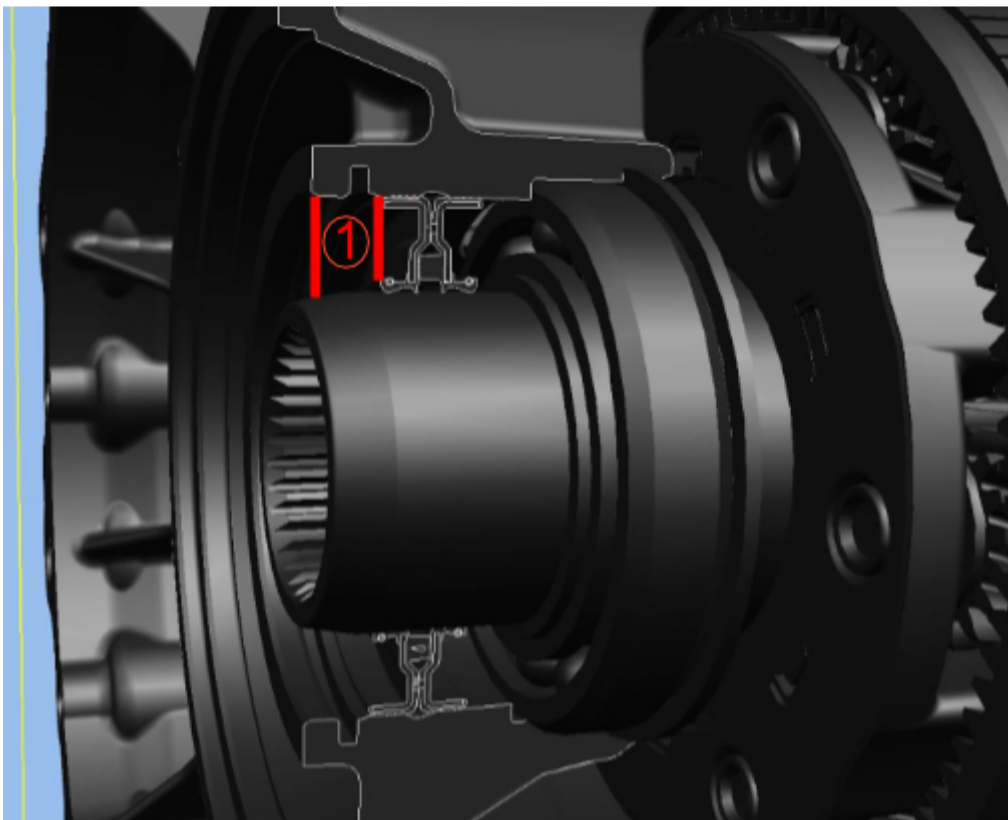
First design dimension 1 is 10 mm.

To verify correct installed depth using a vernier caliper check the distance between the case and the outer part of the seal.

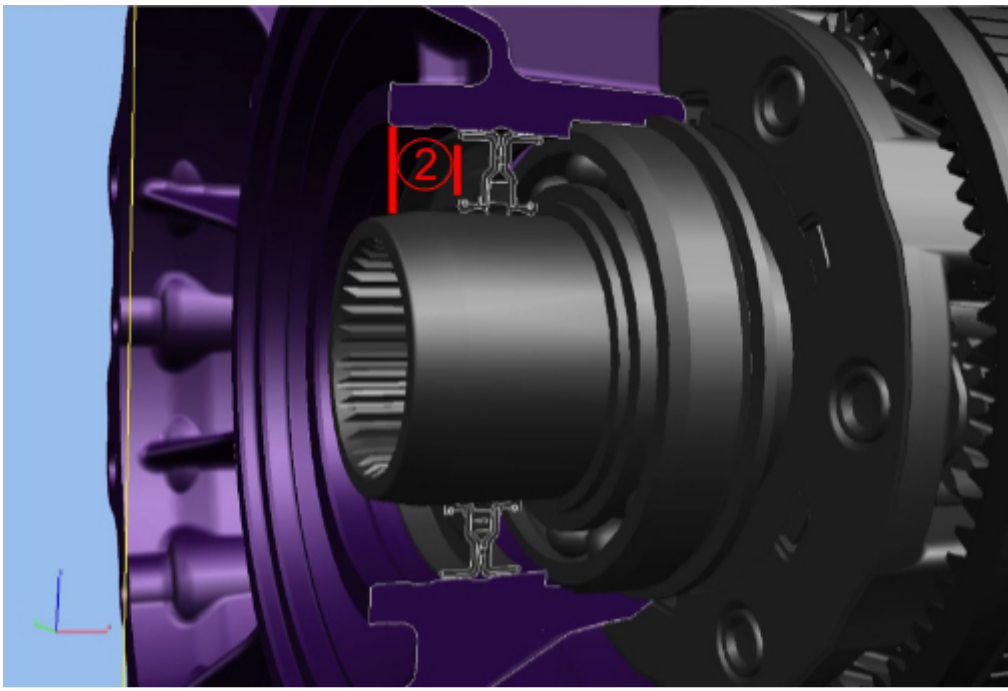
Second design dimension 2 is 13 mm.
