## Model series 223 with code 811: No sound from any source or cracking/popping from all speakers during playback

Topic number	LI82.62-P-073806
Version	1
Function group	82.62 - Loudspeakers, amplifiers, antennas
Date	10/20/21
Validity	Model series 223 with code 811
Reason for change

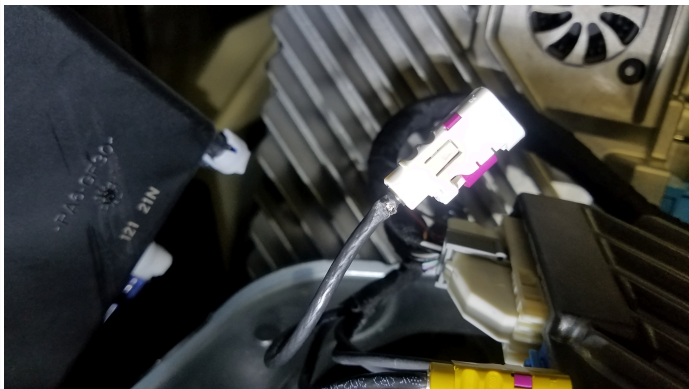
Damage to Sound Amp (N40/7) and Sound Generator (N156/1) eMOST coaxial cabling. See attached pictures

Attachments	
File	Description
<a href="#">damaged coax 1.jpg</a>	Damaged line directly at plug housing.

Inspect the coaxial cabling at the Sound Generator control unit (N156/1) for any externally visible damage or for extreme bending at the connector. If damage is noted then replace the necessary cables. See parts note for appropriate harness depending on if a series vehicle or Maybach is affected.

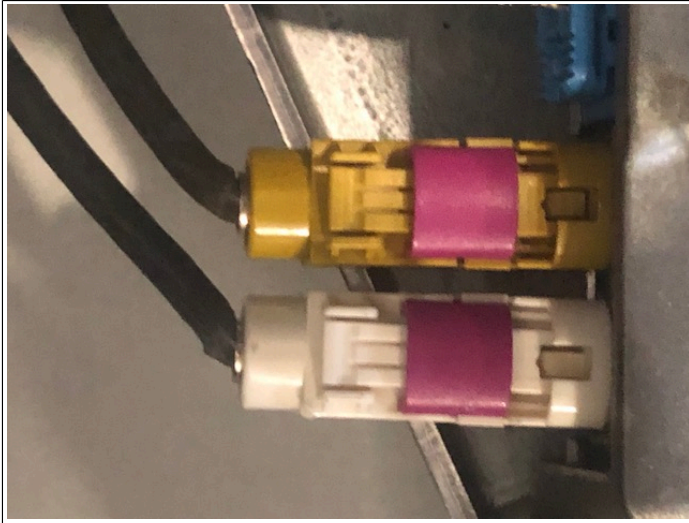
<a href="#">coax cables at N156_1.jpg</a>	Example of eMOST cables bent causing internal damage at N156/1

Note: In some cases the damage may not be obvious. To determine if internal damage has been done to the cabling, manipulate the harness with the sound system on to see if the complaint is reproduced.
