Technical Service Bulletin

SUBJECT:		No: TSB-22-52A-002	
MULTI-INFORMATION DISPLAY SELECTOR ADVANCES IMPROPERLY		DATE: February 2022	
		MODEL: 2022 Outlander	
CIRCULATE TO:	<input type="checkbox"/> GENERAL MANAGER	<input checked="" type="checkbox"/> PARTS MANAGER	<input checked="" type="checkbox"/> TECHNICIAN
<input checked="" type="checkbox"/> SERVICE ADVISOR	<input checked="" type="checkbox"/> SERVICE MANAGER	<input checked="" type="checkbox"/> WARRANTY PROCESSOR	<input type="checkbox"/> SALES MANAGER

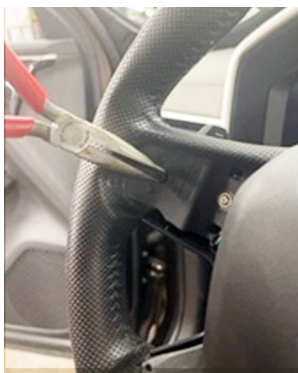
2. Remove SW ASSY Steering parts using caution as the retaining prongs break easily. If the retaining prong(s) break off, be sure to retrieve the broken pieces before replacing with the countermeasure part.

3. Install the countermeasure parts. (Parts are identified with a check mark on all new part orders prior to December 31, 2021.)
