24-18-01 - MIL ON DTCs P2004, P2014 and or P2015 Stored in Engine/Motor Control Module -J623-

Release date: 8/25/2022

Condition

DTC	Description
P2004	Intake Manifold Flap for Air Flow Control Bank 1 Stuck Closed
P2014	Intake Manifold Runner Position Sensor/Switch Circuit
P2015	Sender for Intake Manifold Flap Position/Air Flow Control, Implausible Signal

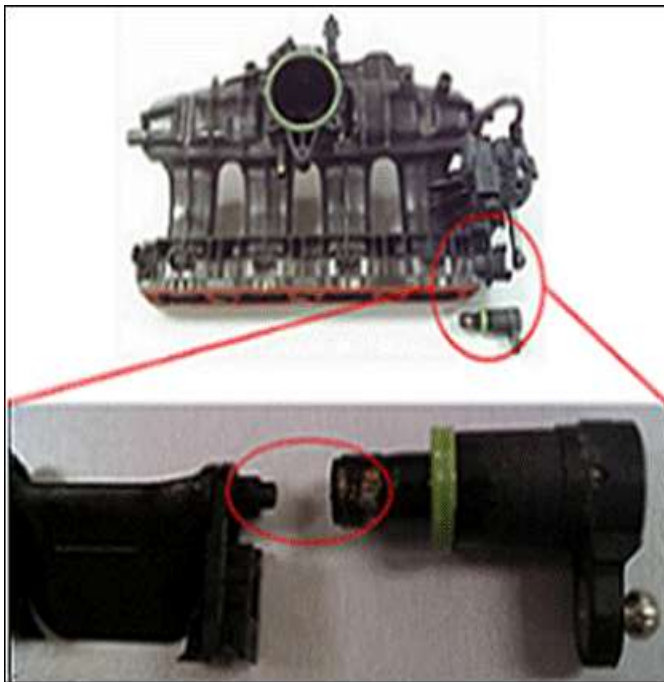
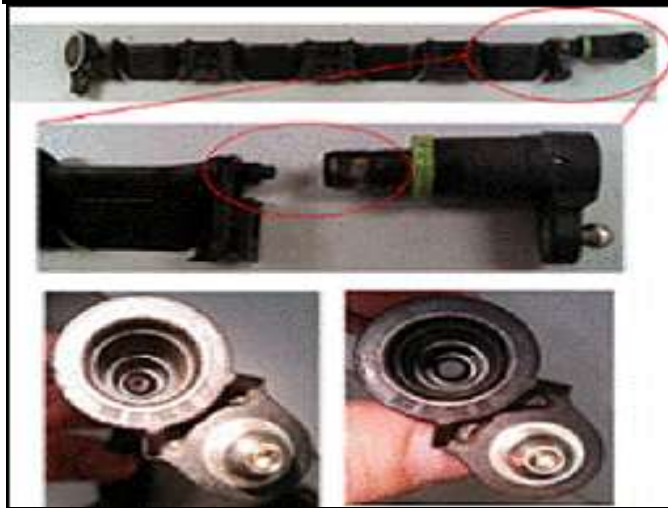
The intake manifold flap can separate internally and will not operate correctly with the regulator valve. See Figure 1. and Figure 2. for an example of a damaged flap disassembled.

If the carrier plate can be pulled out, the flap has separated and the intake manifold must be replaced. See Repair Group 24 Multiport Fuel Injection in Elsa.

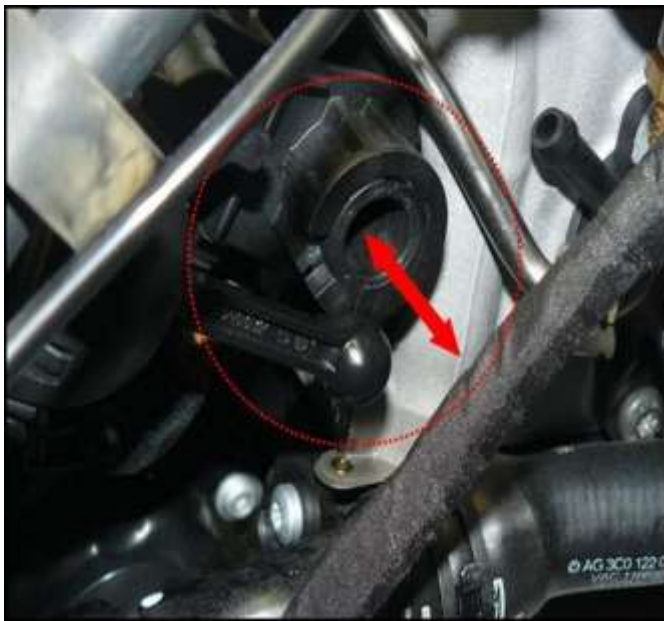
Figure 3.

- Remove the engine cover. See Repair Group 10 Engine Assembly in Elsa.
- Move the carrier plate by hand in an axial direction (Figure 3, red arrow) to check if the carrier plate can be pulled out.

If the carrier plate **cannot** be pulled out, perform the following procedure:
