WLD5 - Replacing Hose for Positive Crankcase Ventilation (Workshop Campaign)

Model Line: **Panamera (971)**

Model Year: **As of 2017 up to 2019**

Subject: **Positive crankcase ventilation hose**

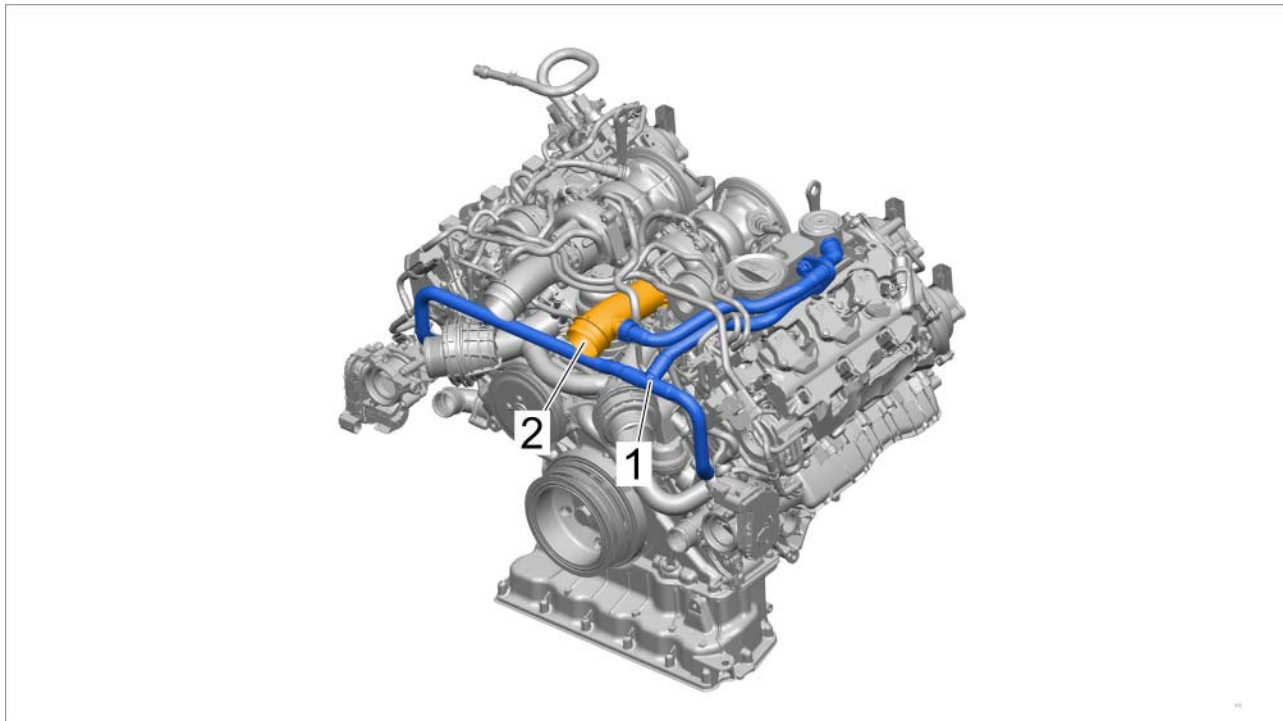
Installation Position:

Information: **A part-load valve was installed in the hose for crankcase ventilation on the affected vehicles which has a sealing washer that does not meet the required specifications and could possibly crack when the crankcase pressure rises.**

Consequently, small amounts of engine oil can leak from the oil filler cover into the adjacent engine compartment, resulting in a reduced engine oil level over time. The driver is alerted by an appropriate warning message if the engine oil level is too low.

Installation location for positive crankcase ventilation hose.

- 1 – Positive crankcase ventilation hose
- 2 – Intake manifold

Remedial Action: Replace positive crankcase ventilation hose with intake manifold.
