GLOBAL SAFETY FIELD INVESTIGATIONS  
DCS6393  
URGENT - DISTRIBUTE IMMEDIATELY

Subject: N222372592 - Service Update  
Charge Air Cooler Icing

Models: 2019 – 2021 Chevrolet Silverado 1500  
2022 Chevrolet Silverado 1500 LTD  
2019 – 2021 GMC Sierra  
Equipped with 2.7L, 4-cylinder Gas Engine (RPO L3B)

## N222372592 Charge Air Cooler Icing

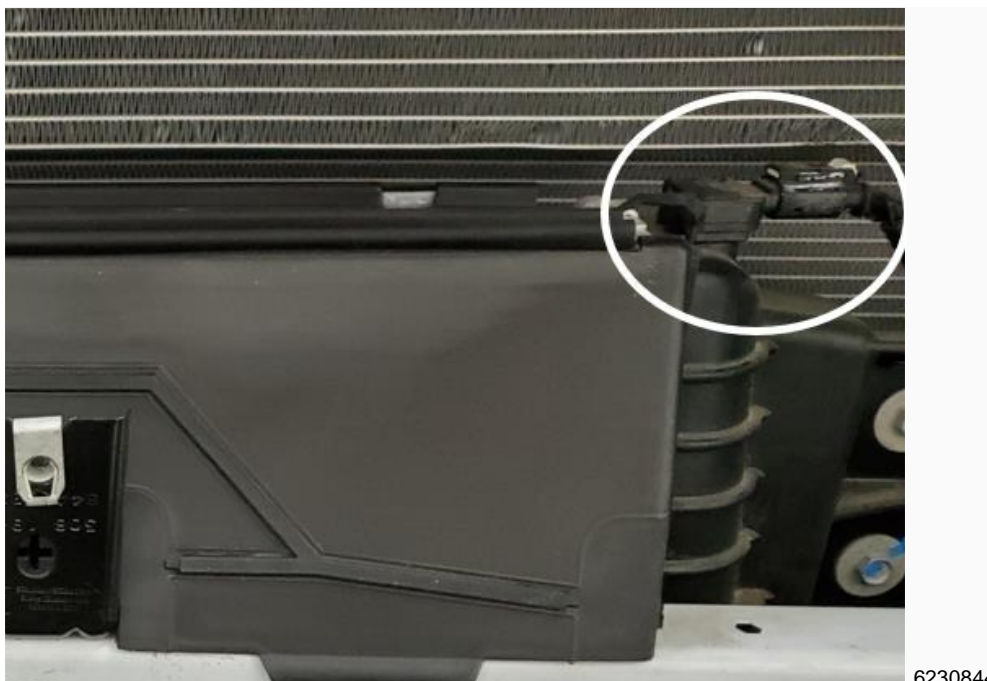
2. Remove the Throttle Inlet Absolute Pressure (TIAP) sensor, circled above.
3. Using a fluid extractor or suction tool, drain any remaining moisture from the Charge Air Cooler end tank.
4. Reinstall and tighten the Throttle Inlet Absolute Pressure (TIAP) sensor and bolt. Refer to *Fastener Specifications* in SI.
