# Preliminary Information

## PIT6088 Diagnostic Tip - Lack Of Power Steering Assist With DTC P25A2 C1597 and/or C1599

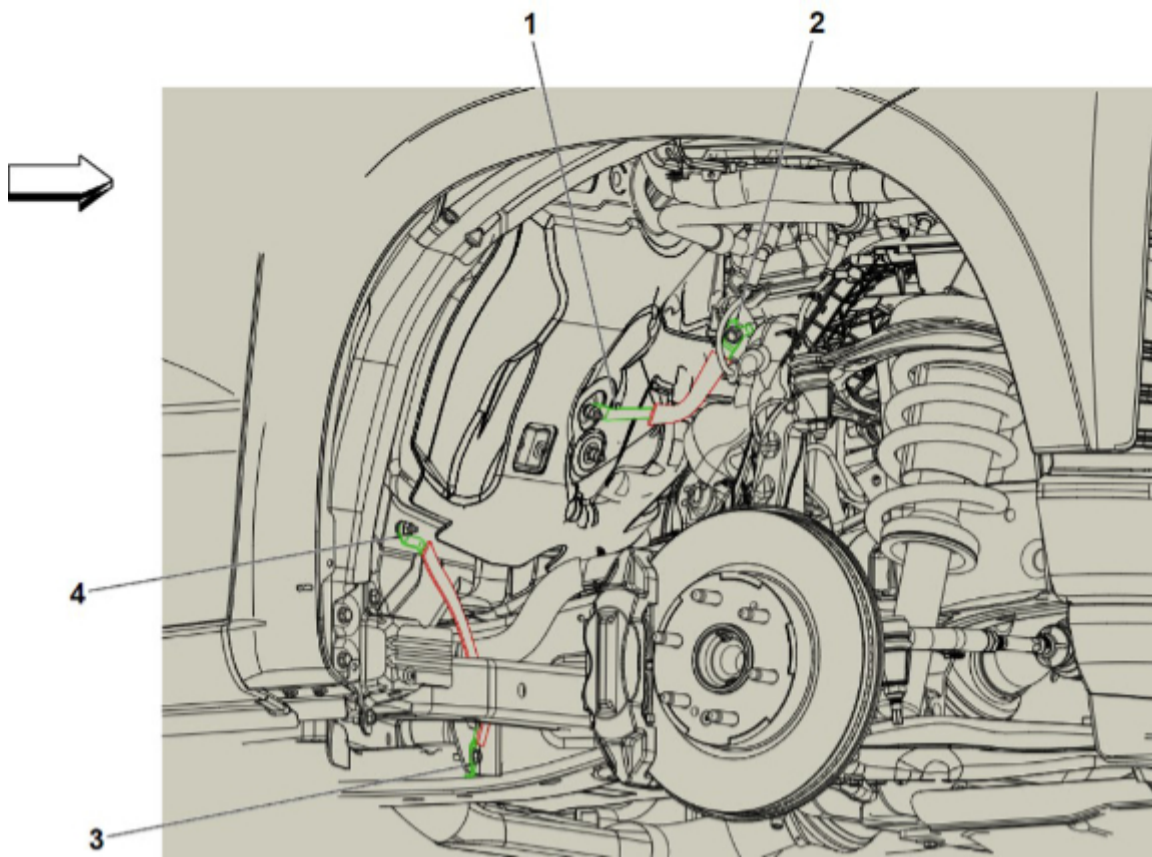
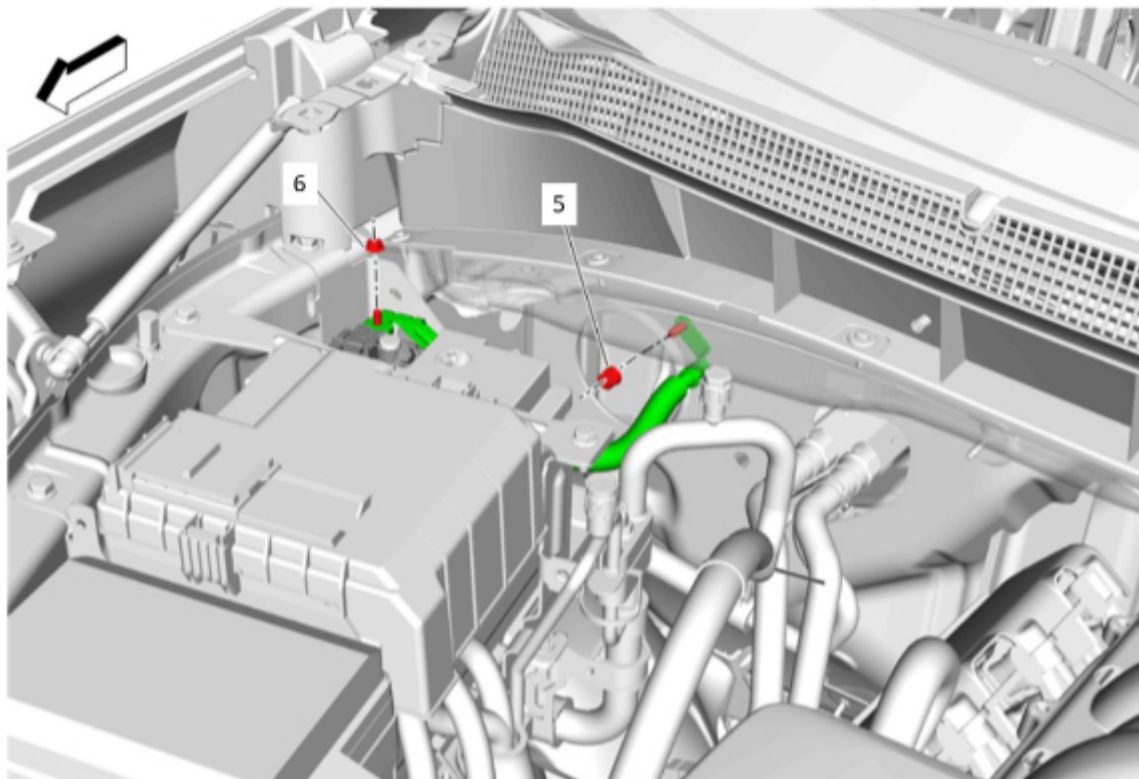
Involved Region or Country	North America
Condition	Some customers may comment on a lack of power steering assist. When checking for DTC's a C1597 and/or C1599 may be set in the power steering control module.
Cause	The cause of this concern could be a poor ground at one of the main ground cable/strap connections.

- (1) G132 Engine Ground Strap
- (2) G134 Engine Ground Strap
- (3) G131 Frame Ground Strap
- (4) G133 Frame Ground Strap
- (5) G130 Battery Negative Cable at Body Ground
- (6) Battery Negative Cable

Inspect the following main ground strap/cable connections, shown below, to make sure they are clean and tight. Also, inspect for any corrosion at the connection or a corroded braided strap/cable. Lightly pull on the ground straps to make sure they do not break in two and the eyelet connections do not move or break. Replace and/or repair any issues found.
