## PIT5888C Air Leveling Suspension Is Low After An Overnight Soak In Very Cold Temperatures

Product Investigation Review Required

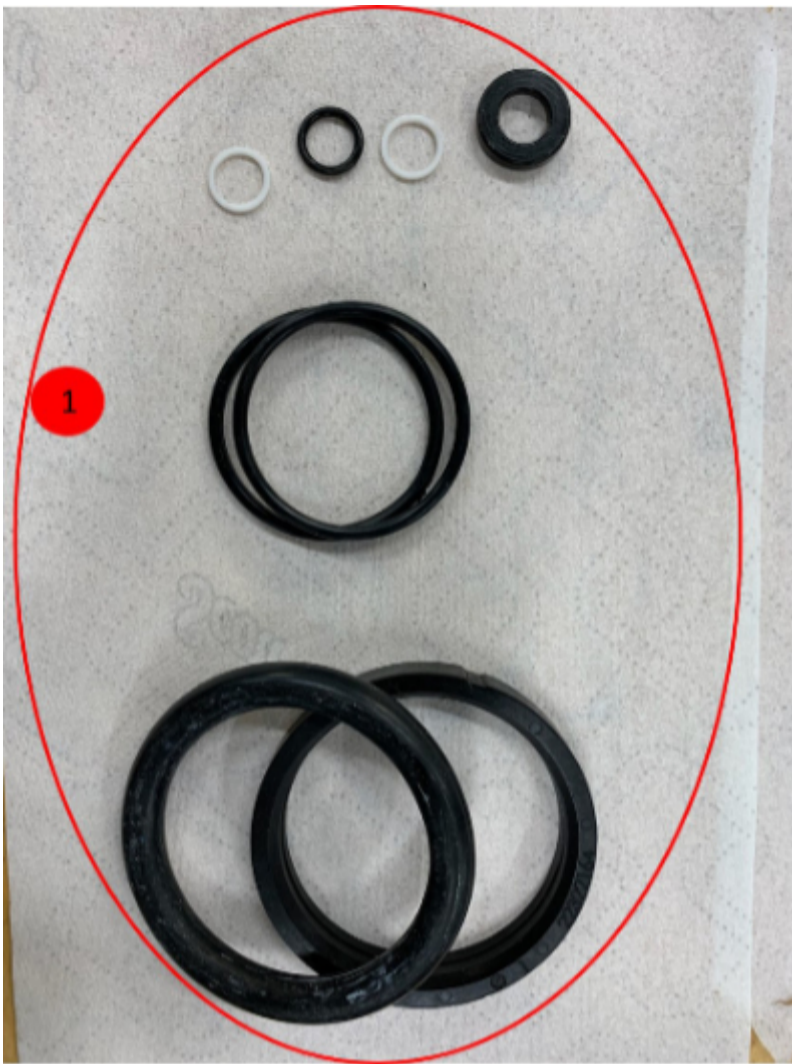
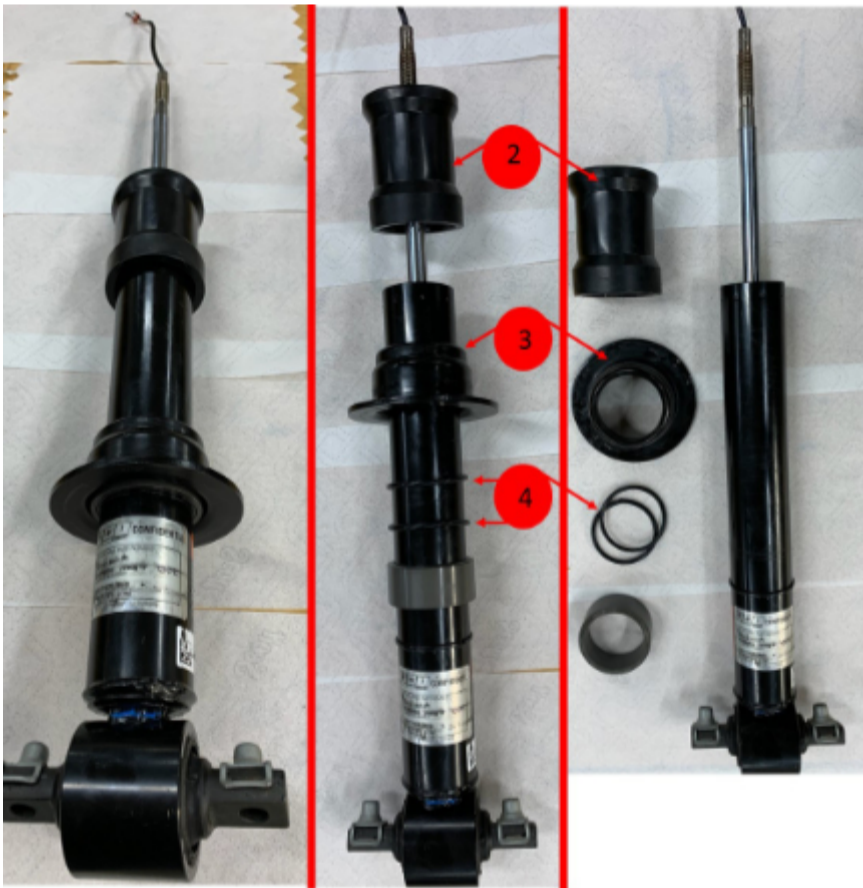
Involved Region or Country	North America
Additional Options (RPO)	F47 - Air Leveling Suspension
Condition	<p>Some customers may report that following an overnight cold soak, in temperatures below 0 Degs F (-15 Degs C), that the front air springs have leaked down resulting in severe suspension sag. A "Service Air Leveling System" message may be present on the driver information center (DIC) accompanied with DTC C118B and/or C118C.</p> <p><b>Note: This condition is not known to manifest itself in ambient temperatures warmer than 0 Degs F or -15 Degs C.</b></p>
Cause	Air spring to upper mount crimp ring.

- If no root cause is found, engineering has found air may leak around the area of the upper air spring to upper mount crimp, which only occurs in very cold temperatures. To correct this concern, replace both front air springs. Follow SI "Shock Absorber, Shock Absorber Component, or Spring Replacement - (F47)" for the air spring replacement procedure. During this repair, the air spring seals must be replaced and the seals come as a kit (1), shown below. The seal kit will contain seals for the air spring itself and two additional o-rings (4) that are used for the shock spring seat (3), see below. These two additional o-rings should also be replaced during the air spring replacement.
