## ALERT SERVICE BULLETIN

**206-20-140**

**MODEL AFFECTED:** 206A/B and TH-67

**SUBJECT:** MAIN ROTOR BLADES P/N 206-010-200-133 /-137 /-139 GRIP PLATES AND ROOT END DOUBLERS, INSPECTION OF.

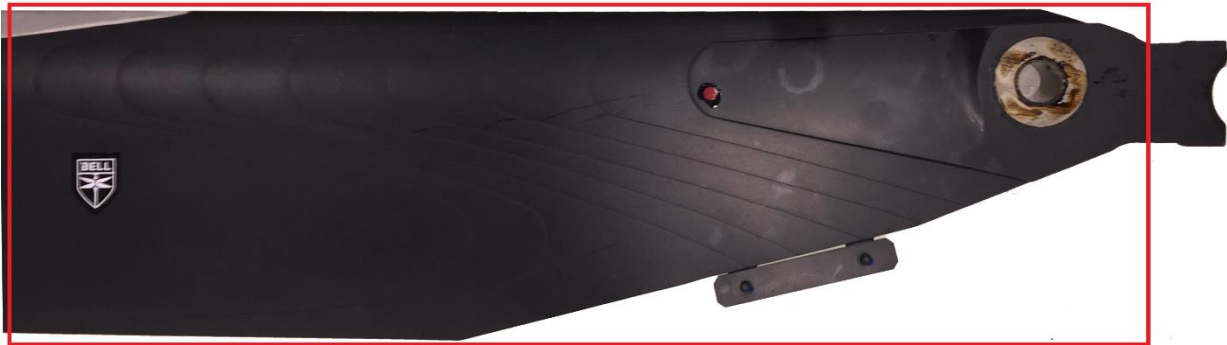
**Figure 1.** Area to be inspected with 3X- power magnifying glass, from STA 15.0 to STA 58.0 (upper and lower surfaces).

2. Wipe the area to be inspected (Figure 1 and 2) with an alcohol-soaked cloth (C-385) and wipe dry with a clean cloth.
3. Visually inspect the main rotor blade upper and lower grip plates and doublers for signs of cracks, corrosion, and edge voids as follows. Pay particular attention to the bond lines between the doublers, grip plates, and skin:
  - a. Using a 3X power magnifying glass and strong light source carry out a detailed visual inspection of the top and bottom inspection areas (Figure 1).
  - b. Check for evidence of a dark line between the doublers, grip plates, and skin with excess alcohol bleeding out for possible edge voids (Figure 2).

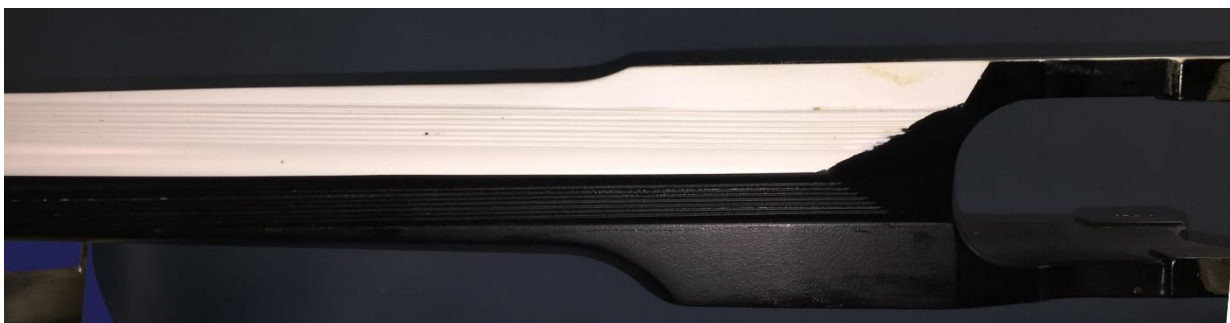
(Leading edge)

**Figure 2.** Inspect the leading edge from STA 15.0 to STA 58.0 and trailing edge from STA 15.0 to STA 56.0 of the blade for crack between each doublers and the grip plates.

- c. If cracks in the finish are found between doublers, grip plates and skin edges, sand the affected area in a spanwise direction with an abrasive cloth or paper (C-406) 180 to 220 grit to determine if the grip plate/doublers are cracked or voided.

- d. If any edge voids are found between doublers, grip plates and skin, determine the depth and length with a 0.0015 inch (0.038 mm) feeler gauge. If edge voids are suspected near the outboard tip of the doublers and grip plate, carry out a tap test of the affected area. Refer to the Maintenance Manual for limits and repair instructions (BHT-206A/B-SERIES-MM-6, Chapter 62). If any void is found outside of limits, contact Product Support Engineering.
  - e. Refinish any sanded areas (BHT-206A/B-SERIES-MM-6, Chapter 62).
4. Following the inspection, apply a light coat of preservative oil (C-125) to all surfaces of the blade (BHT-206A/B-SERIES-MM-6, Chapter 62).
  5. Make an entry in the helicopter logbook and historical service records of the helicopter and the main rotor blade indicating findings and compliance with **PART II** of this Alert Service Bulletin.
