INFORMATION LETTER

206L-21-103

TO: All owners and operators of model 206L, 206L-1, 206L-3 and 206L-4 helicopters

SUBJECT: THROTTLE CABLE ASSEMBLY 1608750-001, INTRODUCTION OF.

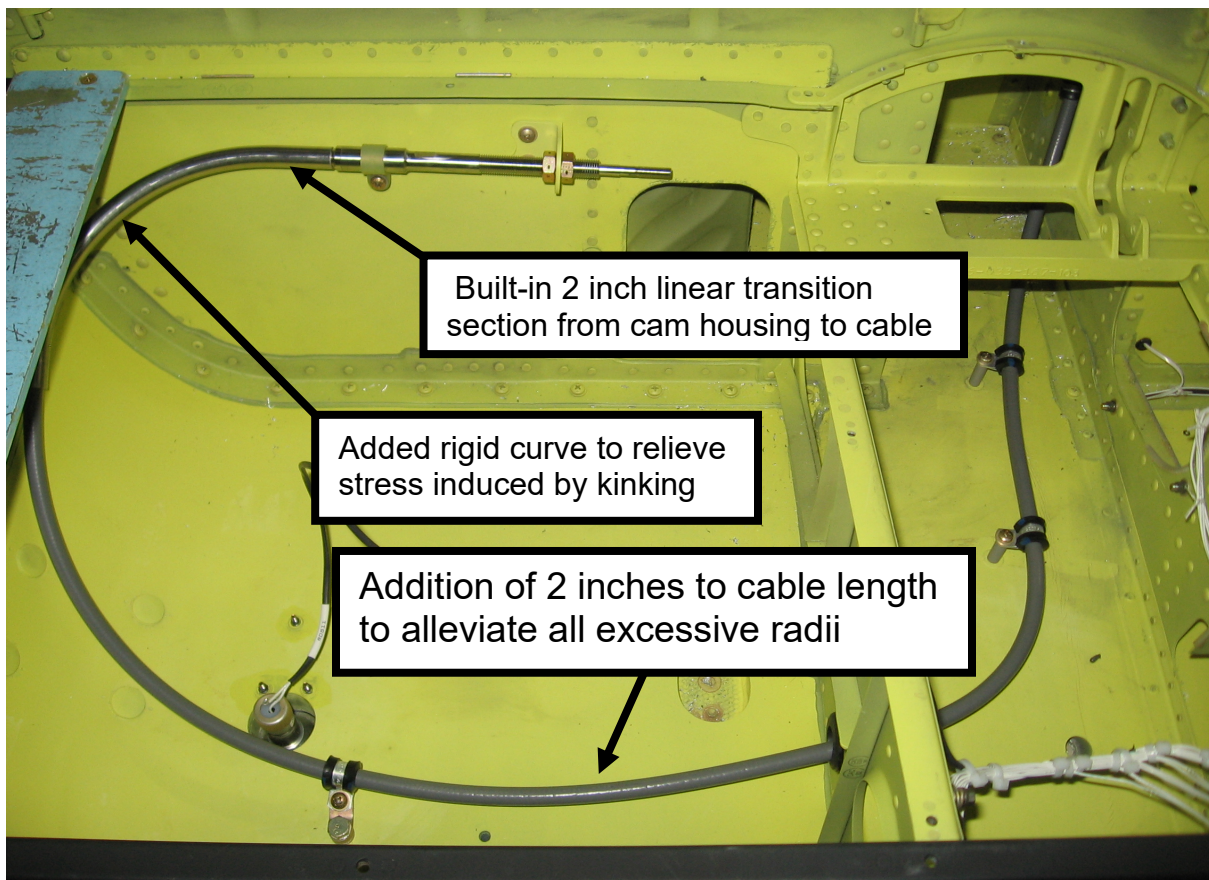
Figure 4 – Throttle Cable Assembly 1608750-001 Design Improvements (206L4 Installation Shown as Reference)

To minimize the possibility of future throttle cable assembly failures, Bell introduced the throttle cable assembly 1608750-001 into the production configuration of the 206L4 at serial number 52449 through 52496. In conjunction with the new design (Figure 4), improved installation procedures, revised rigging procedures, and handling procedures

were incorporated to the applicable sections of the respective Maintenance Manuals (Chapter 76).
