TECHNICAL BULLETIN

214ST-90-112

**MODEL AFFECTED:** 214ST

**SUBJECT:** ROOF FRAME P/N 214-031-516-131, -132, -139,  
AND -140, REPAIR/MODIFICATION OF

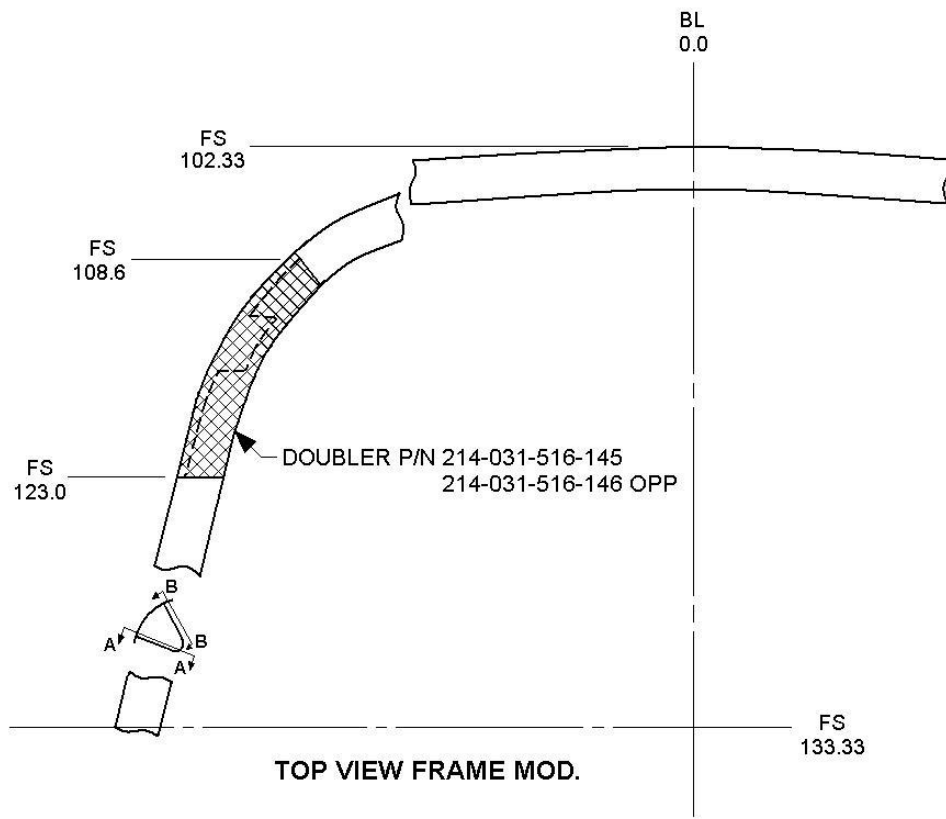
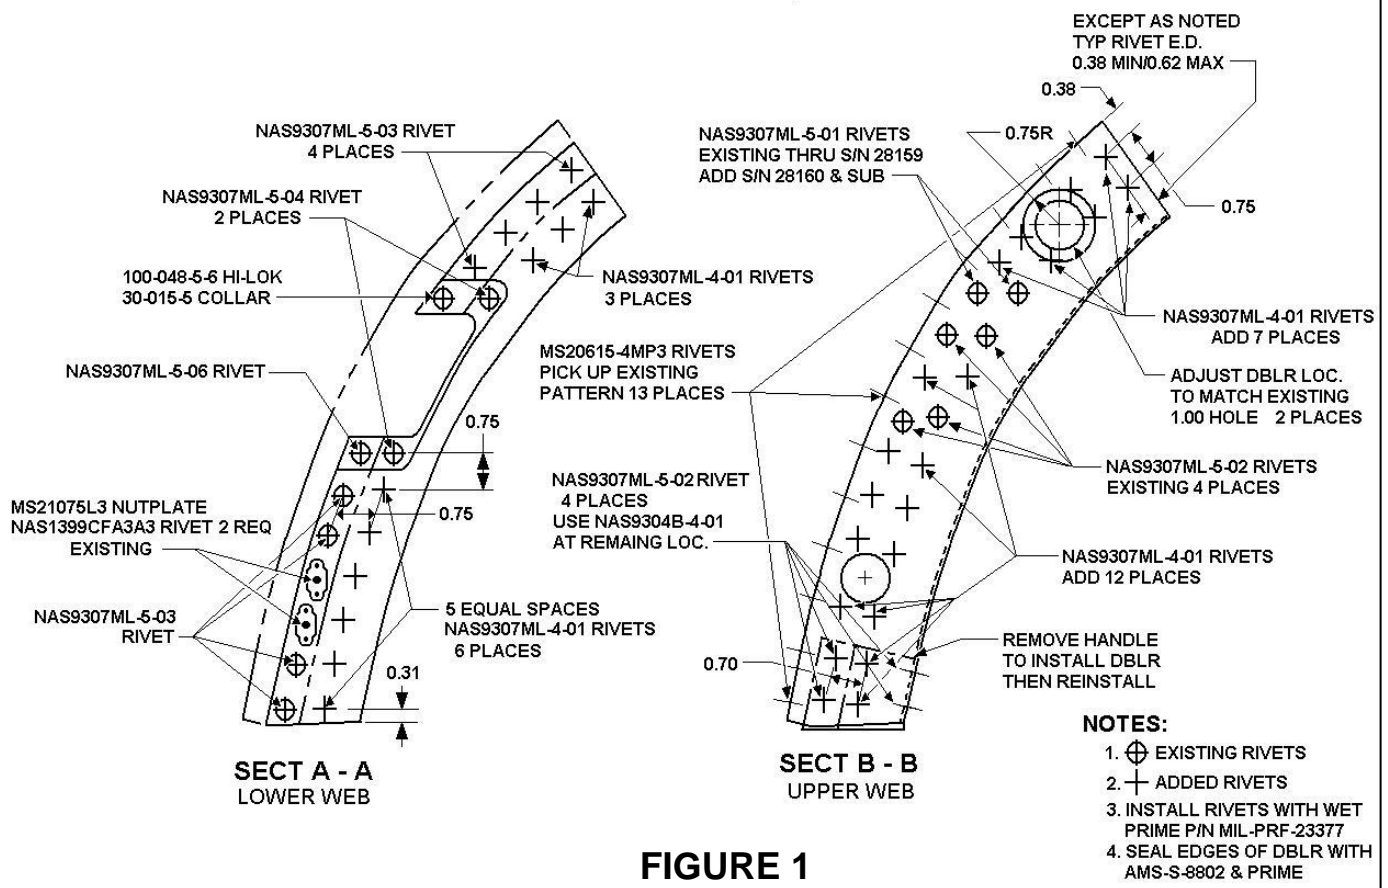
**FIGURE 1**

Several reports have been received of circumferential cracks in subject frame. The cracks originated at the forward crew door post to roof frame attachment. Failure to identify and repair the crack can result in frame cracks requiring major repair.

1. Locate repair doubler P/N 214-031-516-145 over roof frame P/N 214-031-516-131 as shown in Section B-B of Figure 1. Mark end with felt tip marker.
2. Remove rivets in area to be covered with repair doubler and handle.

3. Nest repair doubler over frame with 1.00 inch holes aligned and clamp in place. Verify fastener ED, then drill doubler to match all existing fastener locations shown in figure. Stop drill any crack in frame.

10. Mix adhesive (C-317) in accordance with manufacturer's instructions.
11. Apply thin coat of adhesive (C-317) to 1) marked-off area of frame and 2) faying surface of doubler.
12. Assemble parts being certain rivet holes are aligned. Cleco in place.
13. Install two NAS9307ML-5-04, one NAS9307ML-5-06, and one 100-048-5-5 fasteners through door post fitting, doubler, and frame.
14. Install remaining rivets shown in Section A-A.
