Post Mortem Failure Assessment of MODUs During Hurricane Ivan

September 2004

Minerals Management Service

Hurricane Ivan: MODU Investigation & Recommendations Sept 2004

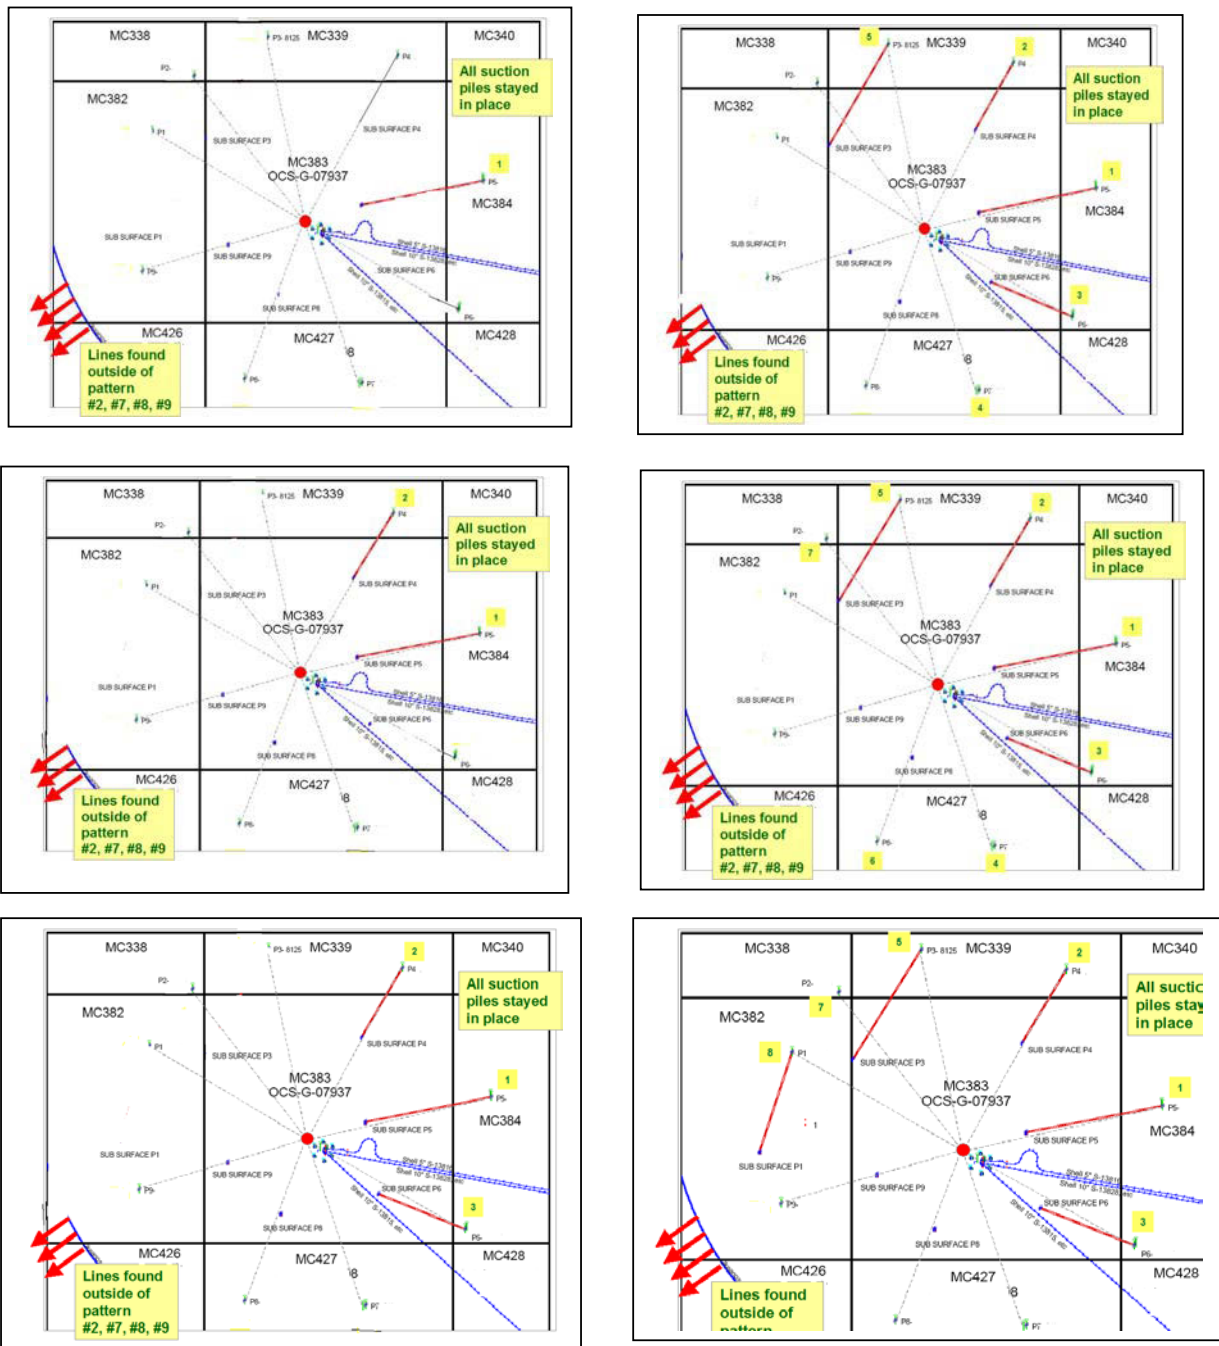
The sequence of failure as determined from the position of the equipment after the rig departed the site can be visualized by following the sequence of diagrams below in Figure 12 in order from view 1 through view 6. The sequence starts in view 1 with the 1st line breaking, line #5. The second view shows the 2nd line breaking is #4, and so on. The vessel moved off to the south-west based on the way the mooring lines on location were found and thus the moorings would most likely have broken with the wind to the west prior to the eye passing by the location.

Figure 12: Showing the Most probable Line Sequence of Failure: Views 1-6 (Ref (21)).

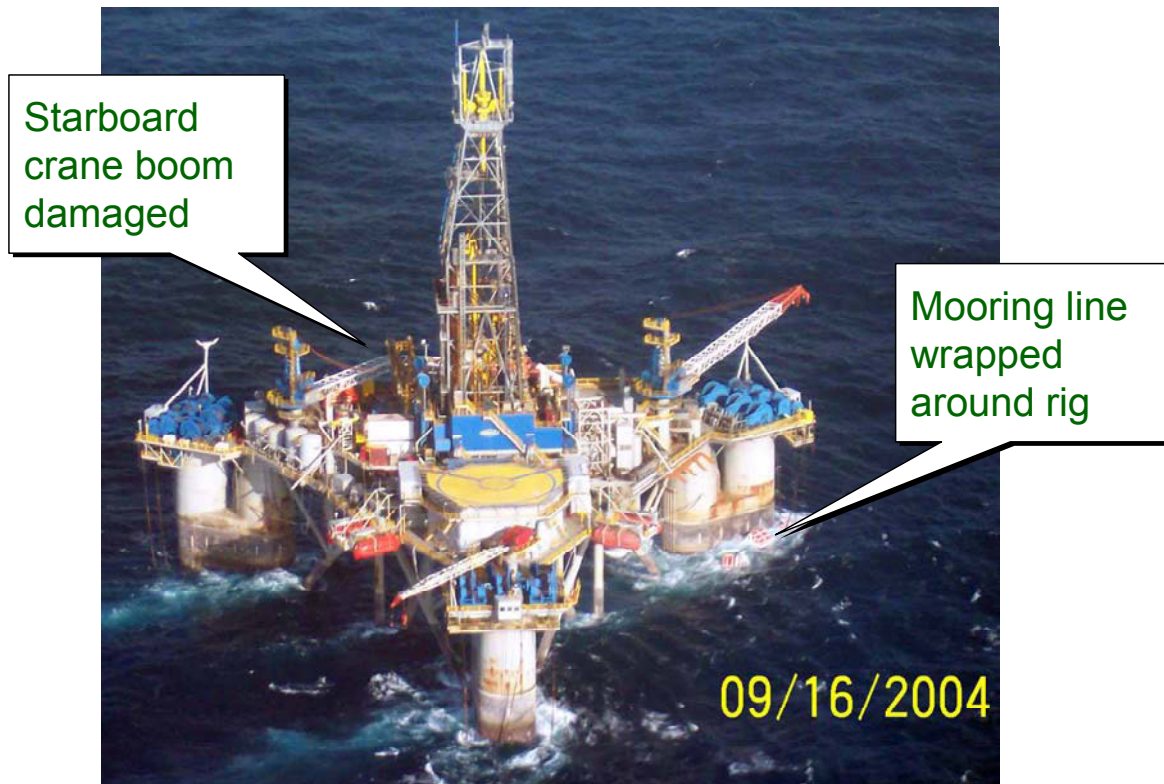
The damage to the rig was significant but it returned to work as soon as the repairs were complete and new mooring equipment procured. The damage can be summarized as follows:

Figure 14: Noble Jim Thompson with damages noted.

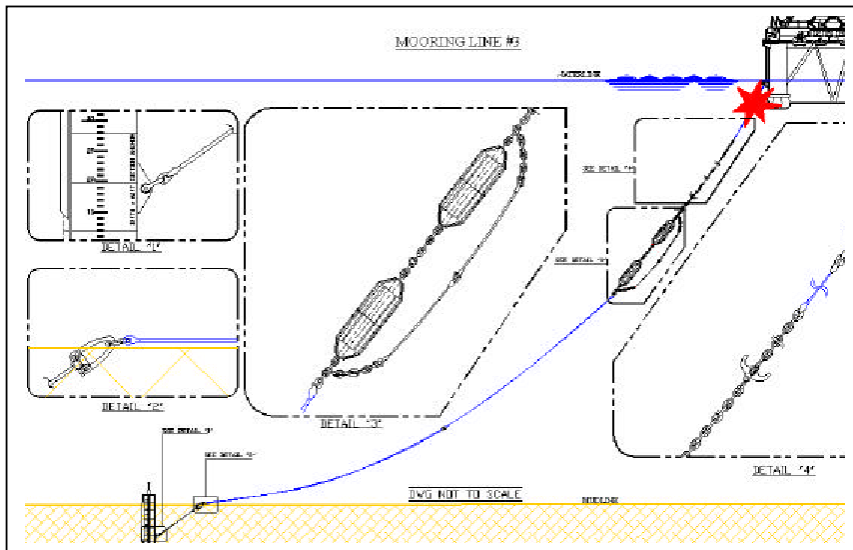
Figure 15
Illustrating the break position for line #5 near to the fairleader

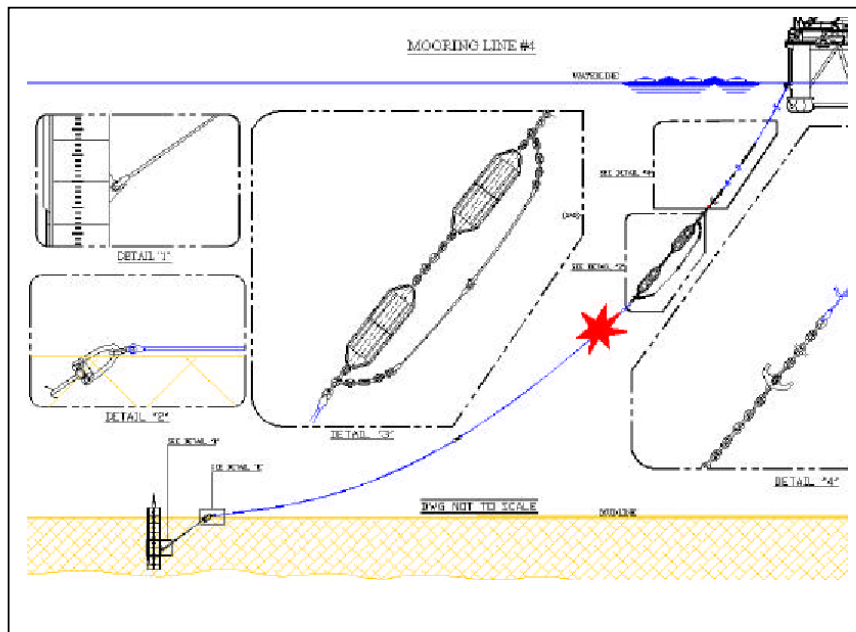
Figure 16
Illustrating the line #4 the 2nd line to break in the wire below the buoys

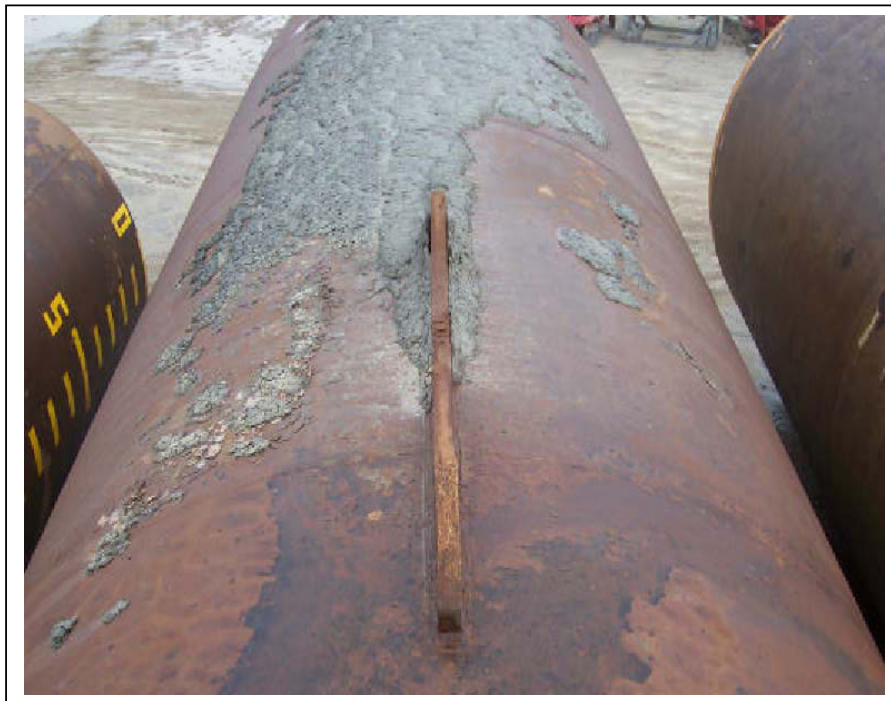
Figure 18: Shows the Damaged Padeye on the Suction Piles. The padeye angle was about 45° at the time of failure.

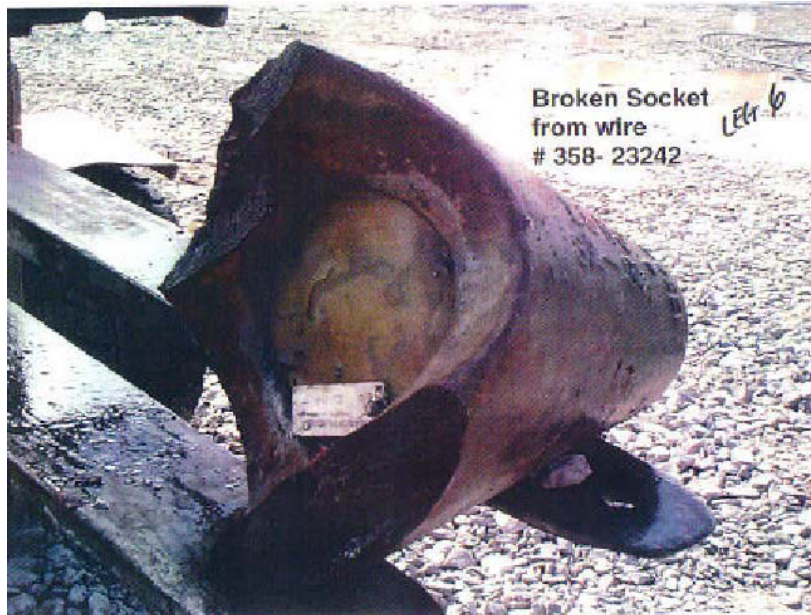
Figure 19: Broken socket from wire on Leg #6

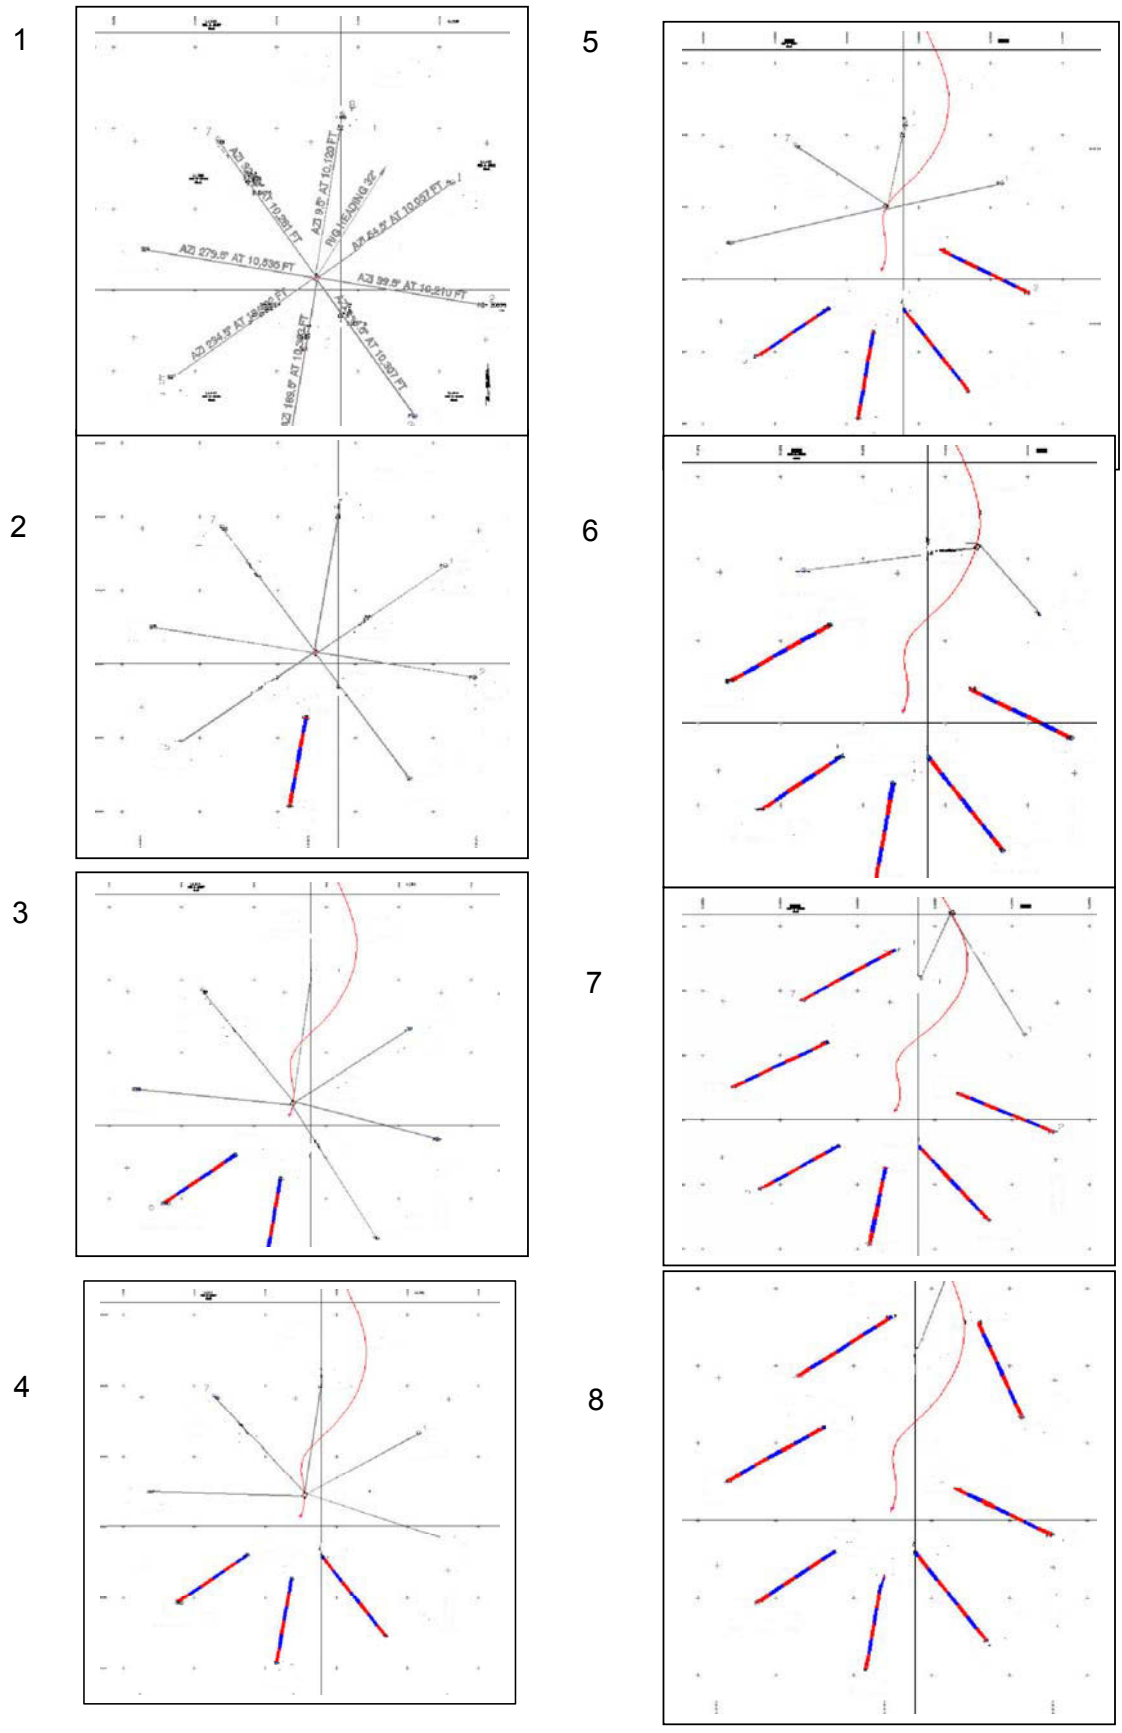
Based on the sequence of the breaks and the direction determined by the lines on the seafloor after the incident the break must have occurred close to the time the storm center was on the same latitude as the Nautilus. A break at this time would allow the unit to move north propelled by the northerly winds on the east side of the storm.

Figure 26: Sequence of Likely Mooring Line Failure – depicted as steps 1-8 (Ref 25)

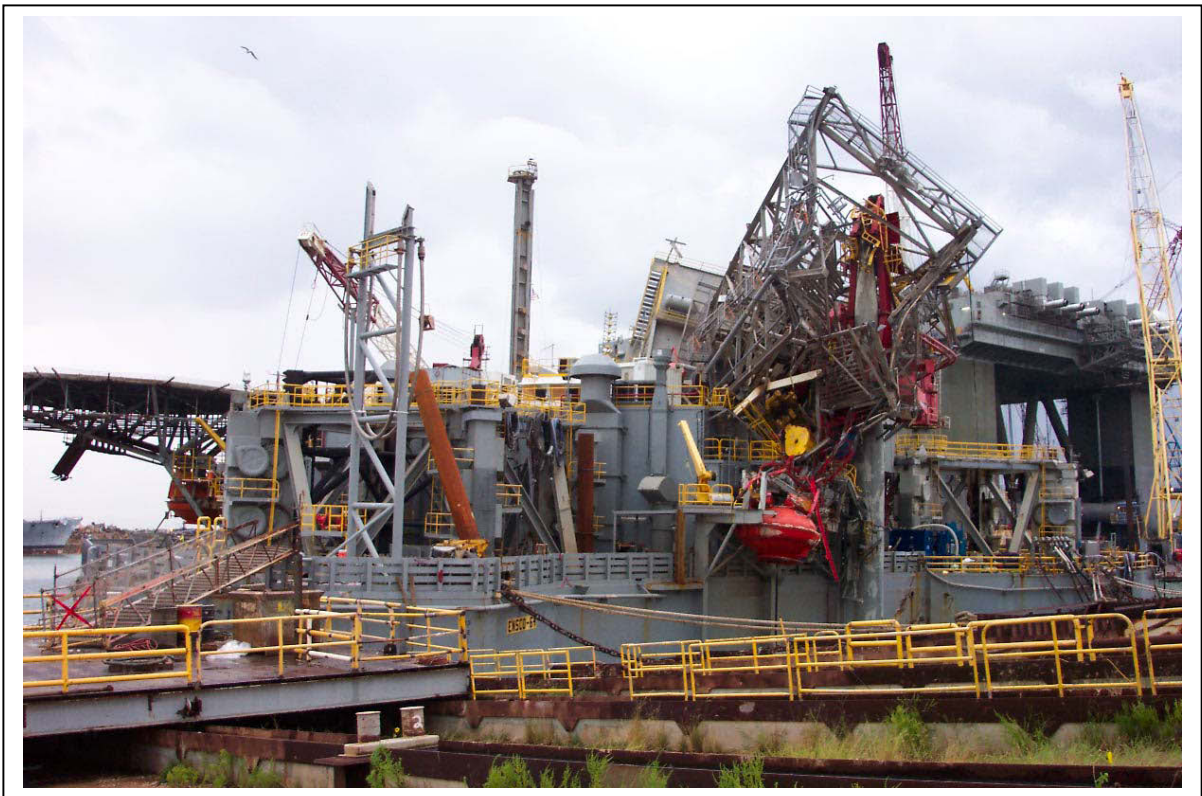
Figure 33: Photo showing the derrick collapsed.

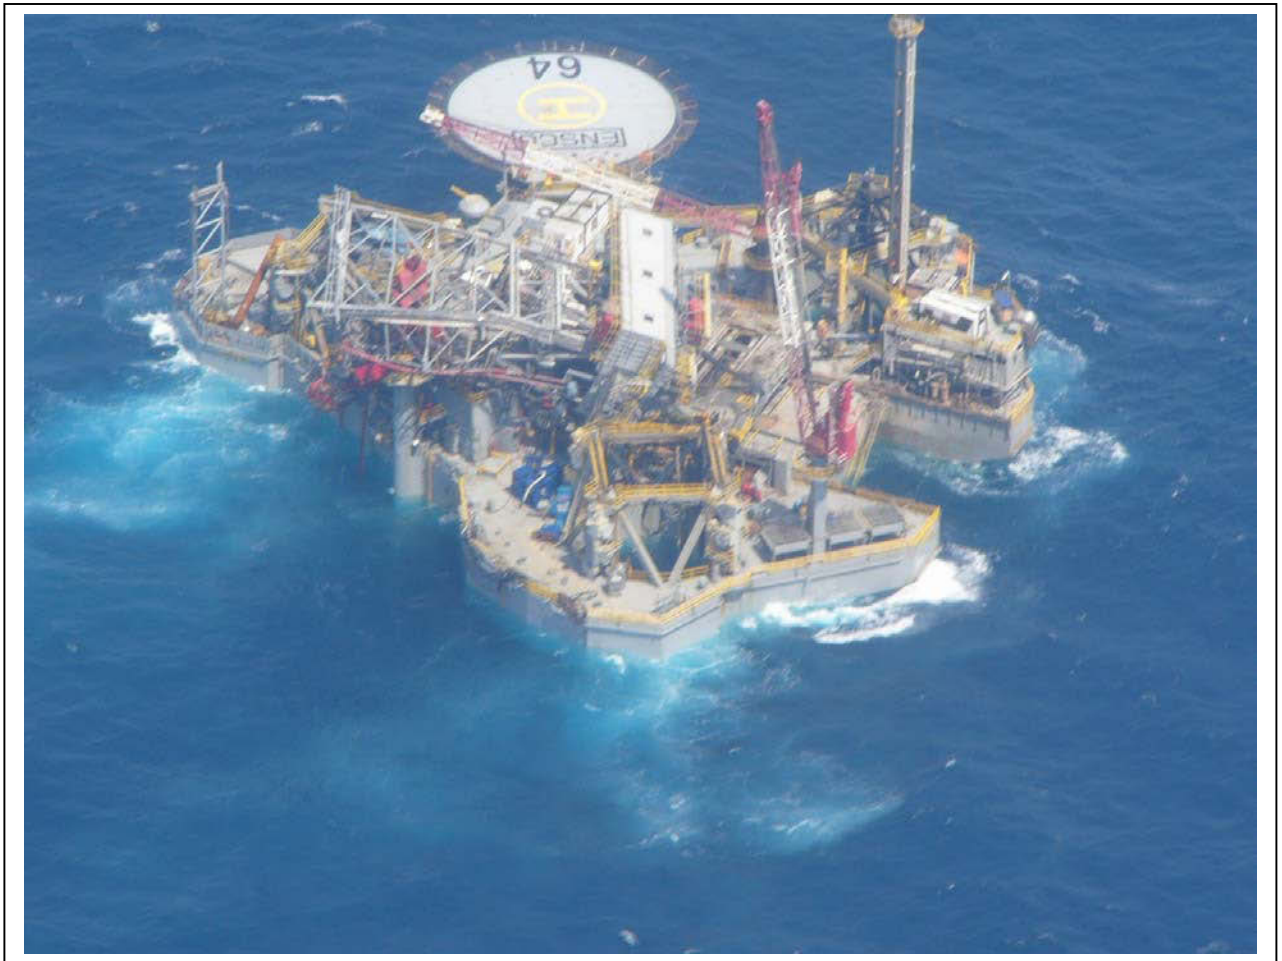
The hull drifted off location and Figure 34 shows a photo taken of the unit after it drifted 40 miles south of location. At Main Pass 280, the bottom of the legs were found laid over to the northwest. The legs had to be removed before a drilling rig could be mobilized to attempt well bore salvage. The well was leaning about 16 degrees toward the west from below the mudline for one full joint, which appeared to be straight. The pipe was cut to about 50 ft above the mudline. All casings were collapsed about 6' above a collar on the 2nd joint above the mudline with an angle greater than 90 degrees. The drive pipe deck and tensioner were laying in the mud at the base of the drive pipe.

The wave height as measured at a nearby buoy was originally reported to be 83 ft. The legs parted below the rig and did not penetrate the hull. Only one tank took on water.

Figure 34: Photo of EnscO 64, 40 miles south of location during recovery efforts.

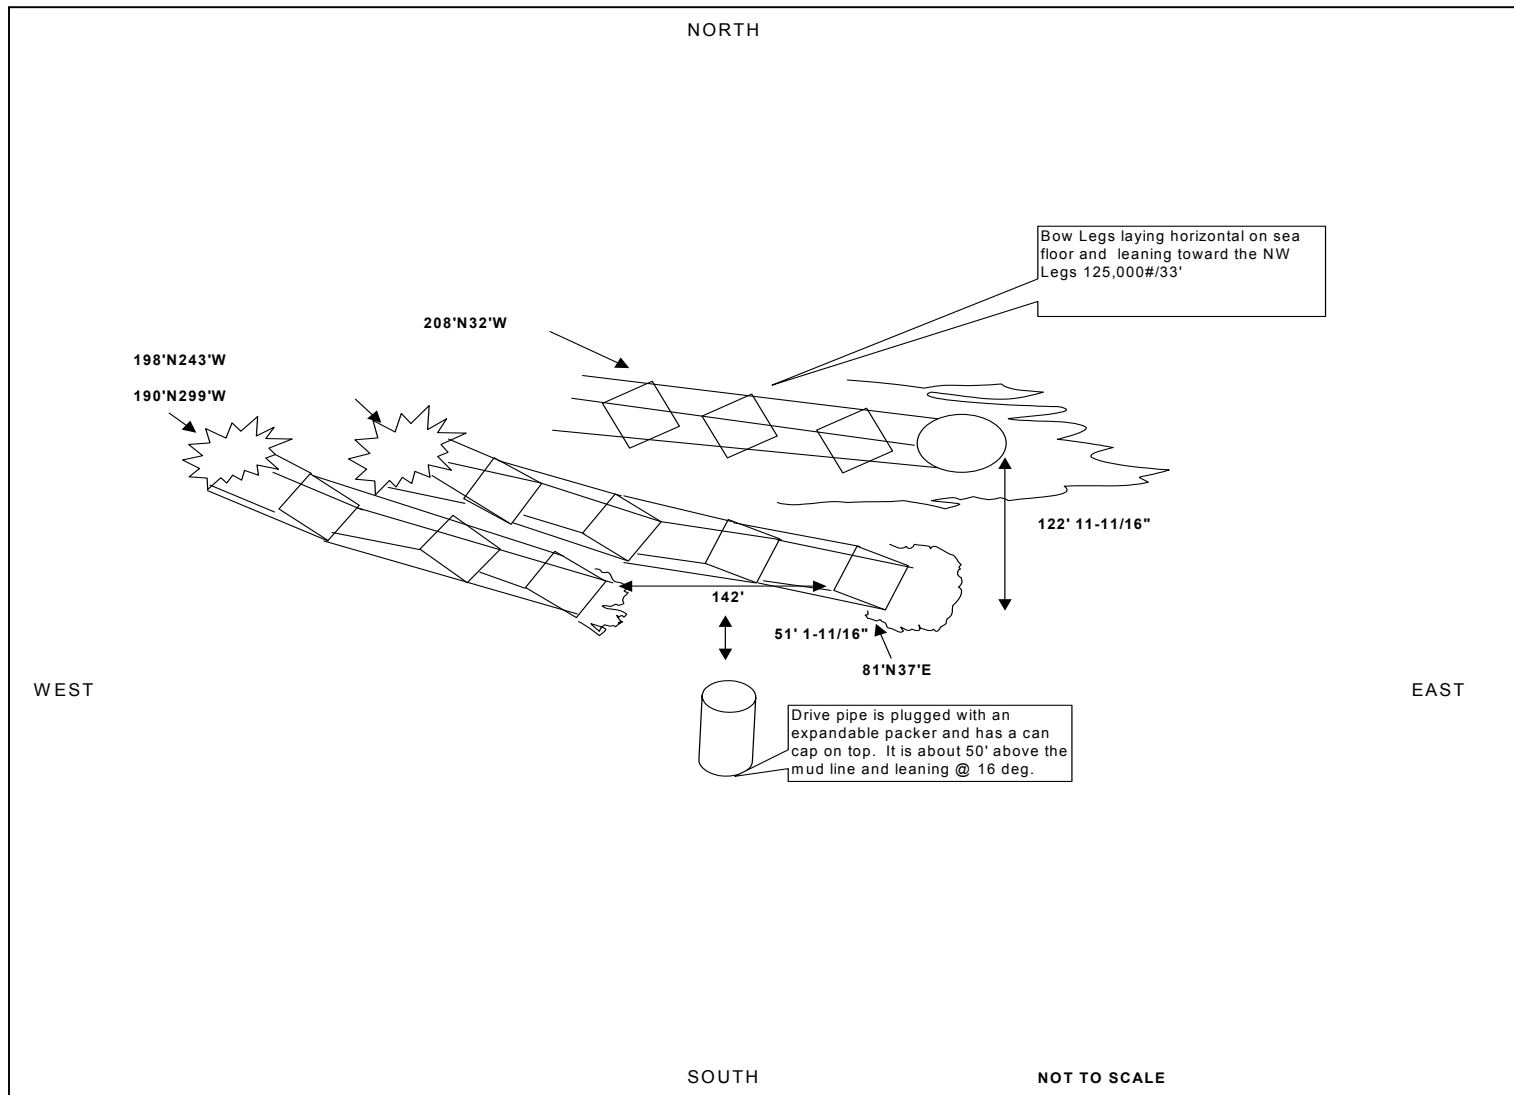
lengths is the H chord. It is the lowermost southern chord and it enters the seabed at the 150 ft mark .The K braces appear intact right up to the break.

Figure 35: 3 legs of Enscø 64 on the bottom, after Hurricane Ivan Port and starboard legs are laying on each other. Bow leg has been excavated and spud can and leg laying horizontal on the seafloor. All small debris was removed from the sea floor.

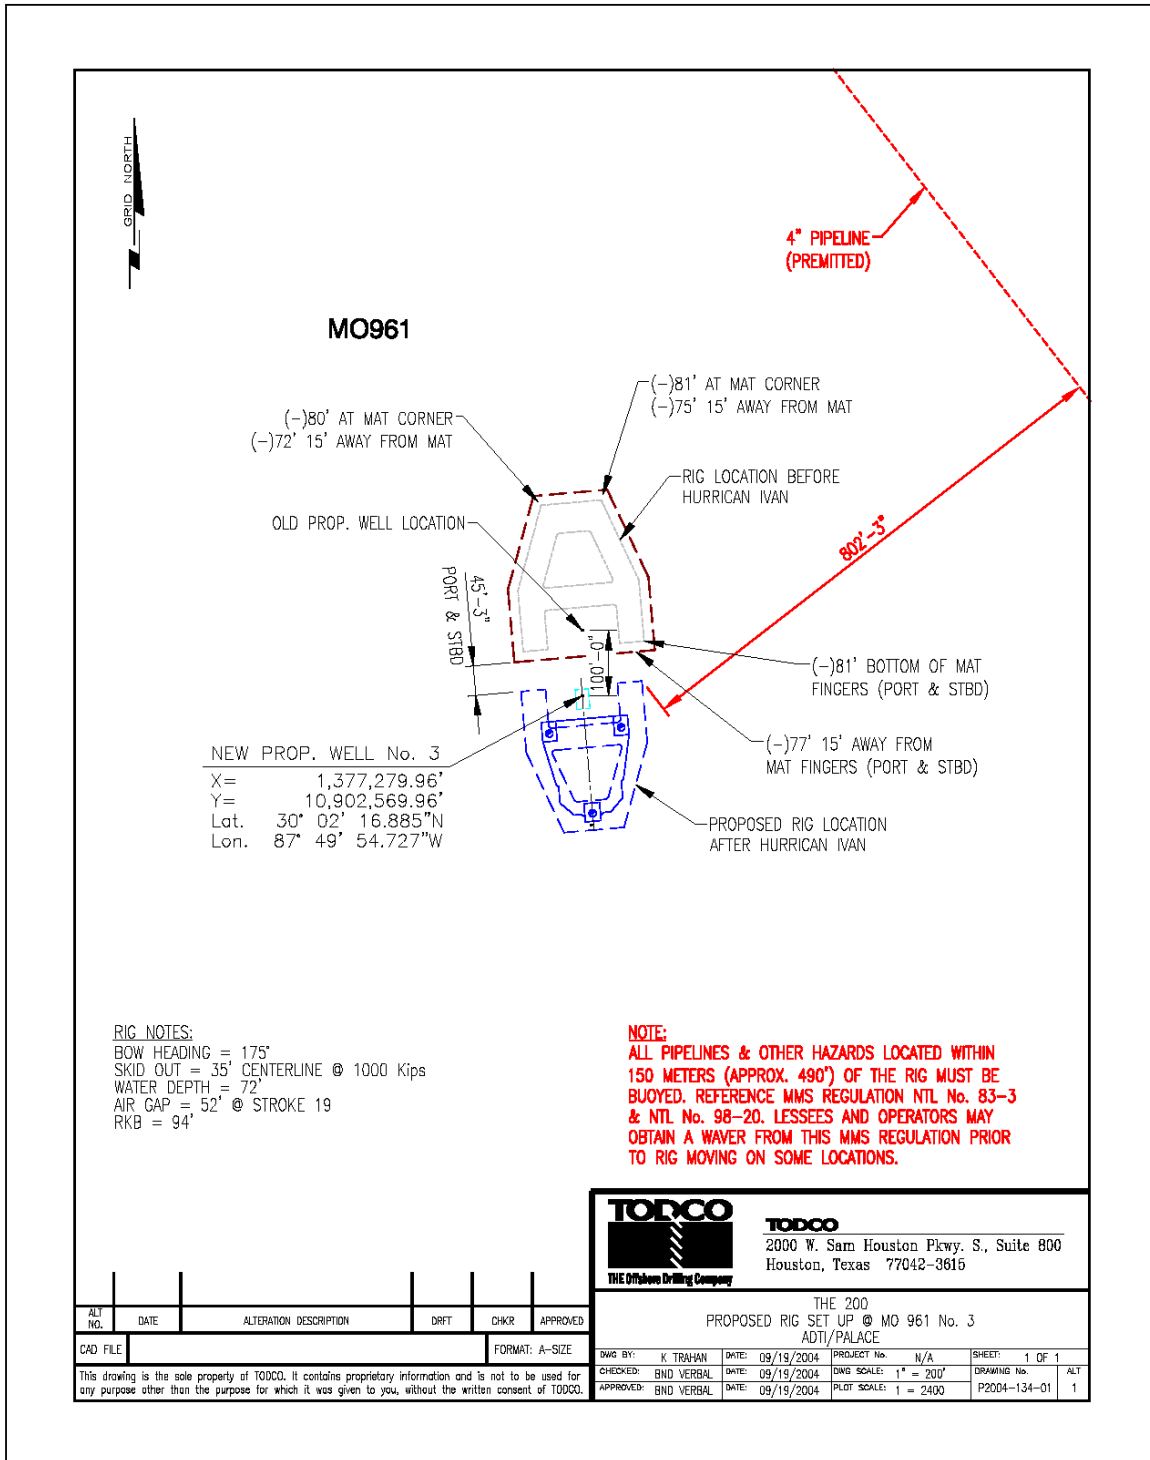
Figure 39: Showing area where THE 200 was set up and new proposed position since there is disturbed soil at the previous location.

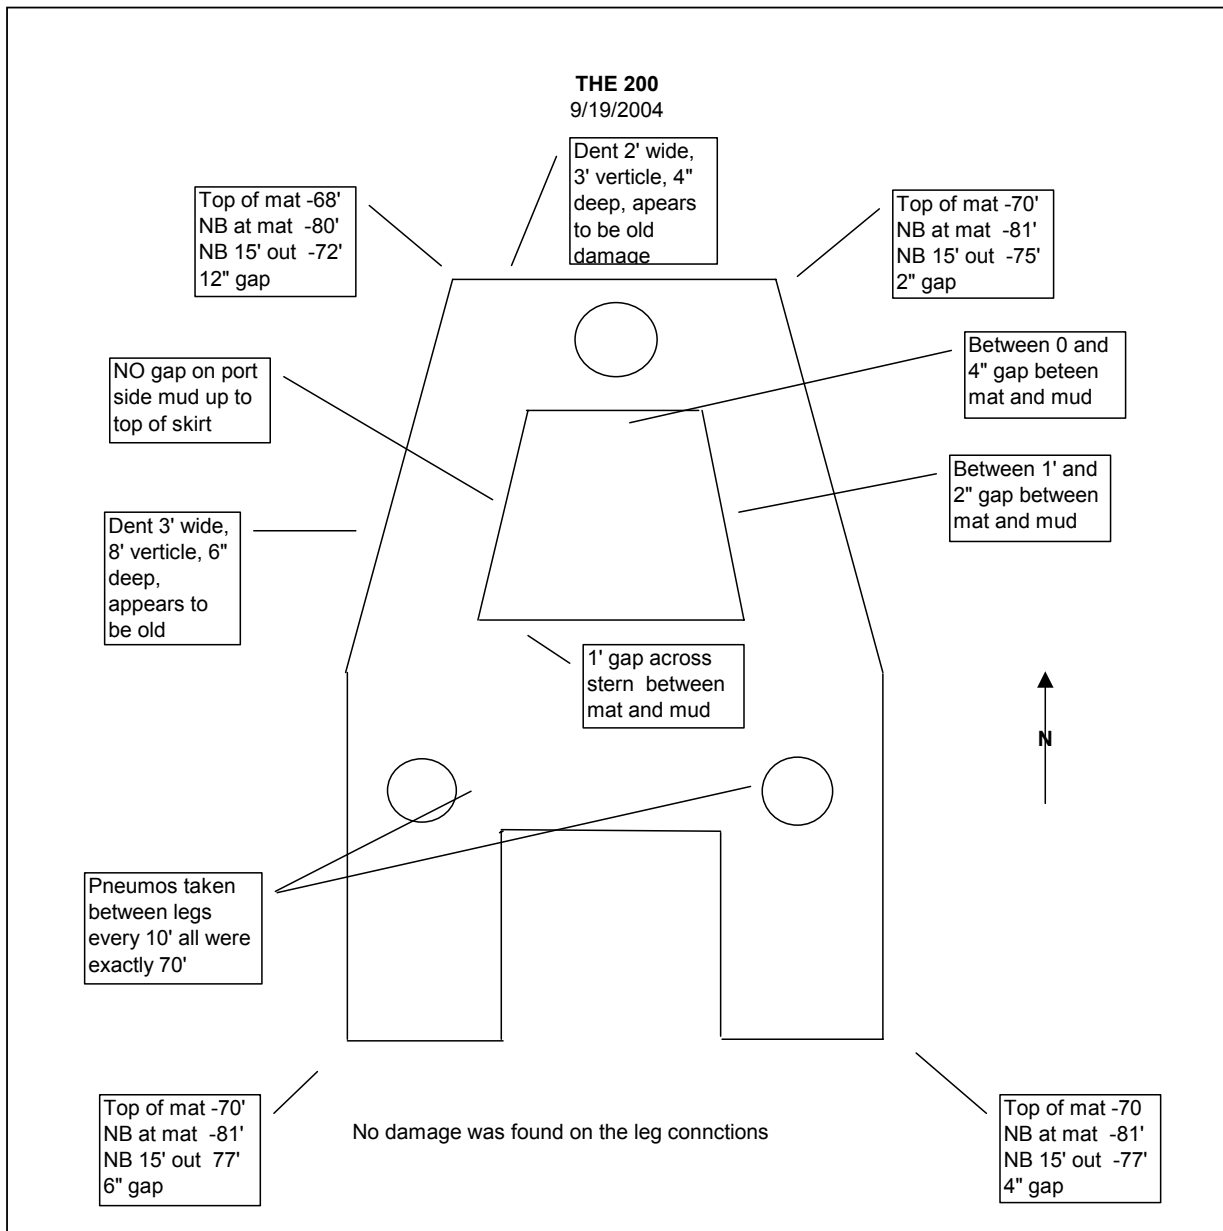
Figure 40: Sketch showing the situation at Location after Hurricane Ivan came through

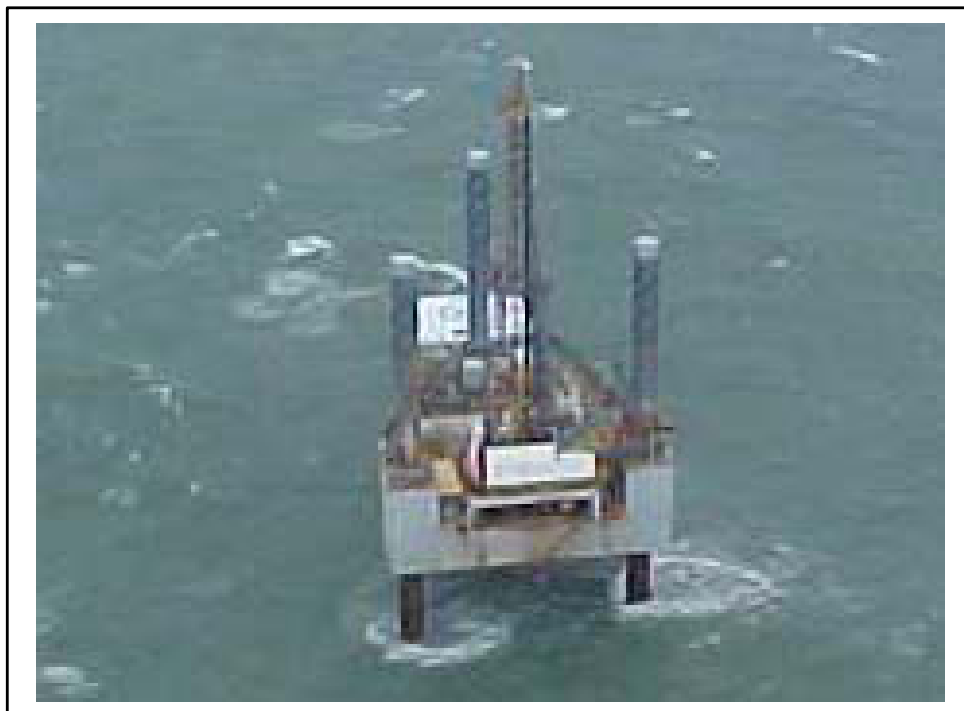
Figure 42: THE 200 Photo taken After the Storm (note effect of currents on the legs)
