**Technical Service
Information Bulletin**

Title:
SHIFT LOCK ASSEMBLY
Models:
'01 – '02 LS 430 & '02 SC 430

ELECTRICAL
EL011-02

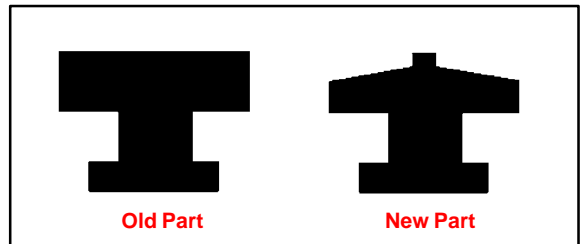
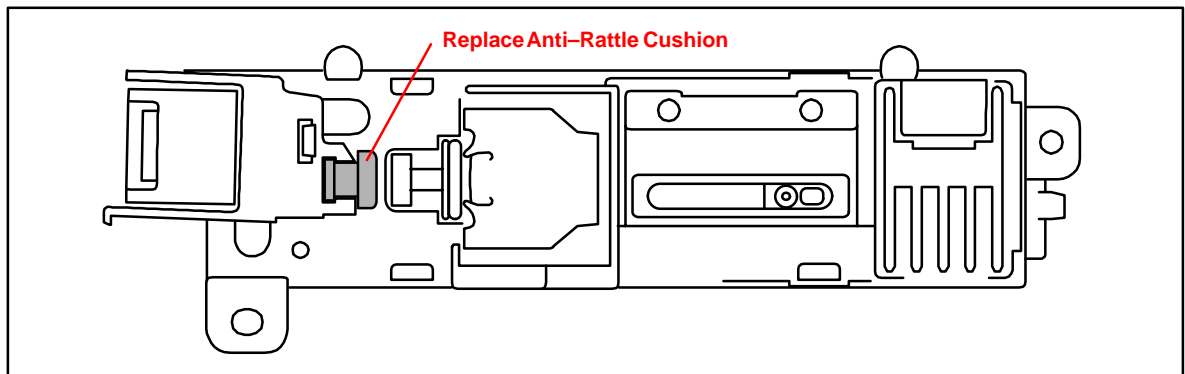
Introduction Some customers may complain that intermittently, their vehicle will not shift out of park after depressing the brake pedal. A component in the shift lock assembly, the Shift Lever Anti-Rattle Cushion, has been changed to help prevent this condition.

3. Remove the original shift lever anti-rattle cushion and replace with the new part, as shown in the illustrations.
