TECHNICAL SERVICE BULLETIN

Lack Of Heat Or Cooling From The Cabin Vents - Temperature Door Or Door Actuator Binding/Inoperative - DTC B1081:07

21-2199
28 June 2021

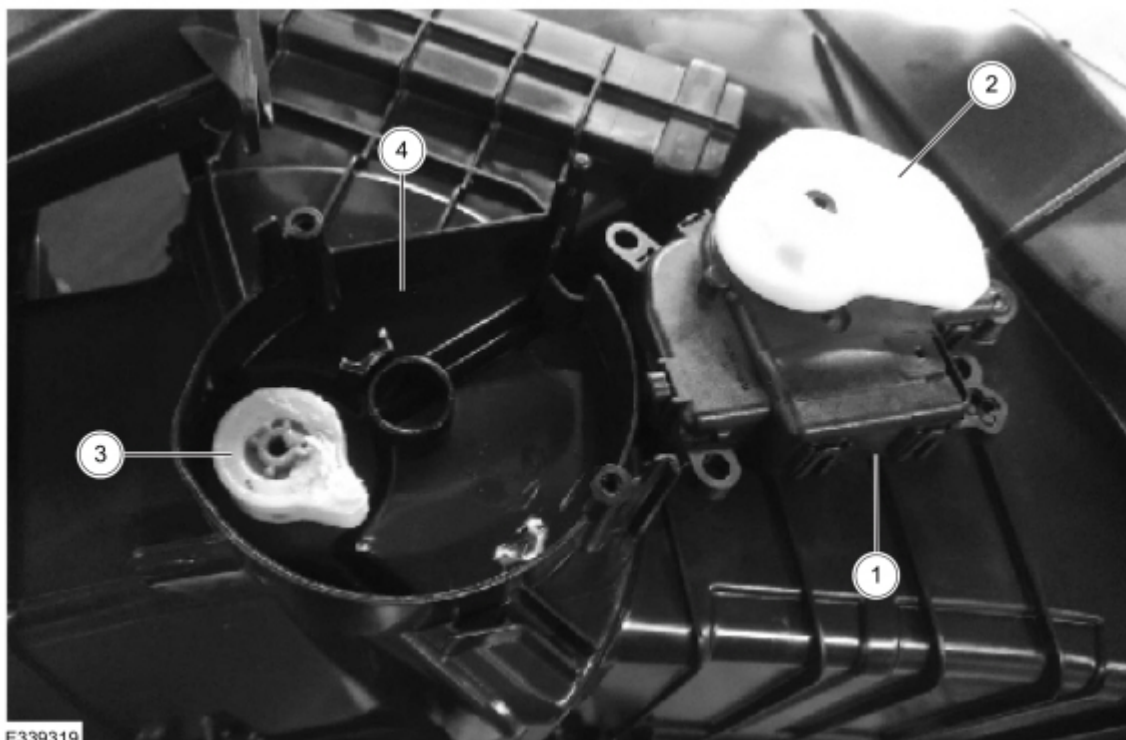
E339319

- Gently wipe the driver side temperature blend door actuator, cam, and cam follower attached to the climate control housing blend door to remove any debris and existing lubricant.

NOTE: Do not remove the cam follower from the climate control housing blend door. It is critical to be gentle when cleaning the cam follower as damaging the temperature blend door shaft will require replacement of the climate control housing. (Figure 1)

2. Replace the driver side temperature door actuator and cam. Refer to WSM, Section 412-00. Lubricate the new cam and cam follower pin using Motorcraft® HVAC Duct Component Grease.
3. Reassemble per WSM. Test the temperature blend door operation. Does the system operate properly?
 - (1). Yes - repair is complete.
 - (2). No - proceed to Procedure B.

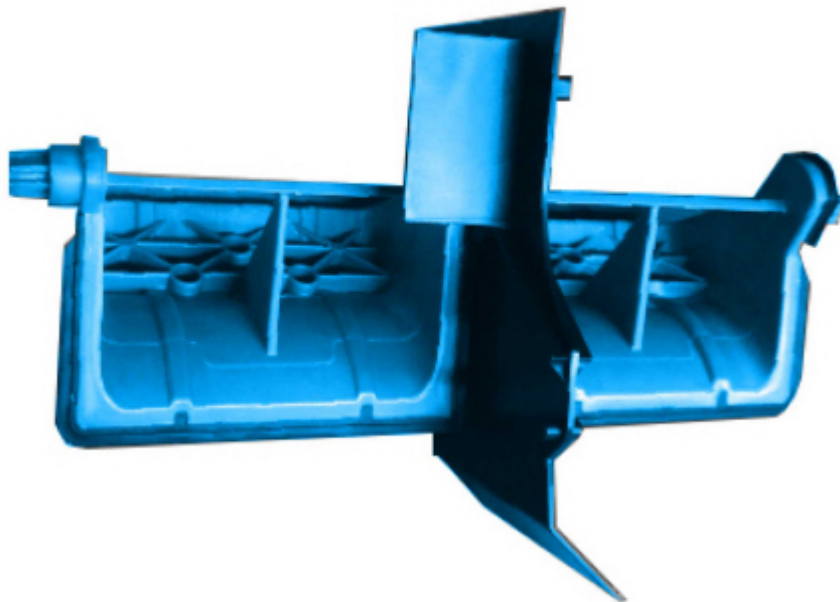
Figure 4 - Temperature blend door assembly

3. Remove the temperature blend door. (Figures 2-4)

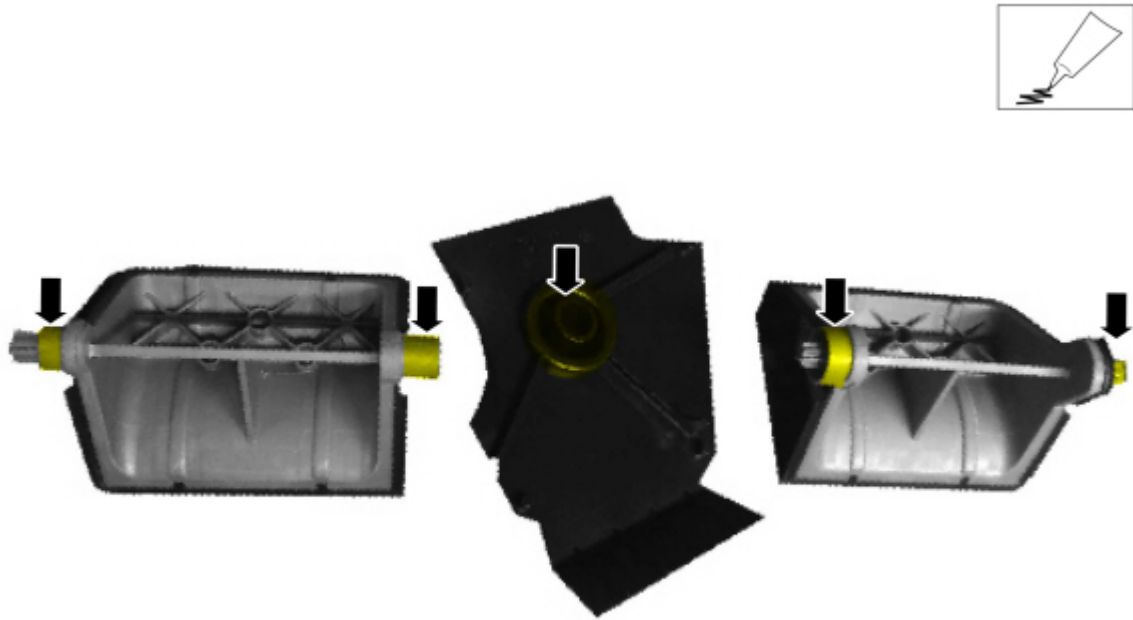
Figure 5 - Arrows indicate where to lubricate the temperature blend door bearing

4. Lubricate the climate control housing and temperature blend door bearing surfaces with Motorcraft® HVAC Duct Component Grease. (Figures 5-7)

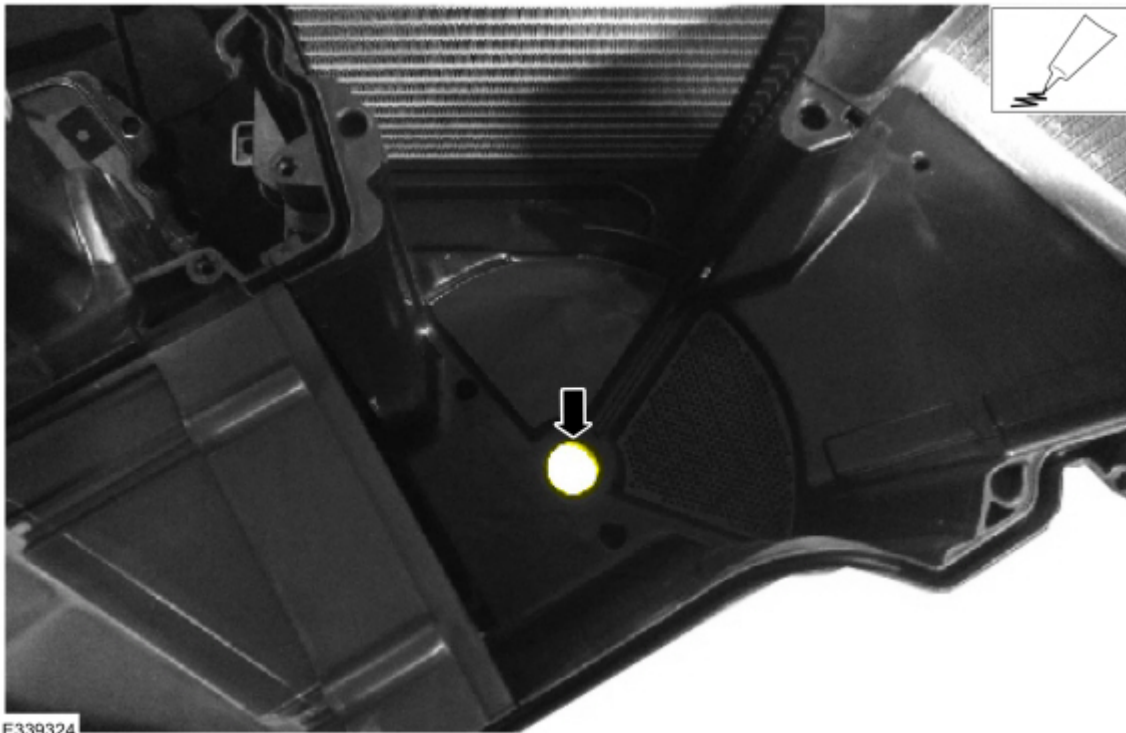
Figure 6 - Arrow indicates where to lubricate the climate control housing surface for the temperature blend door

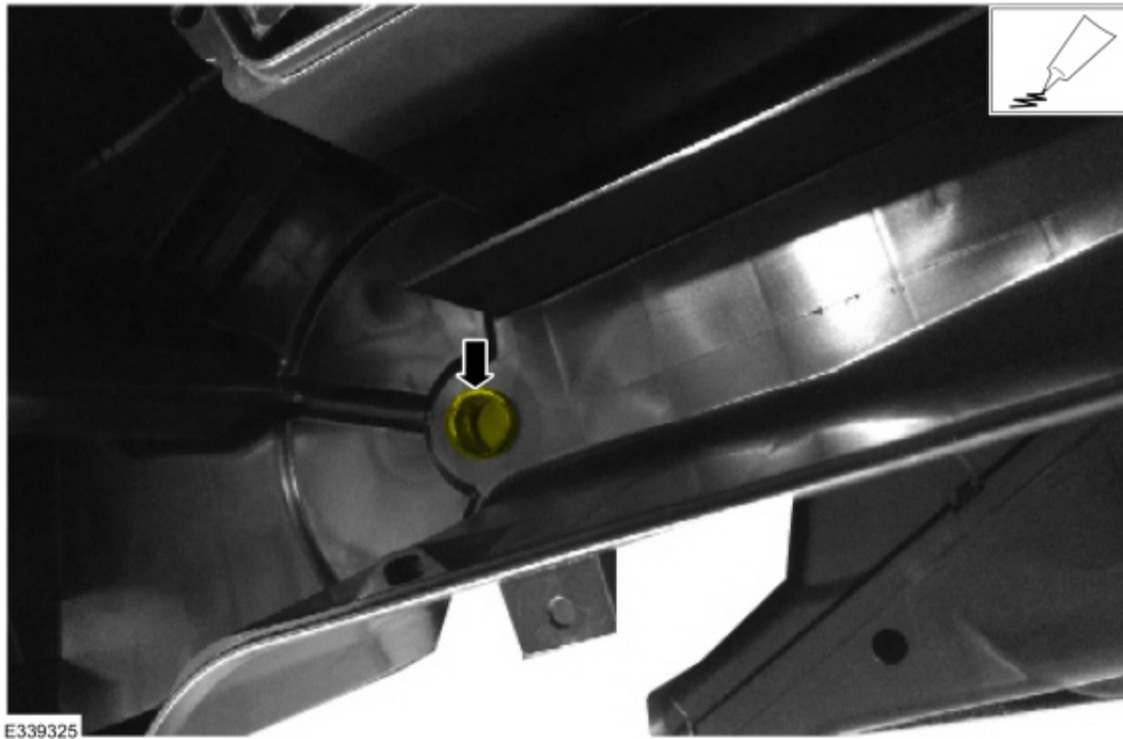
Figure 7 - Arrow indicates where to lubricate the climate control housing surface for the temperature blend door

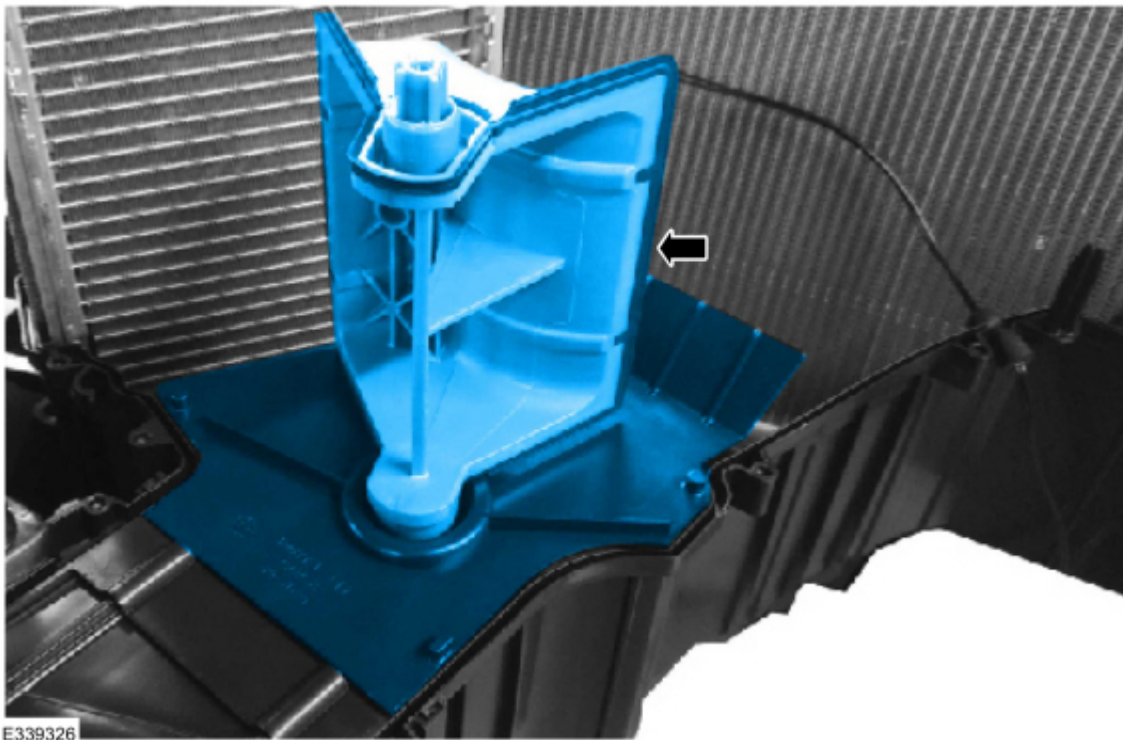
Figure 8 - Highlighted area shows temperature blend door assembly properly installed back into the climate control housing

5. Reassemble the temperature blend door halves and install back into the climate control housing. Align the temperature blend door support half using the dowel pins. (Figure 8)
