Facility: CR3 CRYSTAL RIVER PLANT NUCLEAR
 WR Originator: BATCH
 Unit : 3 Project :
 W/O Type: PM TSK PRI: 3 W/O Dspln: N
 Planner : BAKERJ02 BAKER J D
 W/O Title : E, SP0182, RB STRUCT INTEG TENDON SU
 W/O Task Title: E,Q,OW, RB ASME XI IWE / IWL VISUAL
 EXAMIS LINER / CONCRETE
 Task Dspln : N Due By: 09/01/06

00681043 08

*****PROBLEM DESCRIPTION*****
 THIS TASK WILL BE USED TO CAPTURE AND DOCUMENT THE VISUAL EXAMINATIONS OF
 REACTOR BUILDING CONCRETE CONTAINMENT AND LINER SURFACES.
 INSPECTIONS REQUIRED PER ASME XI, IWE (LINER) AND IWL (CONCRETE CONTAINMENT)

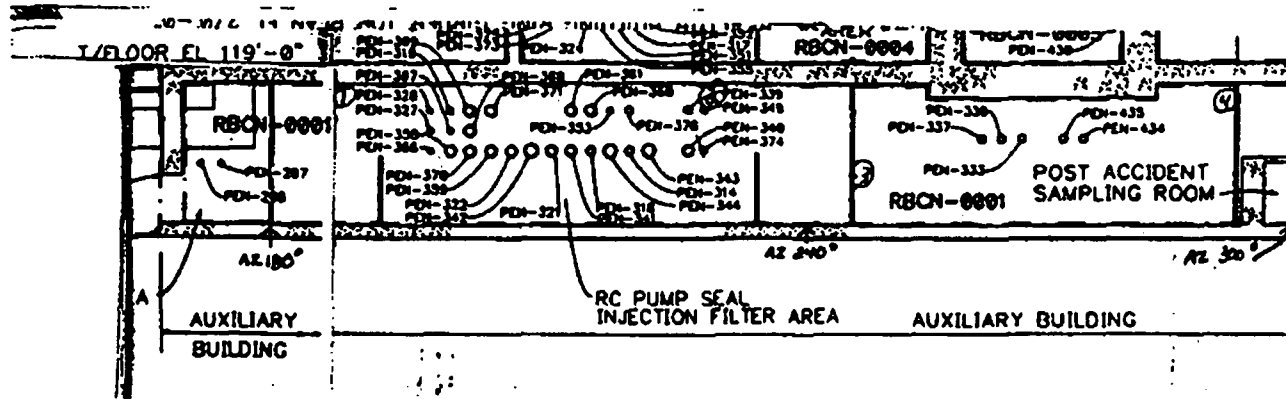
Sketch or Photo: L:\Engineering\Tech Services\ISI IWE & IWL\Photos\2007 R15 IWL Photos\VT-07-201.jpg

ITEM # 1 (REFERENCE PAGE 1, CONDITION 9) - APPROXIMATE ELEVATION 119', APPROXIMATE AZMUTH 190°, 25' X 4" RUST STAIN (SEE VT-3C REPORT VT-07-097) VT-1C DETERMINED STAIN WAS DUE TO PREVIOUS SPILLAGE, NO DEGRADATION TO CONCRETE.

ITEM # 2 (REFERENCE PAGE 1, CONDITION 10) - APPROXIMATE ELEVATION 119', APPROXIMATE AZMUTH 235°, 17' X 3" GREASE AND RUST STAIN (SEE VT-3C REPORT VT-07-097) VT-1C DETERMINED DISCOLORATION WAS GREASE/RUST, NO DEGRADATION TO CONCRETE.

ITEM # 3 (REFERENCE PAGE 1, CONDITION 7) - APPROXIMATE ELEVATION 102', APPROXIMATE AZMUTH 245°, POPOUT, 2 1/2" X 2 1/2" X 1". (SEE VT-3C REPORT VT-07-097)

ITEM # 4 (REFERENCE PAGE 1, CONDITION 10) - APPROXIMATE ELEVATION 118', APPROXIMATE AZMUTH 295°, VT-1C DETERMINED DISCOLORATION WAS OIL/GREASE (SEE VT-3C REPORT VT-07-097) DUE TO COVER LEAKAGE/PREVIOUS SPILLAGE, NO DEGRADATION TO CONCRETE.

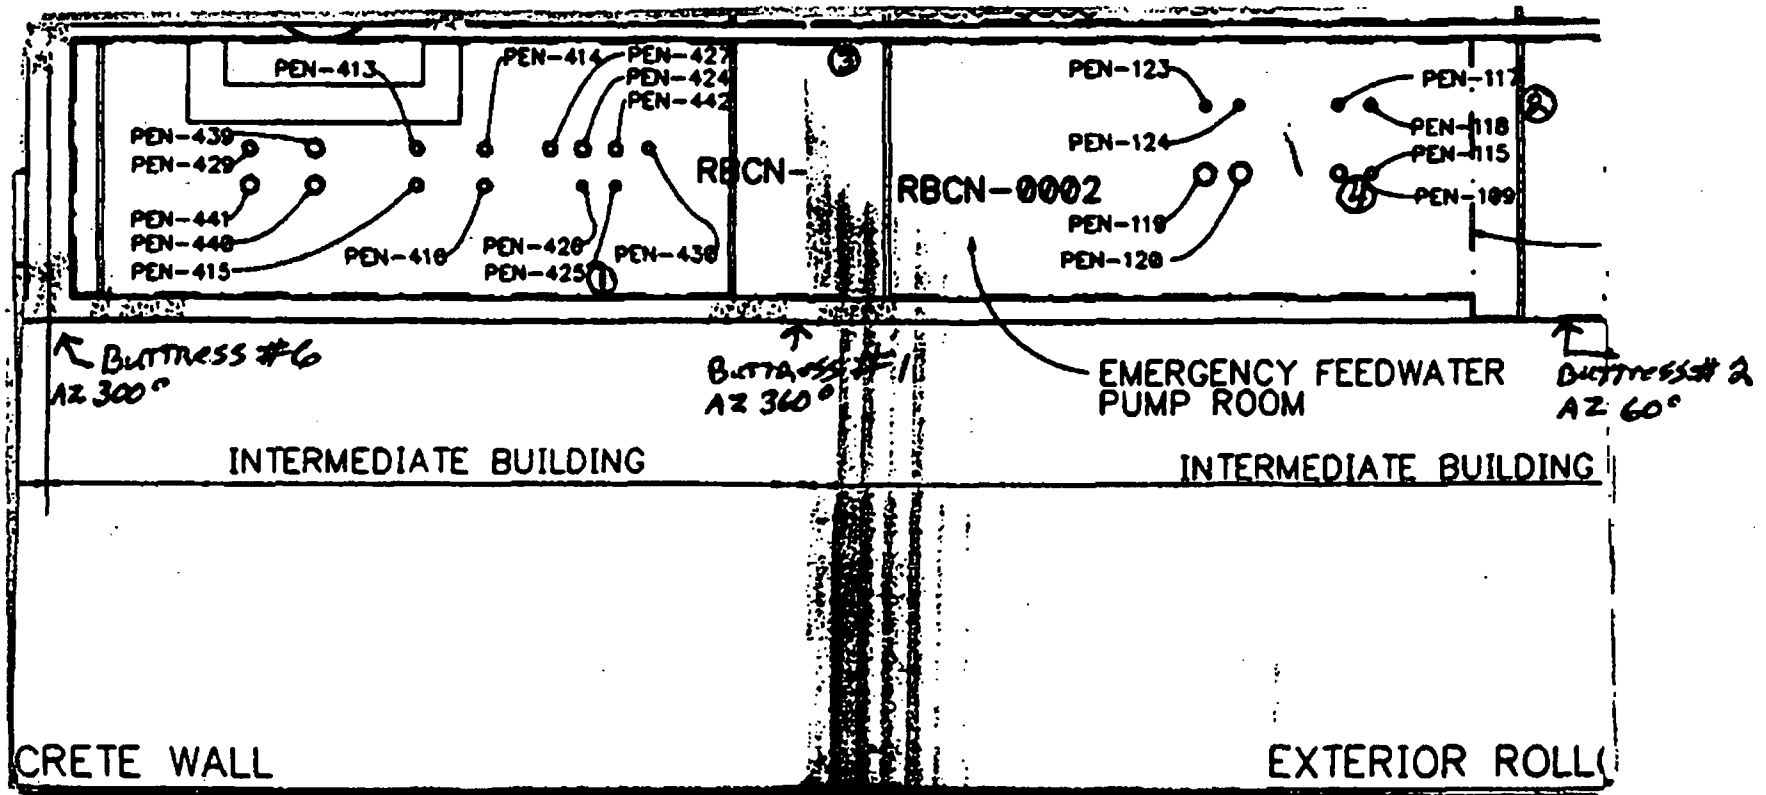
Summary No.: L1.11.0002

- ITEM # 1 : (REFERENCE PAGE 1 - CONDITION 17): 8" L X 4" W X 1 1/4" D - VOID AREA (SEE VT-1C REPORT VT-07-118)
- ITEM # 2 : (REFERENCE PAGE 1 - CONDITION 10): 14" L X 24" W - DISCOLORATION AREA (SEE VT-1C REPORT VT-07-118)
- ITEM # 3 : (REFERENCE PAGE 1 - CONDITION 09): 14" L X 24" - STAINING AREA (SEE VT-1C REPORT VT-07-118)
- ITEM # 4 : (REFERENCE PAGE 1 - CONDITION 08): 8" L X 4" W X 1" D - DEFLECTION AREA (SEE VT-1C REPORT VT-07-118)
