**METALLURGICAL AND FAILURE ANALYSIS OF  
SWS PUMP P-7C COUPLING #6**

**Report No. F11358-R-001  
Revision 1**

**ENTERGY NUCLEAR OPERATIONS, INC.  
PALISADES NUCLEAR PLANT**

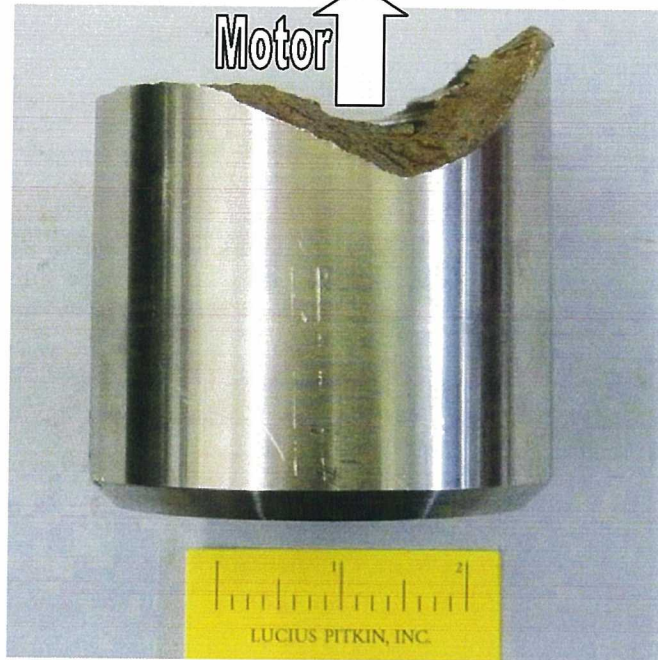
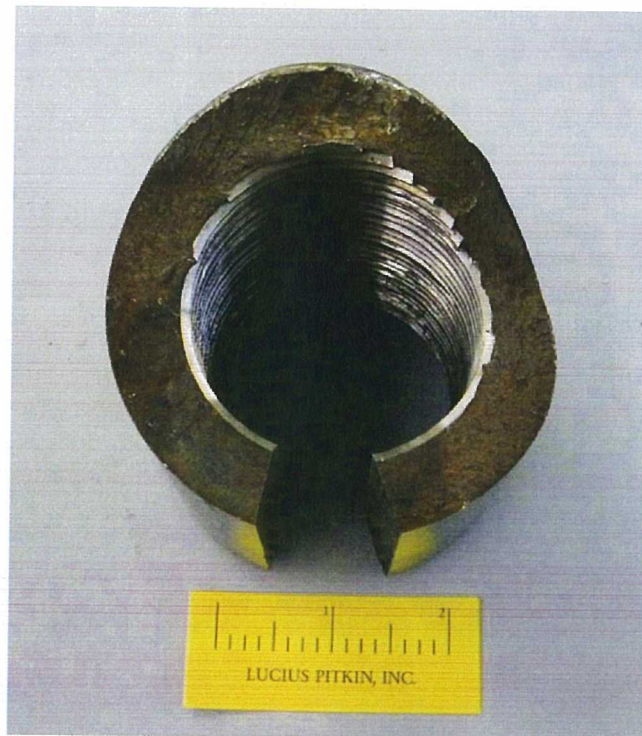
**Figure 1-1: As-Received 09-P7C-7F**

(Only the bottom half or impeller end of 09-P7C-7F was available. Scale in units of inches; typical throughout)

Fractured coupling 09-P7C-7F measured between 2.06" to 3.43" in length. Visual examination of coupling 09-P7C-7F revealed similar fracture surface characteristics to 11-P7C-6F. The fracture surface has a relatively flat region with an elliptical shape emanating from the thread root and extending to the outer diameter (see Figure 3-3). The elliptical feature reveals that the crack initiated at the thread root and propagated to the outer diameter. The remaining portion of the fracture surface was **slanted**, which indicates a subsequent overload of the remaining ligament. Corrosion deposits are also evident on the fracture surface.

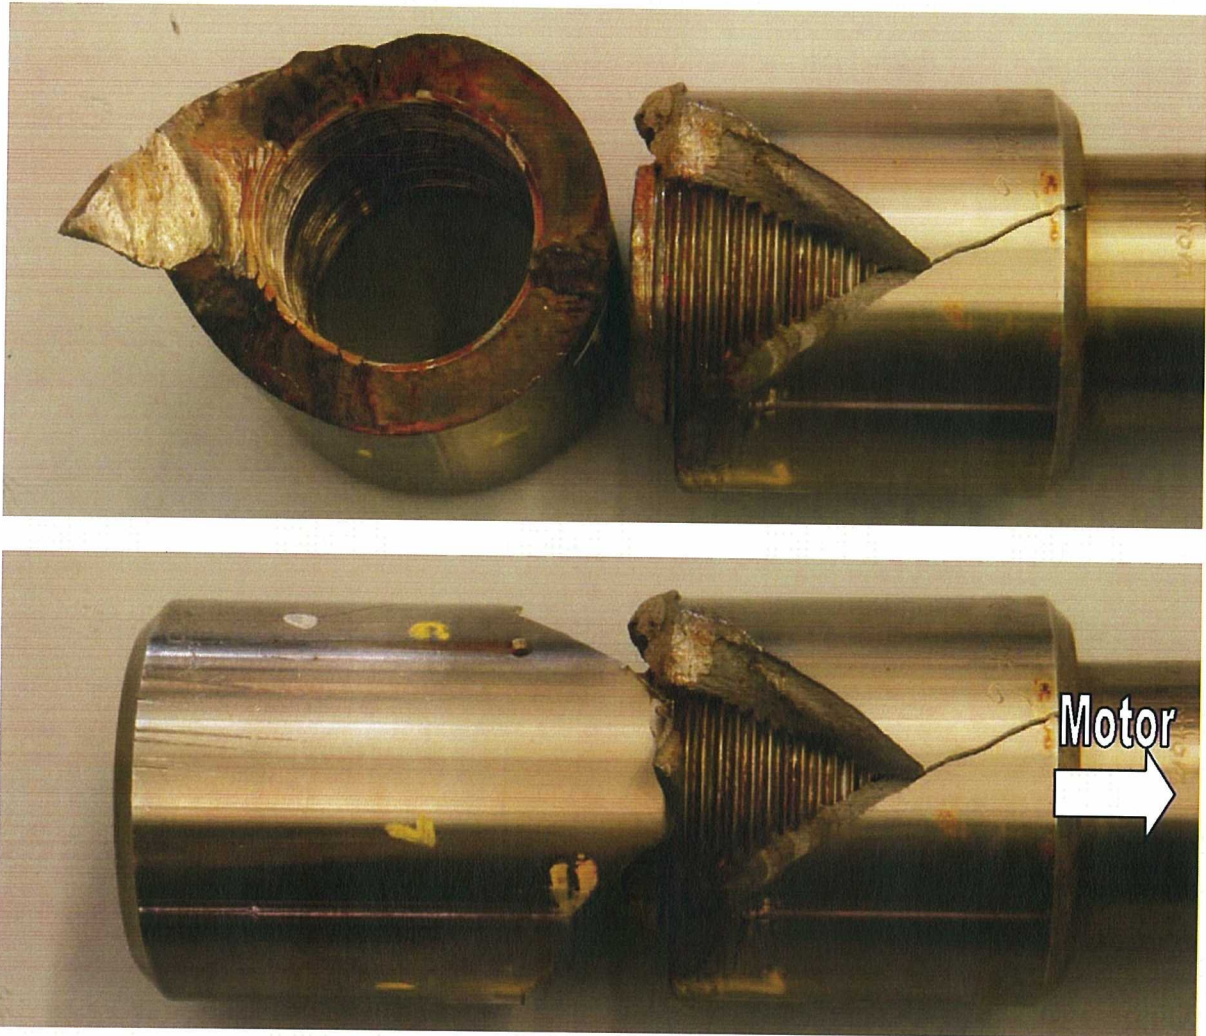
**Figure 1-2: As-Received 11-P7C-6F**

Coupling 11-P7C-6F was received in two halves that each exhibited a circumferential fracture surface. The bottom half (impeller end) of 11-P7C-6F measured between 3.03" and 4.29" in length. The top half (motor end) of the same coupling measured between 1.200" and 3.148" in length.

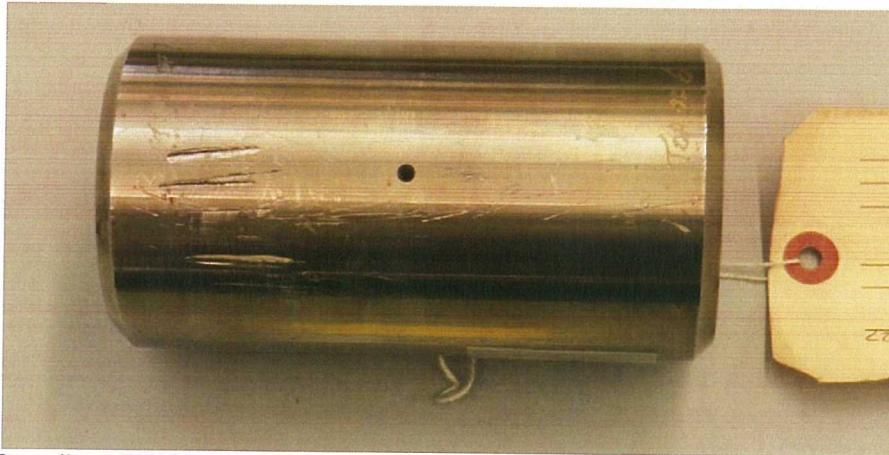
**Figure 3-1: As-Received 11-P7C-7**

Coupling 11-PC-7 in as-received form. Shaft numbers engraved on the ends. Coupling exhibited wrenching marks on outer diameter.

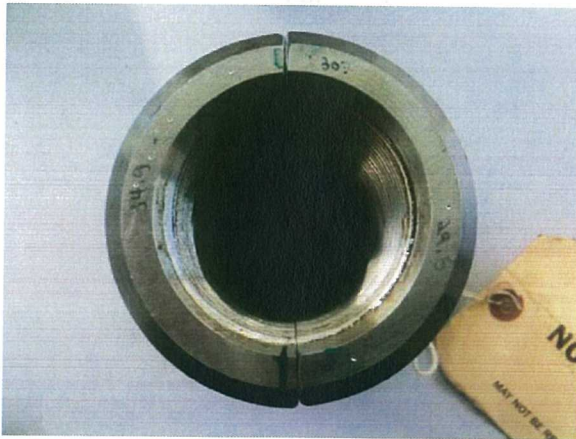
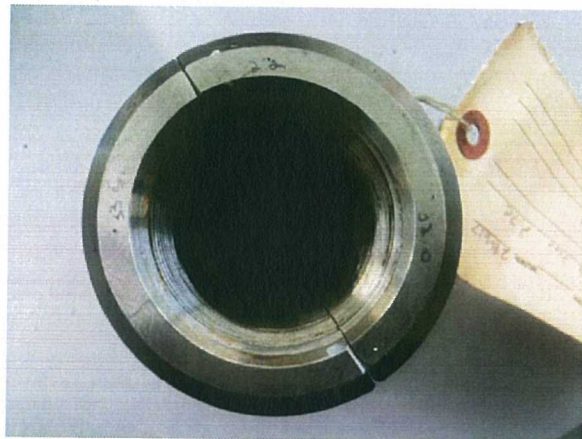
**Figure 3-2: Hardness Indentation and Values Written on 11-P7C-7**

Hardness measurement indentations are present on both ends. Measurement values were 34.9, 30.7, 29.5 and 29.4 on motor end and 33.5, 32.2, 32.0 and 32.5 on impeller end.

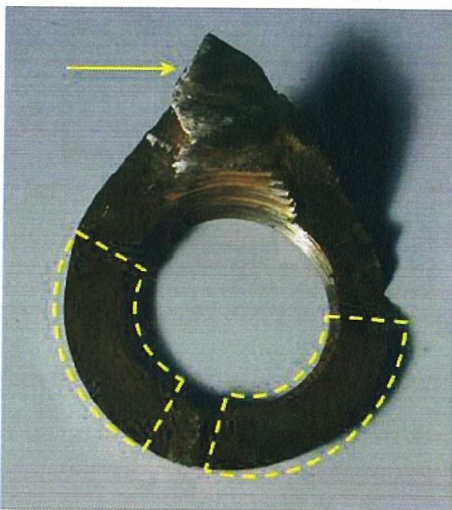
The tips of fracture surfaces on both pieces of fractured coupling 11-P7C-6F exhibited signs of impact from mechanical contact, likely occurring post failure.

(a) Fracture surface was sectioned from the coupling for analysis. Tip exhibited blunting from mechanical damage (arrow).

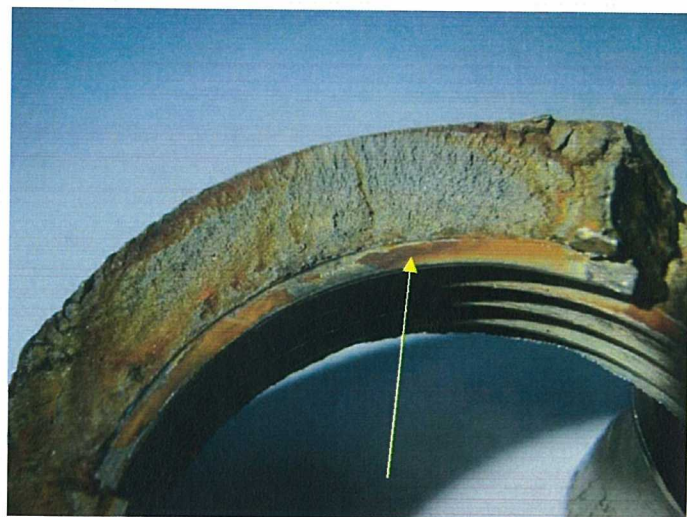
The fracture surface of 11-P7C-6F is located near the mid-length of the coupling. The fracture surface on the impeller end of coupling 11-P7C-6F was sectioned for analysis, as shown in Figure 3-5. Approximately half of the fracture surface exhibited a smooth "flat" appearance and was aligned perpendicular to the coupling axis. The flat fracture surfaces occur in two regions that both display an elliptical shape emanating from the thread root at the inner diameter and extending to the outer diameter, as shown in Figure 3-5. The elliptical features are typically

associated with cracks that initiate at the thread root (and in this case propagated from the inner to the outer diameter of the coupling). **The remaining portion of the fracture surface consisted of slanted fracture, indicating an overload event.** The overload event occurred after the flat fractures propagated through the wall thickness.

(b) Elliptical pattern of crack on flat fracture surface, relative to coupling axis. Also, red/brown corrosion product found on the insides of coupling threads (arrow)

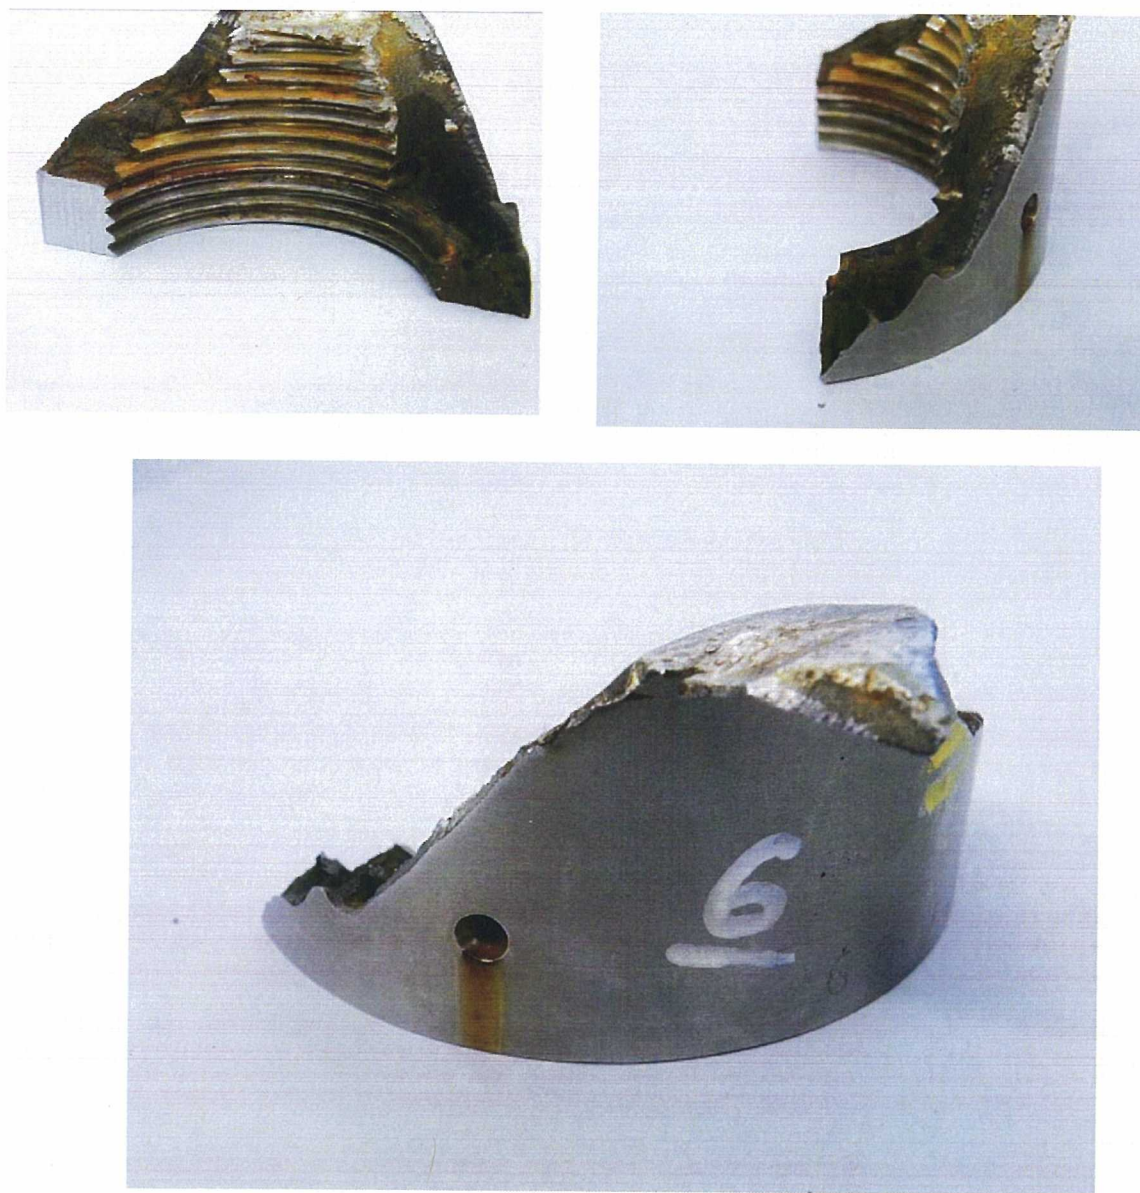
**Figure 3-6: 11-P7C-6F showing Corrosion Deposit**

The thread roots exhibited red/brown corrosion products, as shown in Figure 3-6. Corrosion deposits are visually apparent on the fracture surfaces, threads and at the alignment hole of coupling 11-P7C-6F. The corrosion deposit streak at the bottom of the 1/8" diameter shaft alignment hole suggests that the coupling underwent wet and dry cycles (Figure 3-6).
