NINE MILE POINT NUCLEAR STATION UNIT 2

PROCEDURE NO. N2-RAP-6

POST REACTOR SCRAM ANALYSIS AND EVALUATION

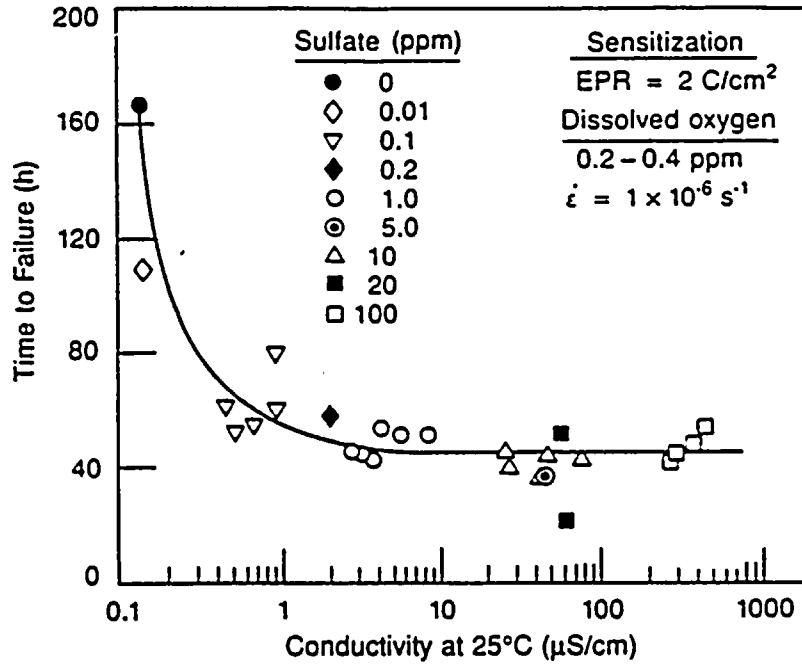
Figure 1. Effect of Sulfate Impurities on Time to Failure (from [1])

4. Sulfate is probably the most detrimental impurity relative to IGSCC in the BWR. Sulfates at levels in the PPB range have been shown to significantly increase both the likelihood of crack initiation and crack growth rate for sensitized Type 304 or 316 stainless steel at BWR operation condition (see Attachment 3). Nickel alloys, used in BWR such as Inconel 600, and the related weld metals (Inconel 182), also exhibit a sensitivity to IGSCC in sulfate contaminated environments at BWR operating temperature.
