# A/T - NO START AFTER HEAT SOAK: WIRE LENGTH INCREASED CAT. G, NO. 001/93

1993 Mazda RX7

TECHNICAL SERVICE BULLETIN

Model(s): 1993 Mazda RX-7 (A/T) with a VIN of JM1FD3\*\*\*P0200001  
through JM1FD3\*\*\*P0210498  
Category: "G" Engine Electrical  
Bulletin No.: 001/93  
Date: 7/2/93

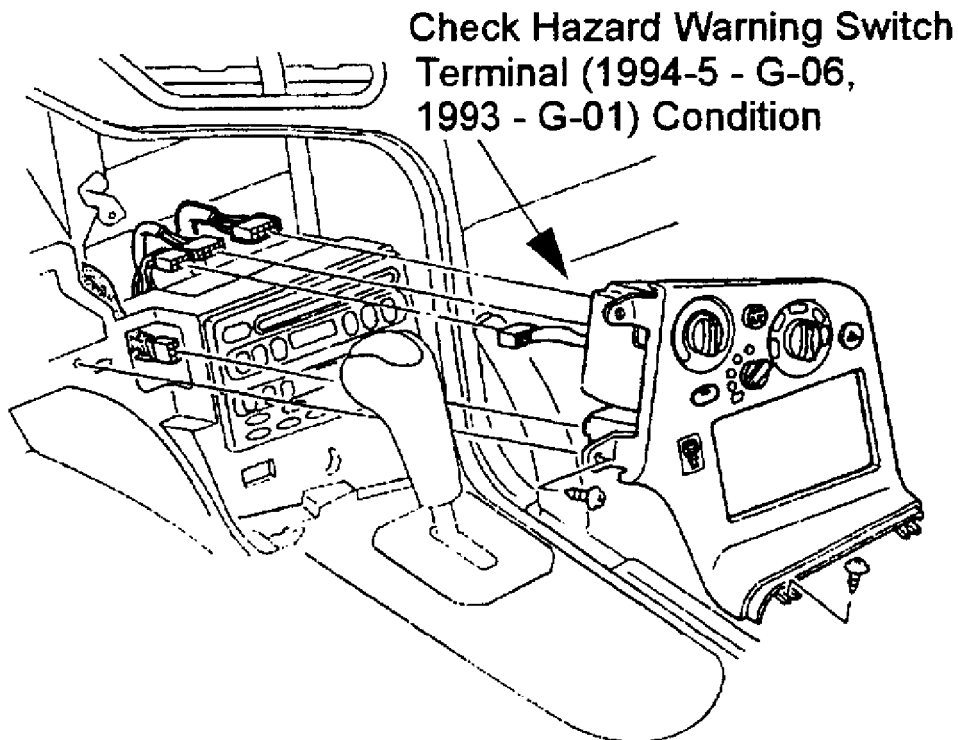
Fig. 1: Removing Control Panel/Heater Control Unit

These conditions may be caused by insufficient contact at the hazard switch connector (1994-95 - G-06, 1993 - G-01). See Fig. 1

3. Check the hazard warning switch terminals. Refer to information in the TERMINAL CONNECTION EXAMPLES for problem examples.

- \* If the female terminals are damaged (expanded), remove the switch from the A/C control unit and replace it with a new part.
- \* If the terminals are normal, re-assemble and test. If problems still exist, refer to the BETM or workshop manual for troubleshooting information.

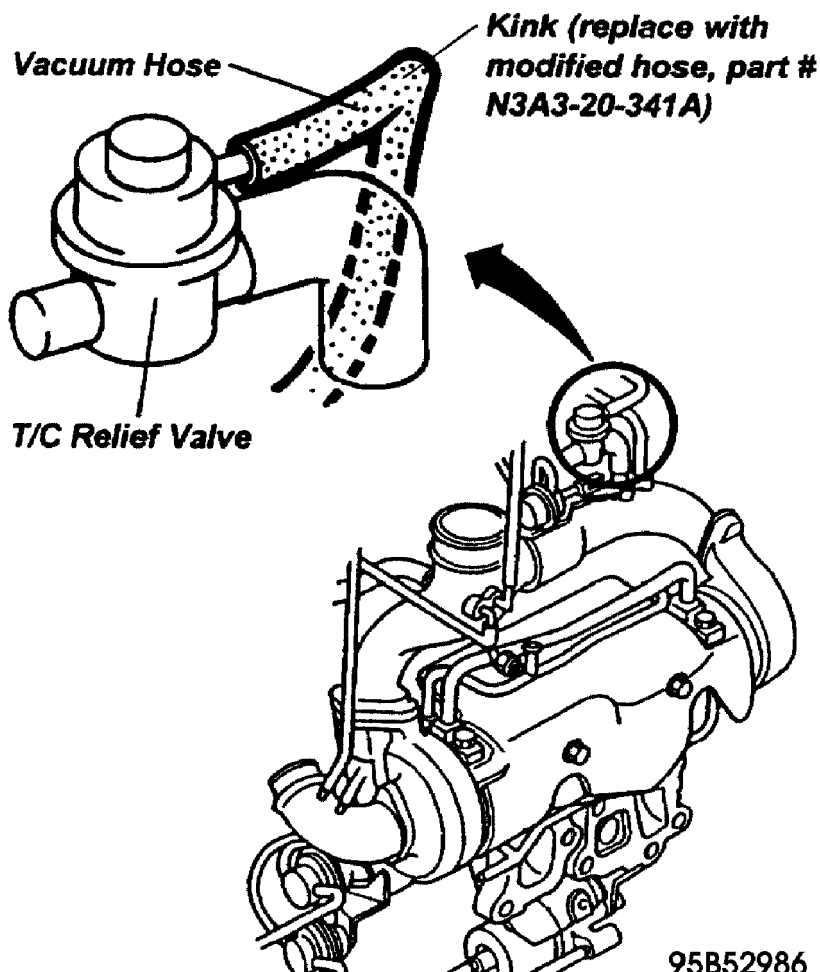
Fig. 1: T/C Relief Valve

A kink in the T/C relief valve vacuum hose may cause the engine to hesitate or lack power during acceleration. Check the hose and replace it with a modified one if it is kinked. The new part number is available through the Means system. Part number N3A3-2341A.

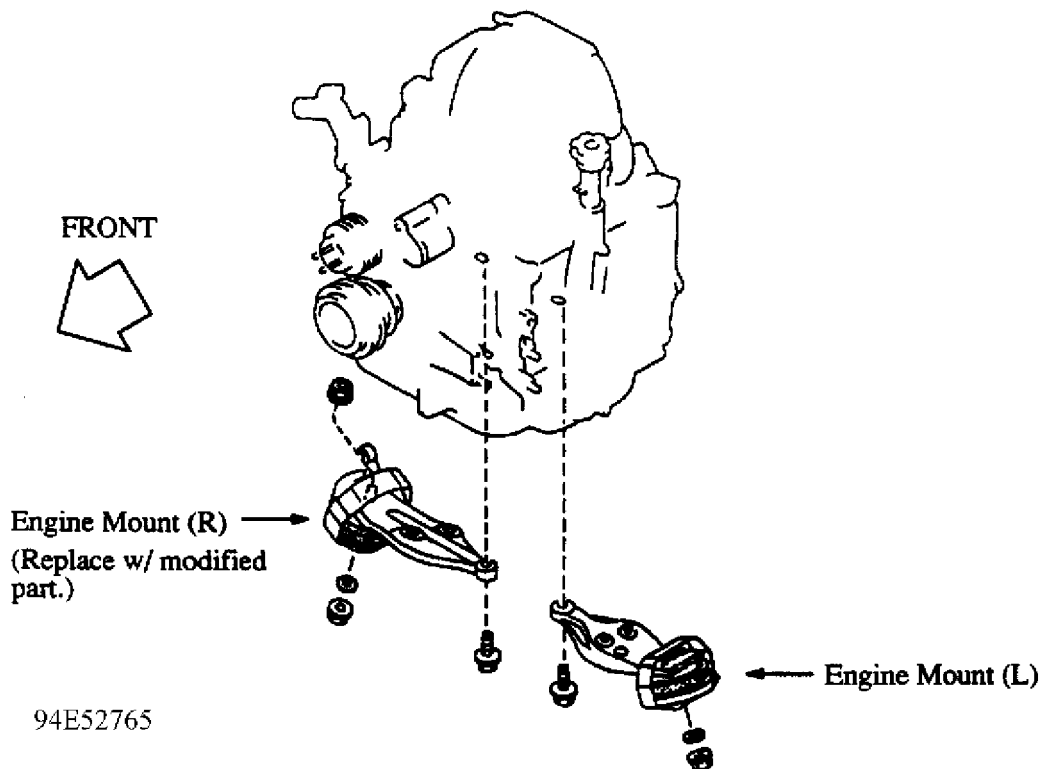
Fig. 1: Motor/Engine Mount Illustration

On some vehicles, an unusual noise may be heard from the right engine mount. This noise is most evident during idle or when driving on rough roads and/or speed bumps. See Fig. 1.

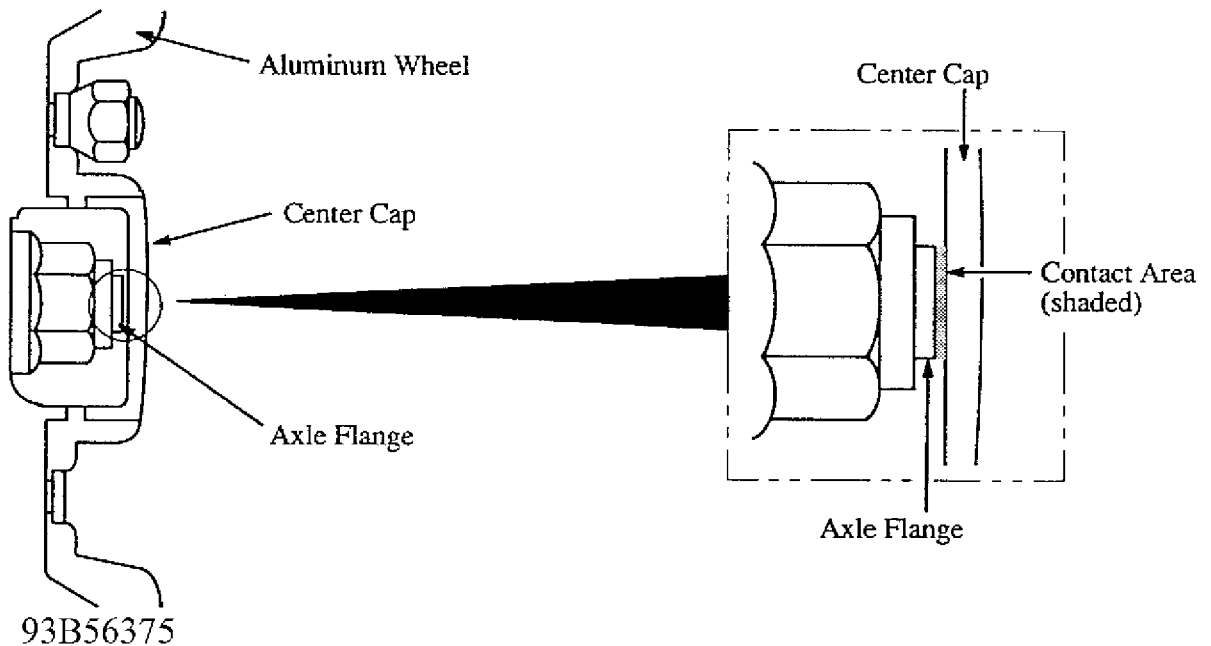
Fig. 1: Center Cap/Axle Flange Contact

Some vehicles may have aluminum wheel center cap(s) that do not fit flush with the wheel. This is caused by the contact between the cap and the axle flange. (See Fig. 1).
