Number	A.1.
Section	General Information
Sheet	1 (of 1)
Date	January, 1960

PRELIMINARY INFORMATION

(Mark 2 Models)

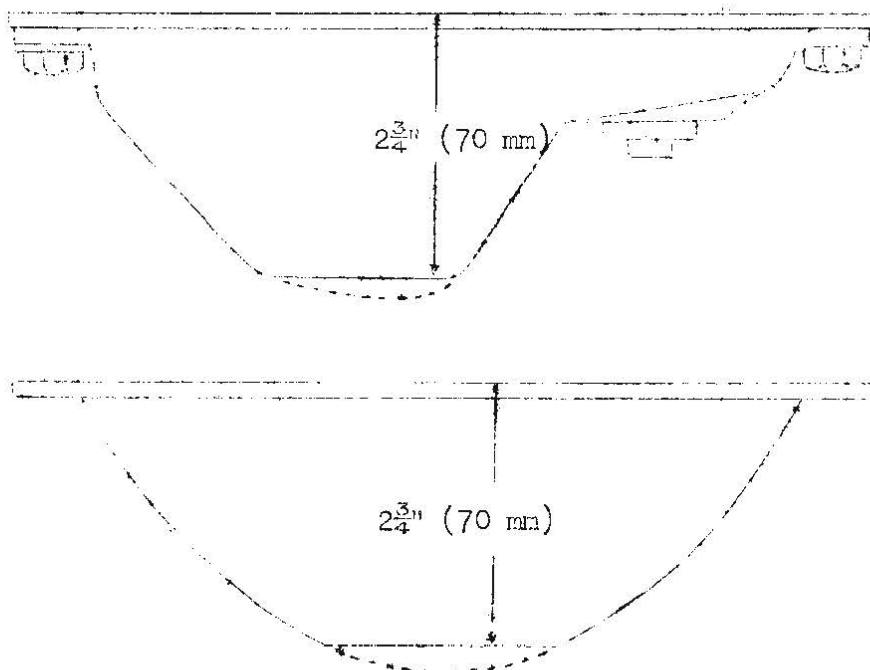
On the majority of cars prior to chassis number 970592 R.H.Drive and 986301 L.H.Drive there is a possibility that the rear axle cover plate may foul the body giving rise to a knock from the rear of the car under fully laden or full bump conditions.

1. Drain the rear axle.
2. Remove the rear axle cover plate and gasket.
3. Modify the rear cover plate in accordance with following sketch. It will be necessary to locally heat the portion to be flattened and when modified the distance to the flange of the cover plate must not be less than $2\frac{3}{4}$ " (70 mm.)
4. Offer up the rear cover plate to the rear axle case without the gasket, and temporarily secure with four setscrews.
5. Check that no fouling occurs between the rear cover plate and the drive gear, by jacking up both rear wheels and rotating in the same direction. Examine the inside of the cover plate for signs of contact.
6. If satisfactory refit cover plate and gasket and replenish with oil.

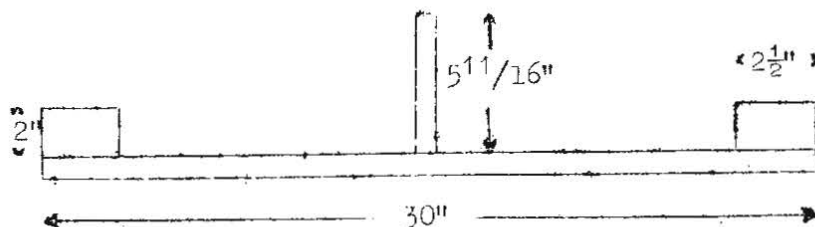
Check the distance from the bottom of the front flange of the front propeller shaft to the bottom faces of the longitudinal chassis side members. This distance should be $3.11/16" \pm 1/16"$ ($93.5 \text{ mm} \pm 1.5 \text{ mm}$). A simple checking jig can be made for checking this distance as shown in the following sketch.

Remedy

If the propeller shaft flange is too LOW suitable packings can be fitted between the rear engine mounting rubbers and the mounting brackets at the top or bottom of the rubbers.

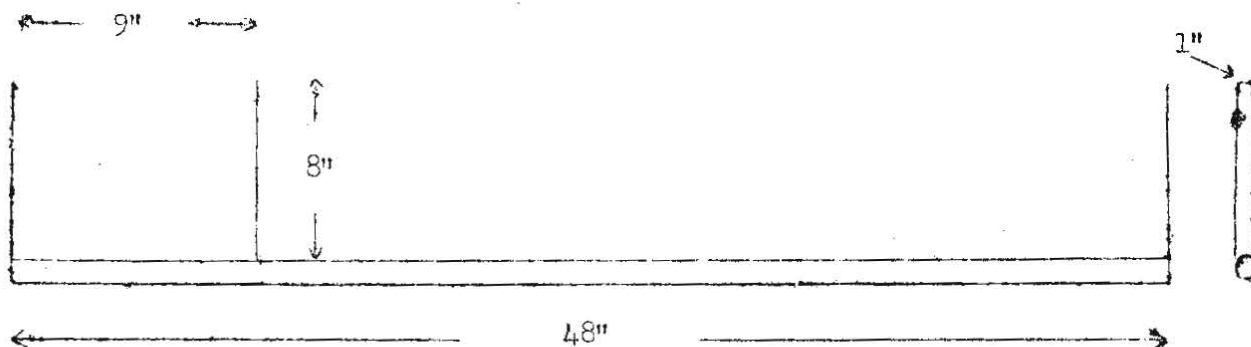
The most convenient way to do this is to make up a simple jig as shown in the following sketch. The jig consists of 3 pieces of flat bar 8" x 1" x 3/16" (20.5 cm x 2.5 cm x 4.75 mm) which are welded exactly in line on to a piece of tube of 1 1/8" (28.5 mm) outer diameter at the distances shown in the sketch. The jig is then held against the front and rear propeller shafts, with the three bars vertical, when any malalignment will be evident.

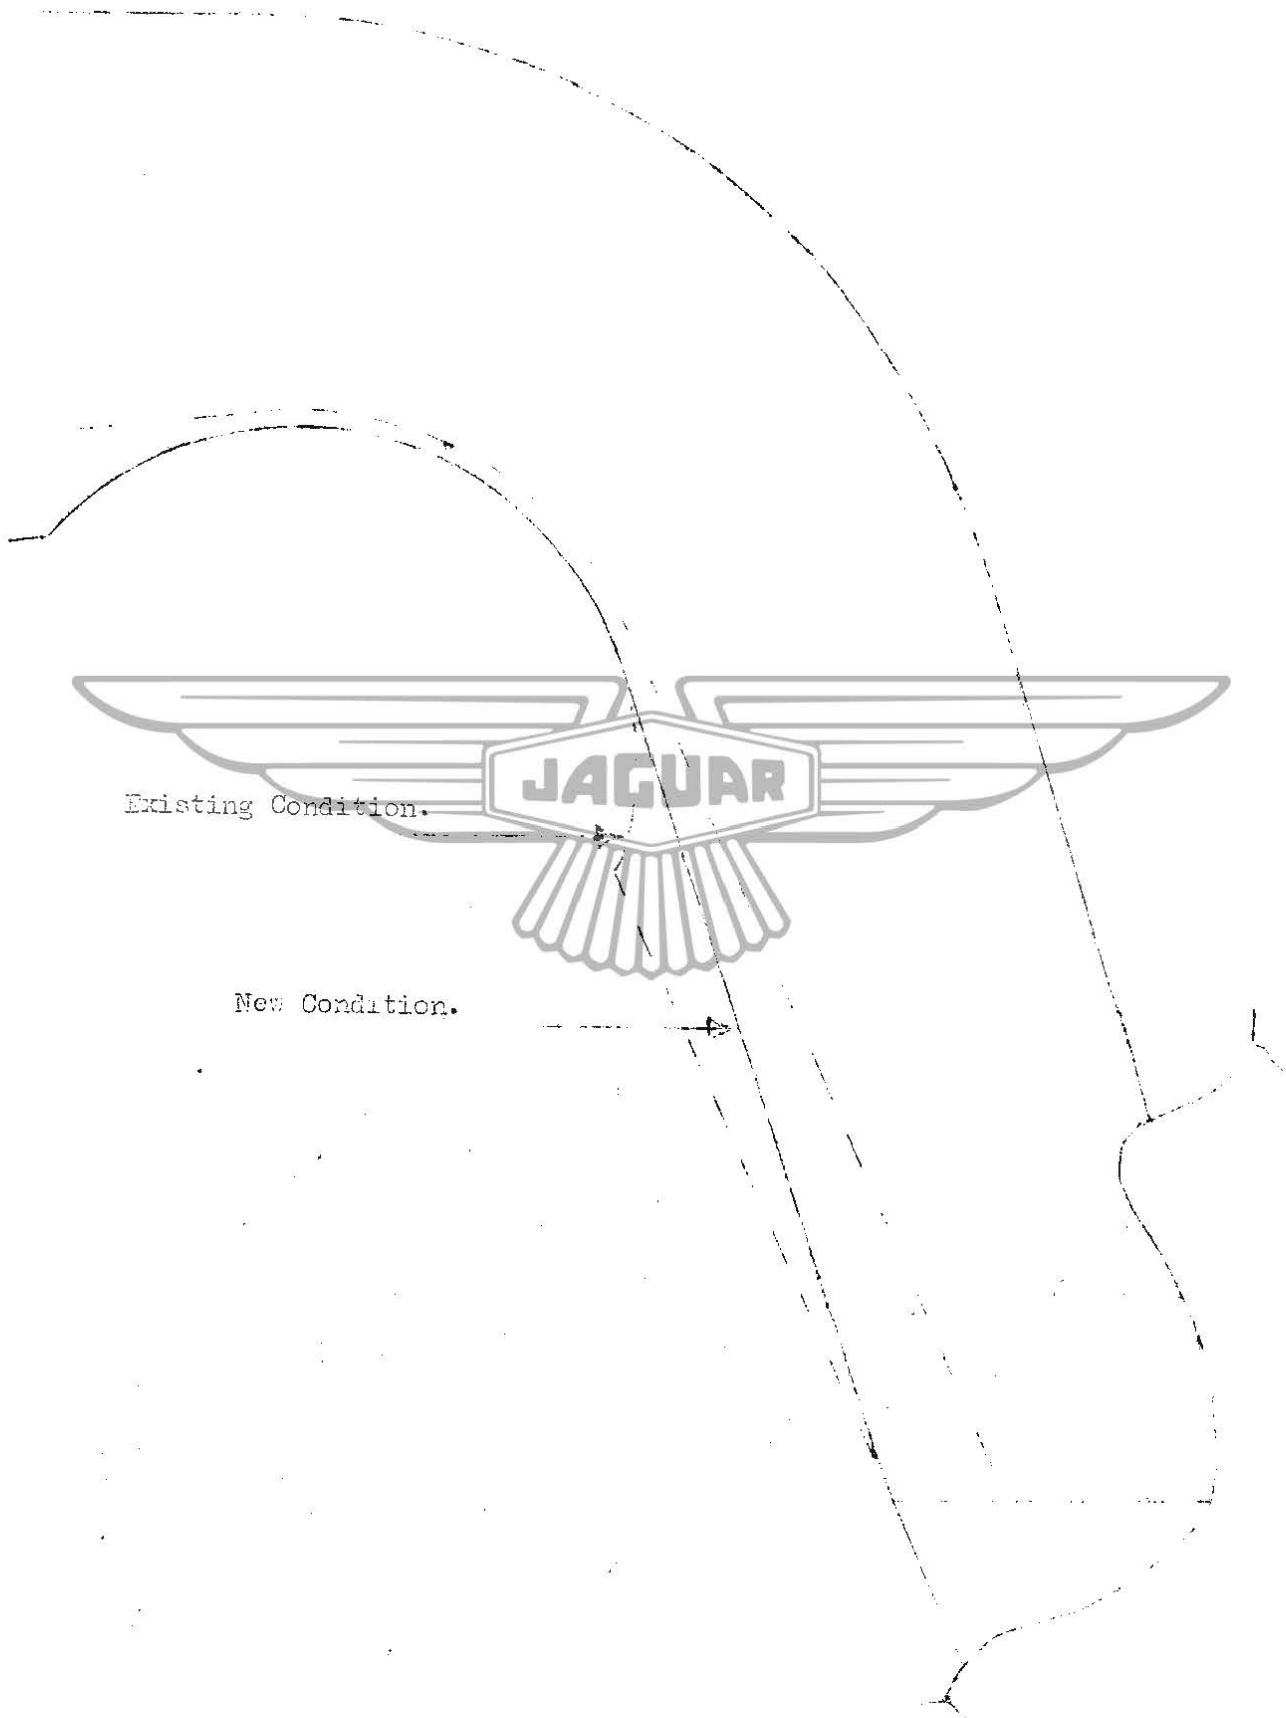
MODIFICATION TO WHEEL ARCH.

Note: It is IMPORTANT to carry out the above two body modifications otherwise fouling will take place between the handbrake compensator and trunk floor, and also between the handbrake cross cables and the wheel arches.
