## **IS-WEBCARD compatibility with GXT4 UPS**

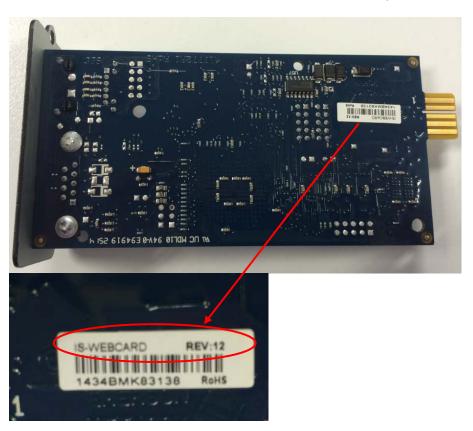
The card Revision is written on the box that the IS-WEBCARD comes in (bottom right hand corner of the box) and also can be found as a label stuck on the card, see picture below.

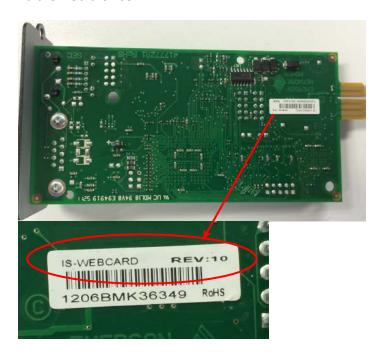
As an example, IS-WEBCARD with **Rev\_10** does not have the latest firmware loaded to support GXT4, however it can be updated as it has **"HID9"**, and this can be done by uploading the firmware via the web browser.
