Release Notes

SmartX IP Controller Firmware for MP-X, RP-C, and IP-IO Series

v3.01.01

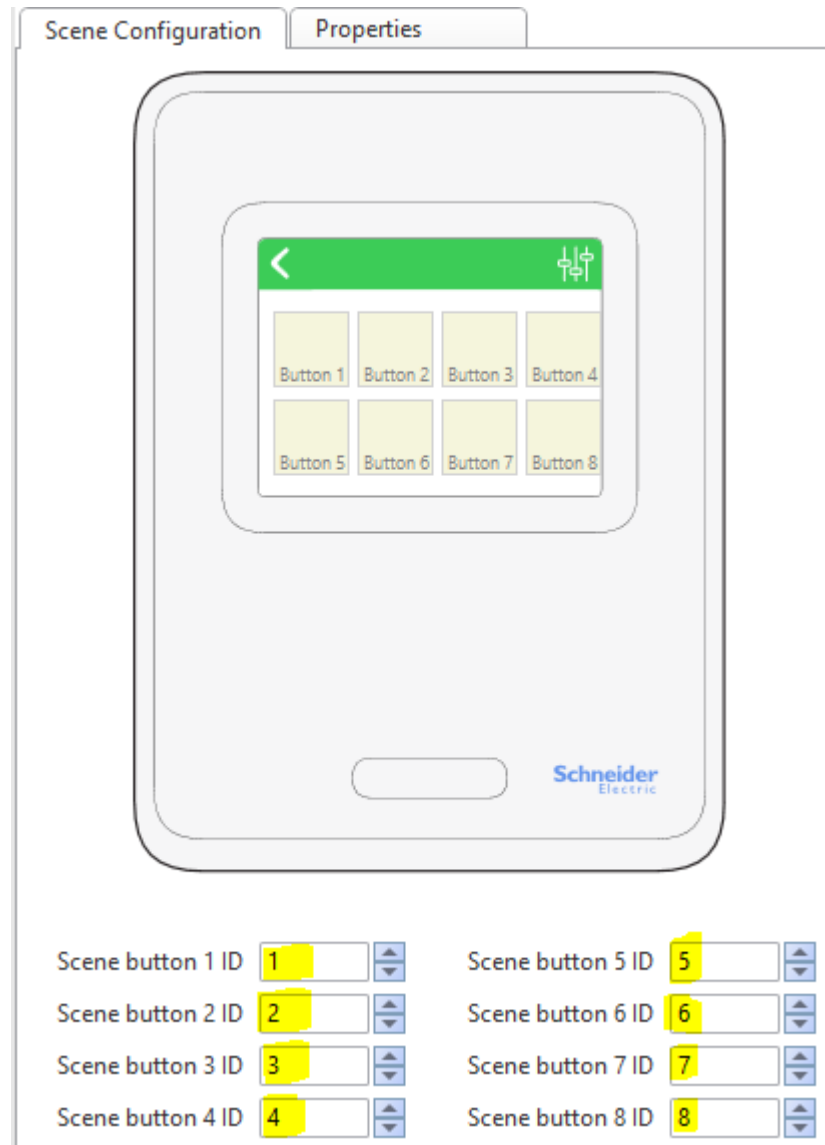
Room Unit – Scene ID

Defect #42491 - Clicking on the scene icons gives the instance of the icon, not the set trigger number.

The workaround for this defect is to simply only use only 1 to 8 for the Scene button ID 1 to 8, as highlighted below.
