Title: Horton VMaster Ultra (Stratis) Viscous Fan Hub Diagnostics and Troubleshooting Guide

Applies To: ProStars, LoneStars, WorkStar, TranStar, IBB

This article is a Troubleshooting Guide for the Horton VMaster Ultra (Stratis) Viscous Fan Drive.

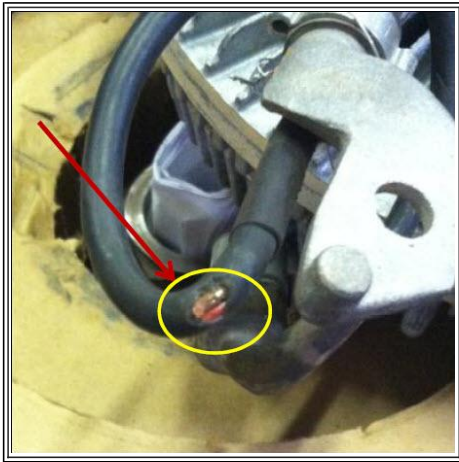
1. Check for rubbing on wire:

- If rubbing is present and inside wires are visible, but no copper is visible apply heat shrink over the harness.
- If copper can be seen, check to see if it is only one single wire, or multiple wires.
 - ▶ If it is one wire, place electrical tape over the wire.
 - ▶ Using 4:1 heat shrink will allow the heat shrink tubing to pass over the connector as shown. P/N: ZBJE849565 or equivalent

- ▶ If multiple wires are showing copper, remove and replace the fan hub assembly.
 - Reroute the wiring harness as outlined in the "Harness Re-Route Procedure" in this iKNow article.

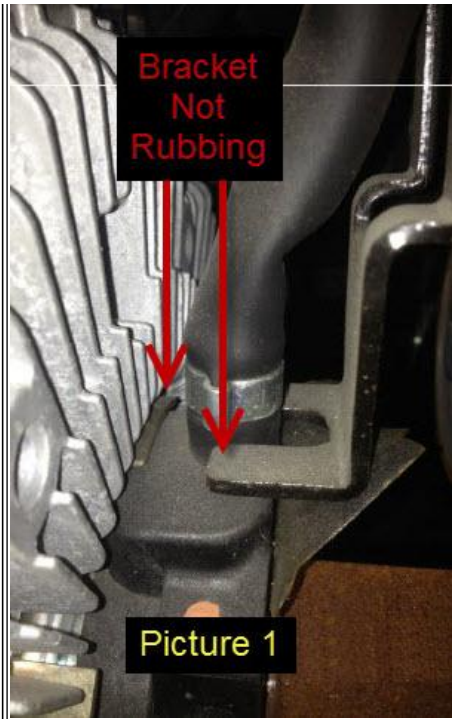
Figure 1

2. Check to see if ARB is touching the target wheel. Refer to *Figure 1* and *Figure 2*.
 - If it is touching, reposition ARB to clear the target wheel as shown in *Figure 1*.

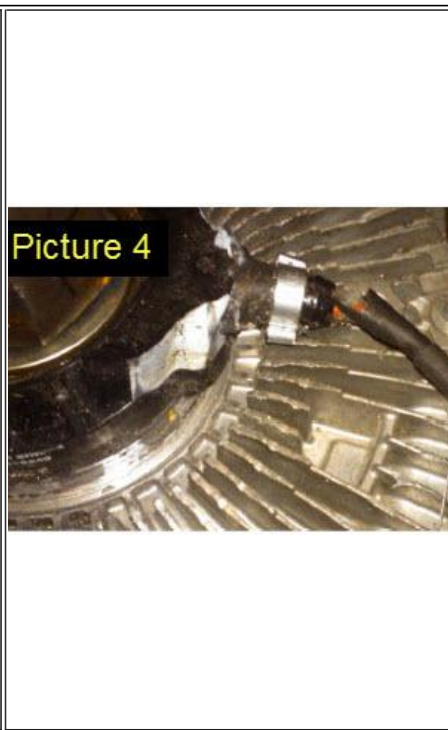
Figure 4

3. Check to see if the target wheel is loose, moves, or spins freely.
 - If it is loose, moves, or spins freely replace the fan hub assembly.
 - An improperly positioned ARB or loose target wheel can cause the damage in *Figure 4*.

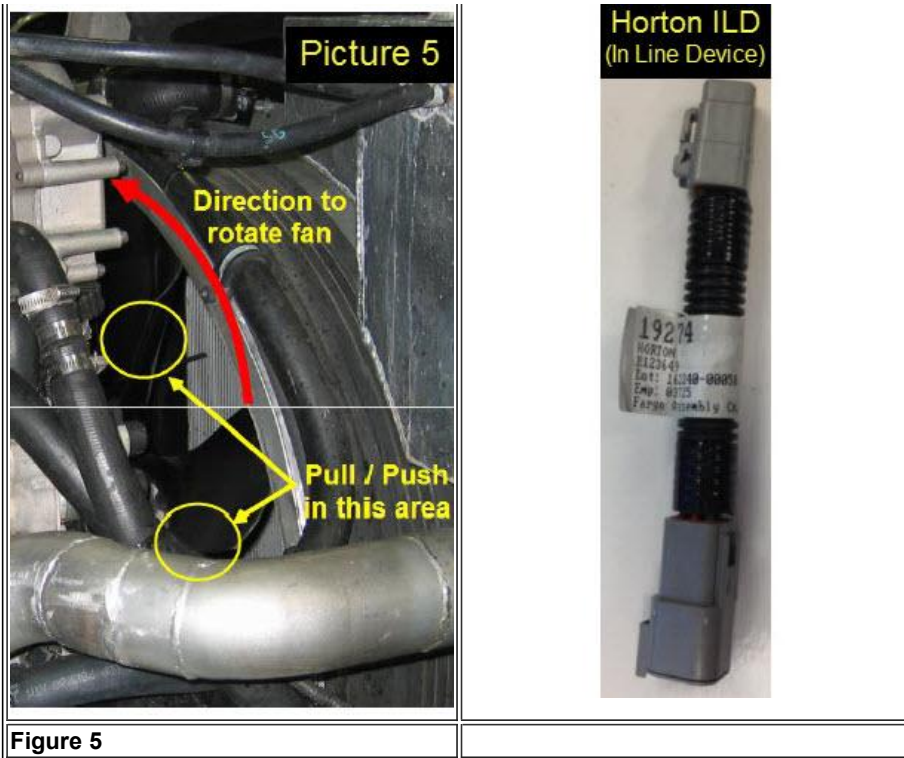
Figure 5

4. Pull / Push fan ON - refer to *Figure 5*.
 - Rotating the fan by hand, the hub should provide a smooth and consistent resistance.
 - If it rotates freely approximately 1" or more before resistance is felt, replace the fan hub assembly.

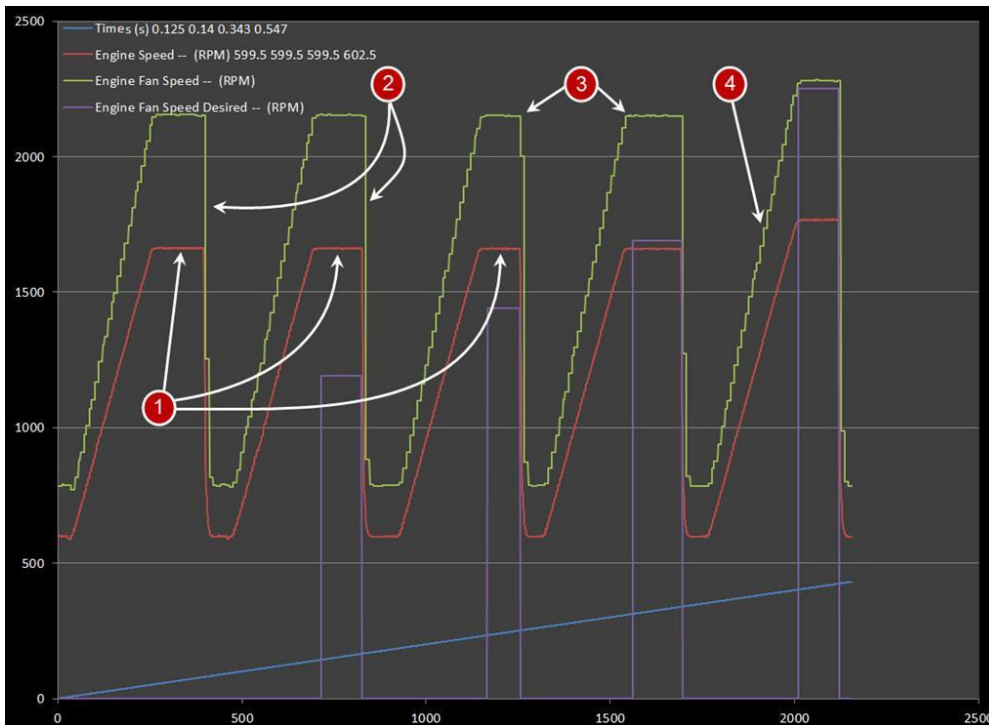
Figure 10 - Failed Fan Hub Assembly

- Engine ramps to the same speed for each section of the test.
- When the ECM is no longer requesting a set fan speed, the fan disengages. However, in this example, the viscous portion of the fan is not responding, allowing the fan speed to drop off rapidly.
- Notice the fan speed is always engaging to over 2000 RPM. The fan is turning on fully. This is not normal operation for the fan test.
- This is showing when the fan is commanded off, the fan hub speed increases with engine speed. Fan speed never drops back off, as shown in the working fan example above.
 - Note: This is one example of a failed fan. Not every fan hub will fail this way.
 - You can review your fan test in ServiceMaxx to see a chart view of the signals shown in this chart.

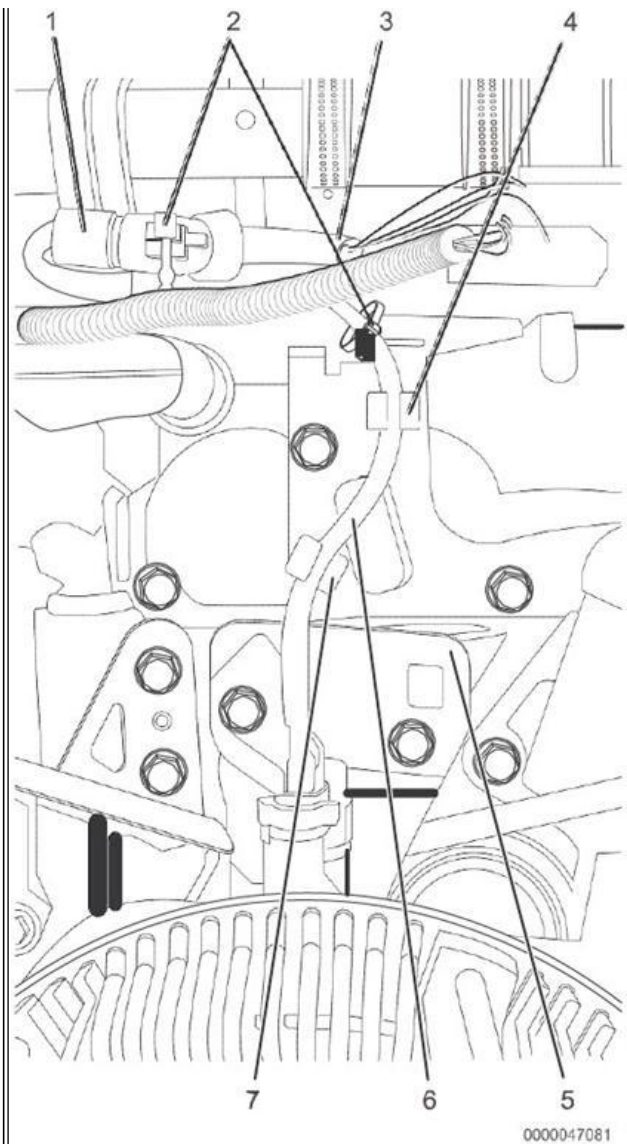
Figure 14 - Fan Clutch Harness

Wiring on the Horton Stratis Fan Hub has shown to be rubbing, causing DTC codes. Re-routing of the wiring harness before a failure will prevent future failures. Re-routing after a failure will prevent multiple failures.

The fan clutch harness can rub on the fan wiring harness bracket and cause intermittent fault codes. Some of the symptoms can include:

5. Remove two tie straps (*Figure 14, Item 2*) securing fan clutch harness (*Figure 14, Item 6*) to engine harness (*Figure 14, Item 3*) and fan clutch harness bracket (*Figure 14, Item 5*). Discard tie straps.
6. Remove harness from upper and lower push pins (*Figure 14, Items 4 and 7*).
 - a. If secured with two push pins, discard lower push pin (*Figure 14, Item 7*)
7. Inspect fan clutch harness (*Figure 14, Item 6a*) for signs of wear from contact with sharp or hard surfaces of harness bracket (*Figure 14, Item 5*).
 - a. If no damage is observed, proceed to Step 16.
 - b. If insulation chafing is observed or if copper is exposed or damaged, proceed to Step 8.
8. Disconnect harness connector (*Figure 14, Item 1*).
