June 12, 2003
RC-03-0112

Subject: VIRGIL C. SUMMER NUCLEAR STATION
DOCKET NO. 50/395
OPERATING LICENSE NO. NPF-12
RESPONSES TO REQUEST FOR ADDITIONAL INFORMATION (RAI) FOR
THE REVIEW OF THE LICENSE RENEWAL APPLICATION FOR VIRGIL C
SUMMER NUCLEAR STATION

**20th YEAR PHYSICAL SURVEILLANCE
 OF CONTAINMENT BUILDING
 POST-TENSIONING AT THE
 V. C. SUMMER NUCLEAR PLANT**

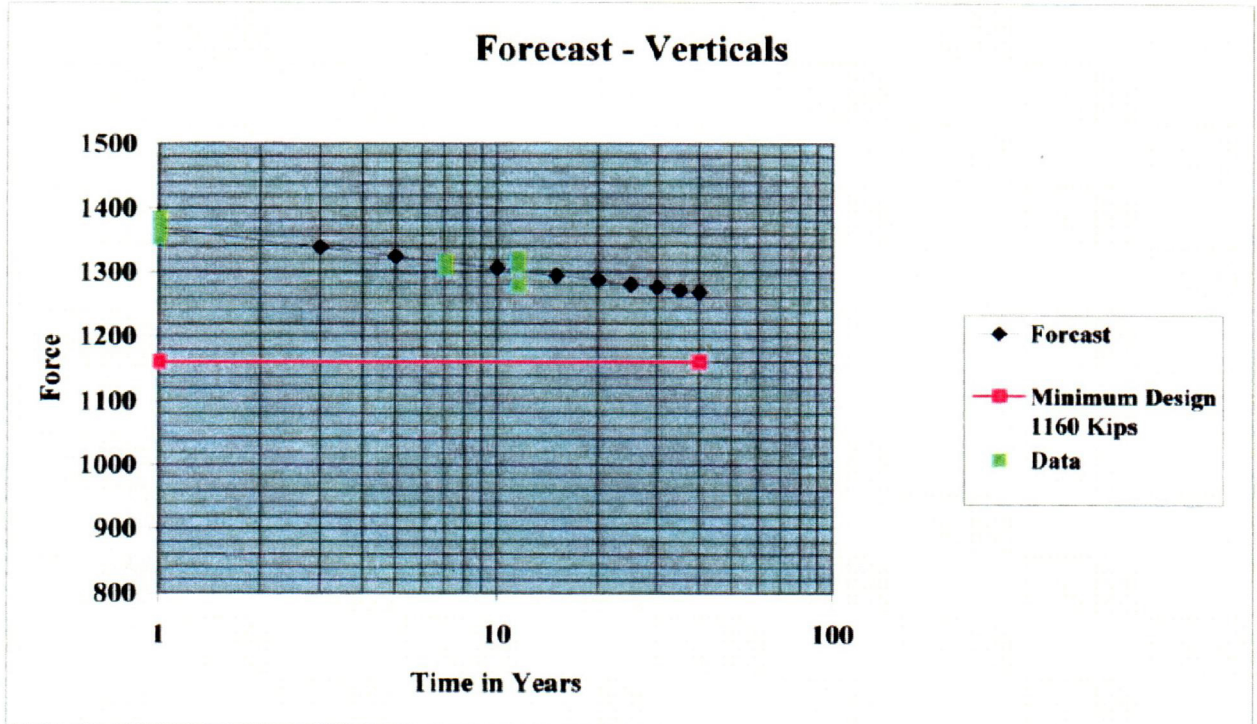
Years	Forecast (kips)
1	1368
3	1338
5	1324
10	1306
15	1294
20	1287
25	1280
30	1276
35	1271
40	1268

Due to retensioning conducted in 1990 the vertical timeline starts from that point. Therefore the thirty year value is effectively forty year plant life, and as expected minimum required force levels are easily achieved.

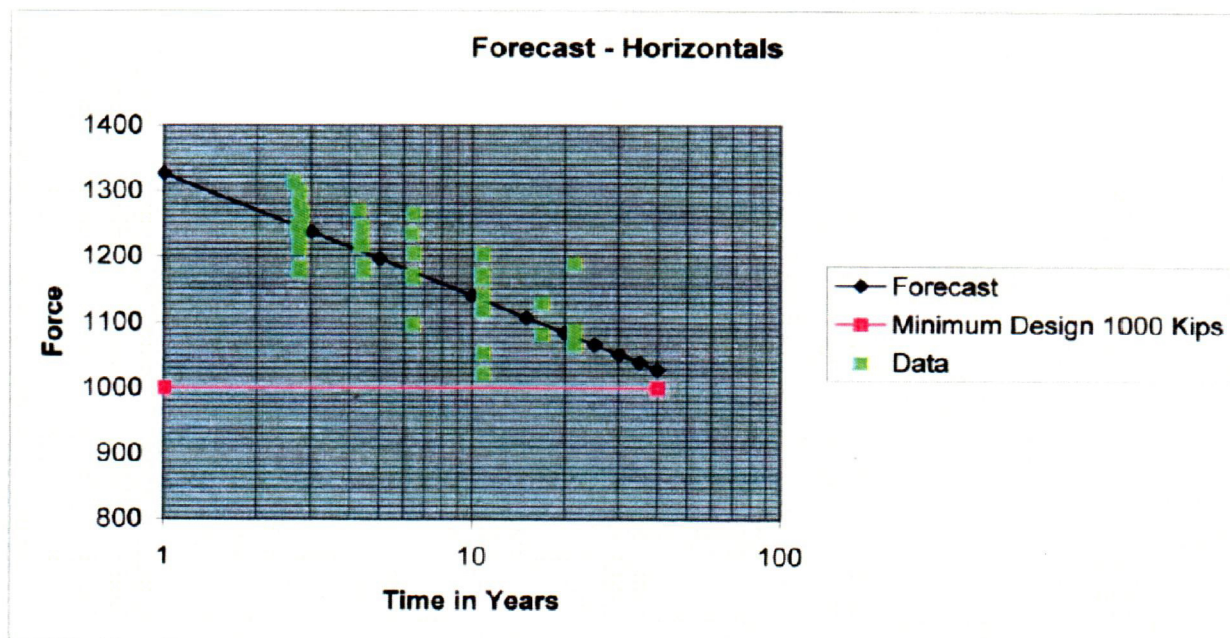
Years	Forecast (kips)
1	1326
3	1237
5	1196
10	1140
15	1107
20	1084
25	1066
30	1051
35	1039
40	1028

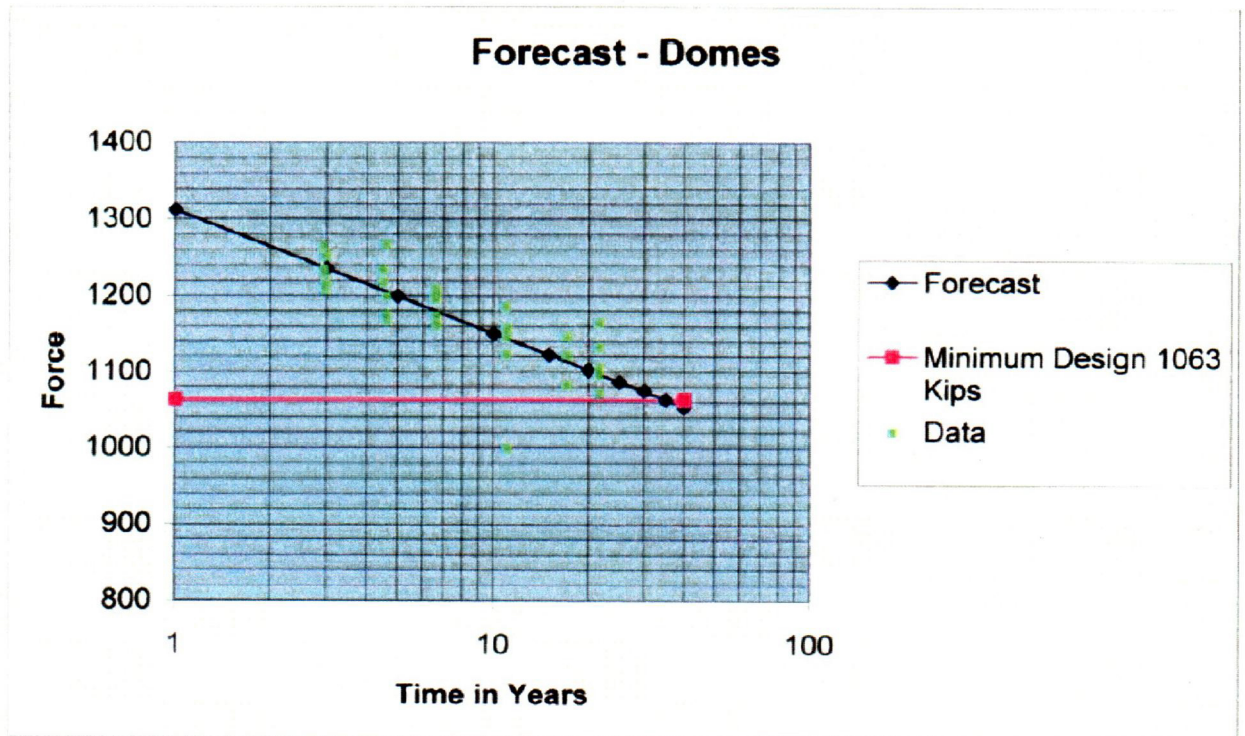
Years	Forecast (kips)
1	1312
3	1235
5	1199
10	1150
15	1122
20	1102
25	1086
30	1074
35	1063
40	1053
