West Branch Passumpsic River & Calendar Brook Corridor Plan Caledonia County, Vermont

August 18, 2010

Fitzgerald Environmental Associates, LLC.
316 River Road
Colchester, VT 05446

**Caledonia Country Natural
Resources Conservation District**
481 Summer Street, Suite 202
St. Johnsbury, VT 05819

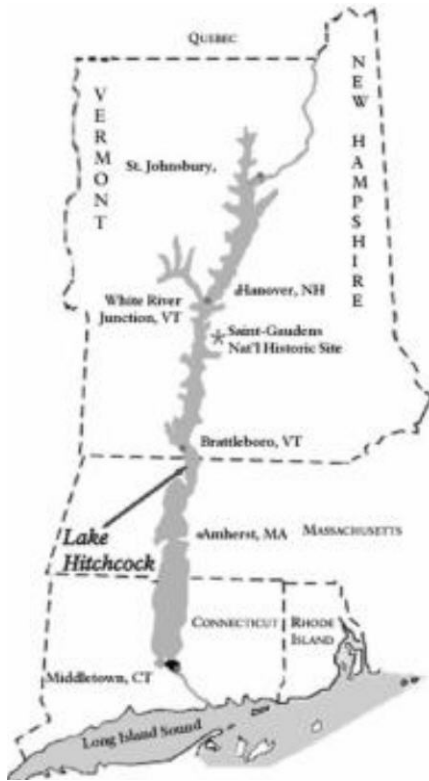
Figure 2.2 Extent of Glacial Lake Hitchcock (NPS, 2010)

The presence of Glacial Lake Hitchcock also had a significant effect on the surficial geology of the West Branch Passumpsic watershed (Figure 2.2). This lake occupied the Connecticut River Valley from central Connecticut to north of St. Johnsbury during the retreat of the Laurentide ice sheet beginning approximately 18,000 years ago (Ridge and Larson, 1990). The great size of the lake, combined with the erosive forces of the glacier moving over bedrock surfaces allowed for the development of annual layering of fine sediments (e.g., varves) throughout the area affected by the lake.

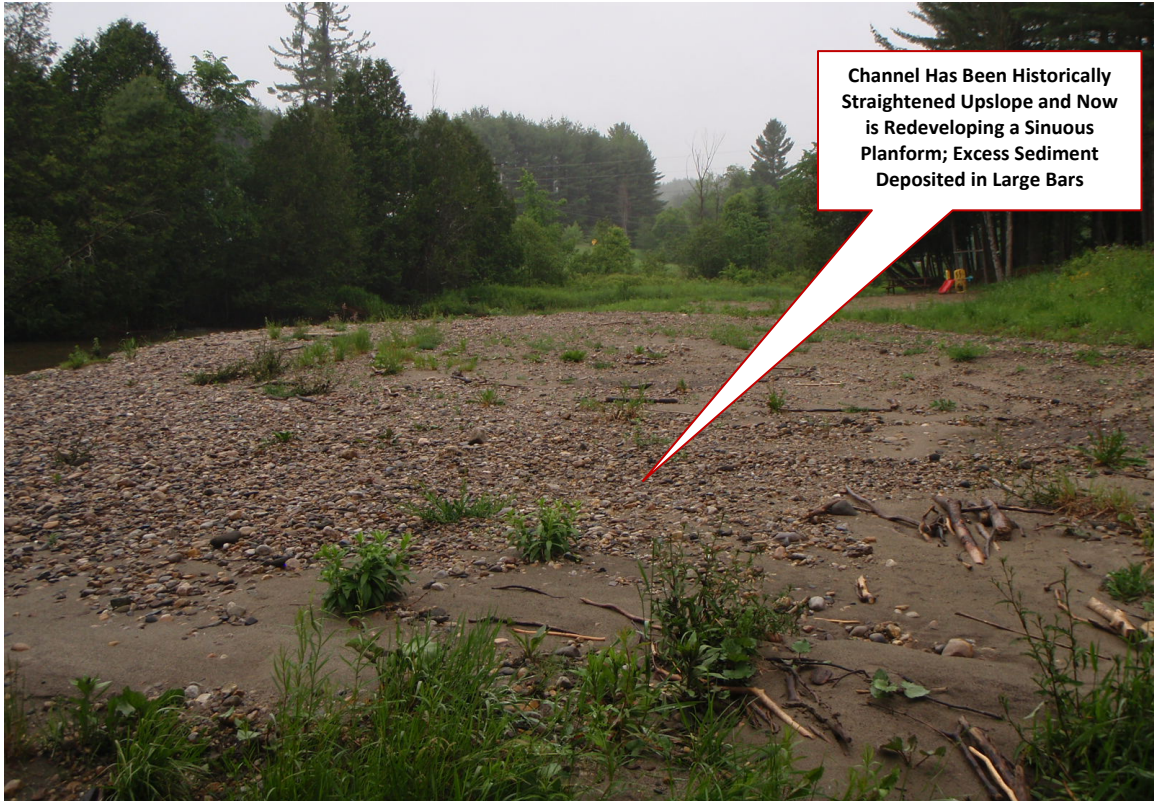
Figure 4.4 Looking upstream at large point bar feature located in reach T3.S1.02-B

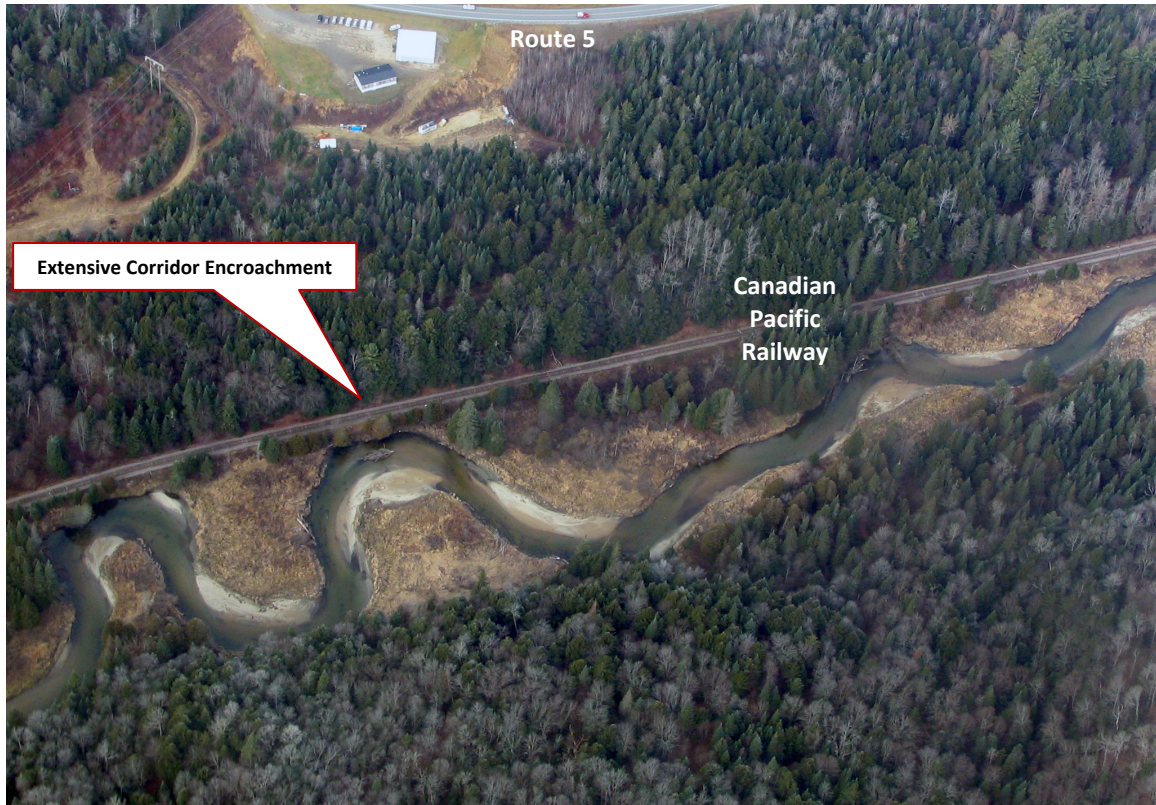
Figure 4.7 Corridor encroachments along the west side of the channel in reach T3.02 and T3.03

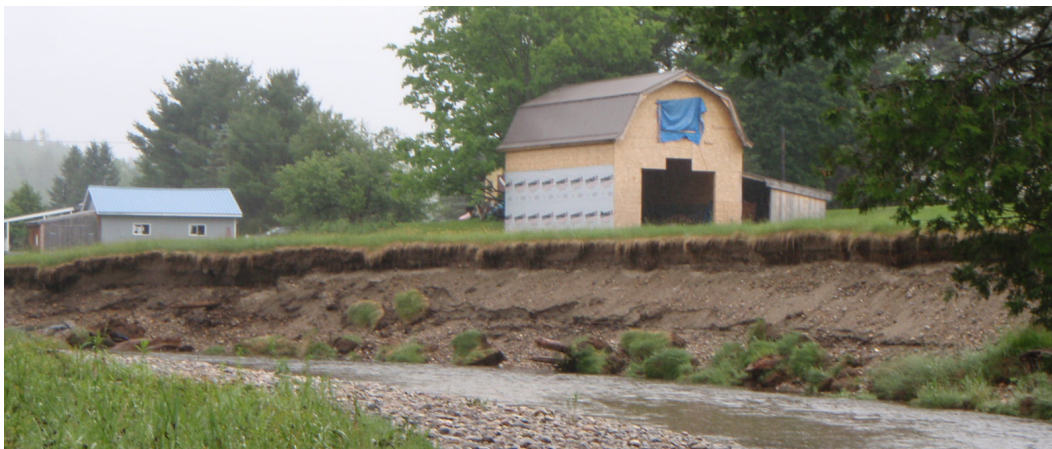
Figure 4.9 Calendar Brook T3.S1.02-A: No riparian buffer and development in the corridor

- High bank erosion on reach T3.02 (33.7%)
- Buffer width less than 25 feet on the right bank along segment T3.S1.02-A
- Buffer width impacts along the right and left banks in segment T3.01-A
- Dredging activity on T3.S1.02-A and T3.S1.02-B

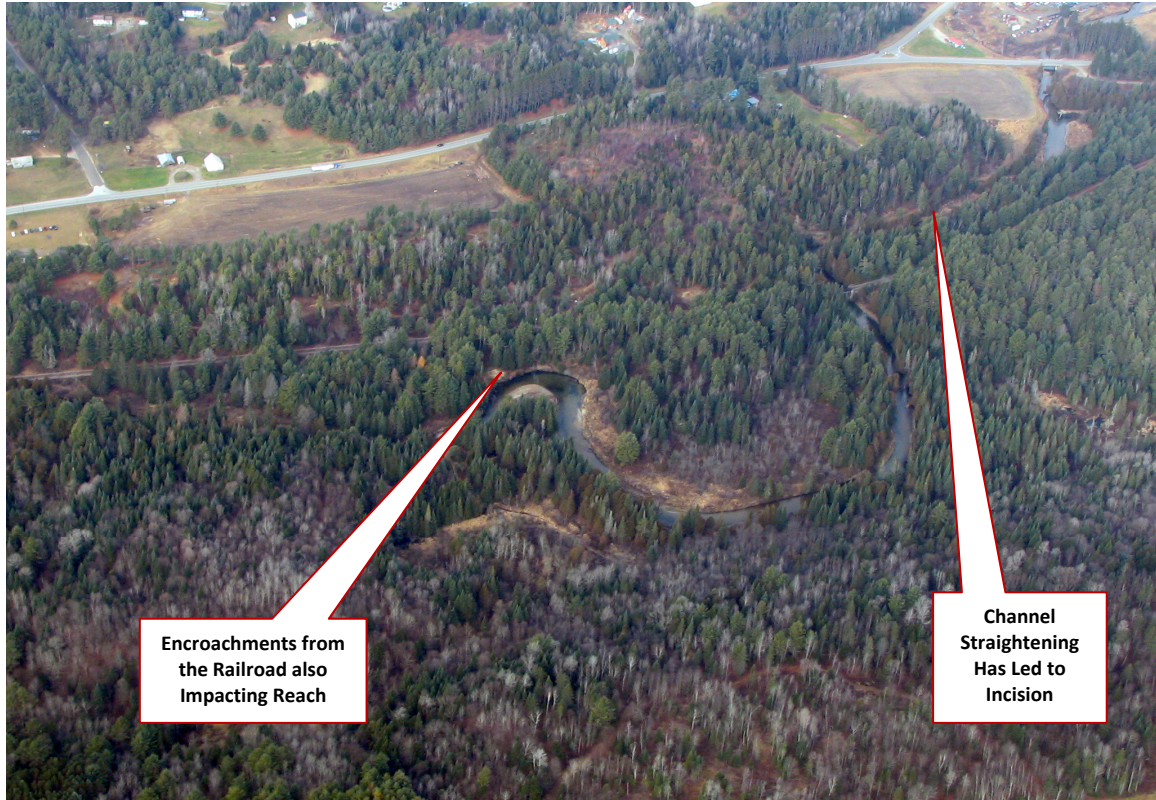
Figure 4.15 Reach T3.03 has corridor encroachments and channel straightening, which has led to channel incision
