NONDESTRUCTIVE DETECTION OF STRUCTURAL
DAMAGE UNIQUELY ASSOCIATED WITH
FATIGUE

AFML-TR-74-131

**JOHN F. MOORE
SCHILLINGS TSANG
DONALD O. THOMPSON
ROCKWELL INTERNATIONAL CORPORATION**

JULY 1974

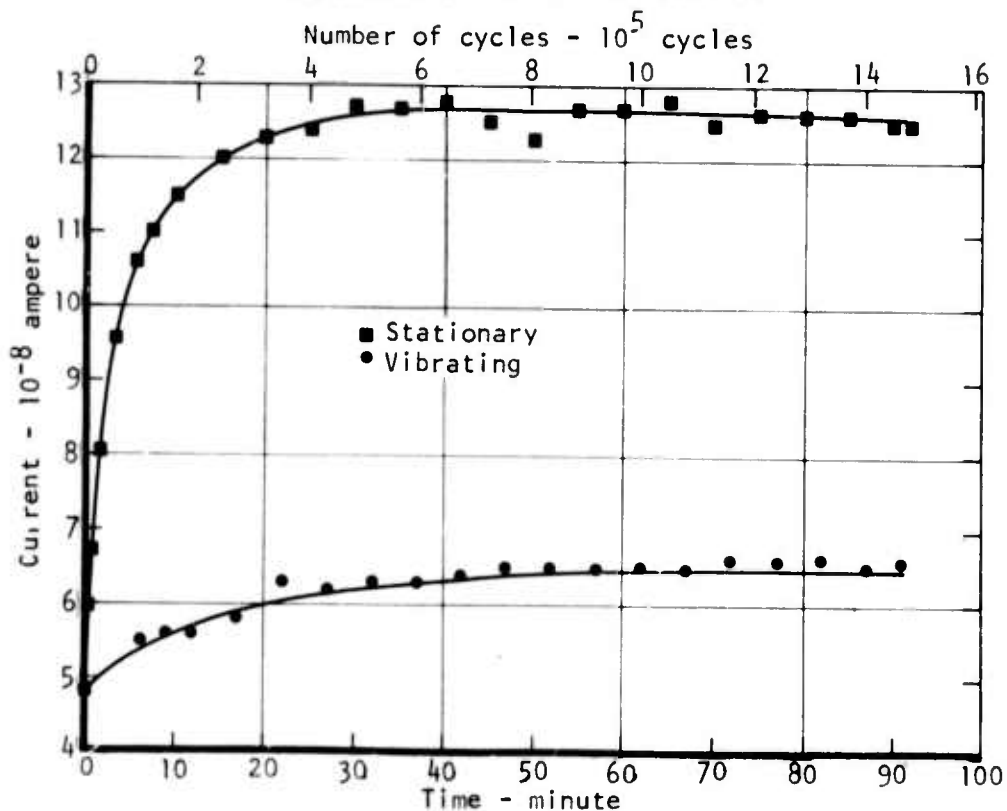
Figure 18. Exoelectron emission curves for 1100 aluminum without surface oxide in fatigue at strain amplitude 2.7×10^{-3} in vacuum.
