## **APPENDIX 3-1**

### **CABLE CHARACTERISTICS**

# 1. CHARACTERISTICS OF AEC2 UNDERWATER FIBRE OPTIC CABLE

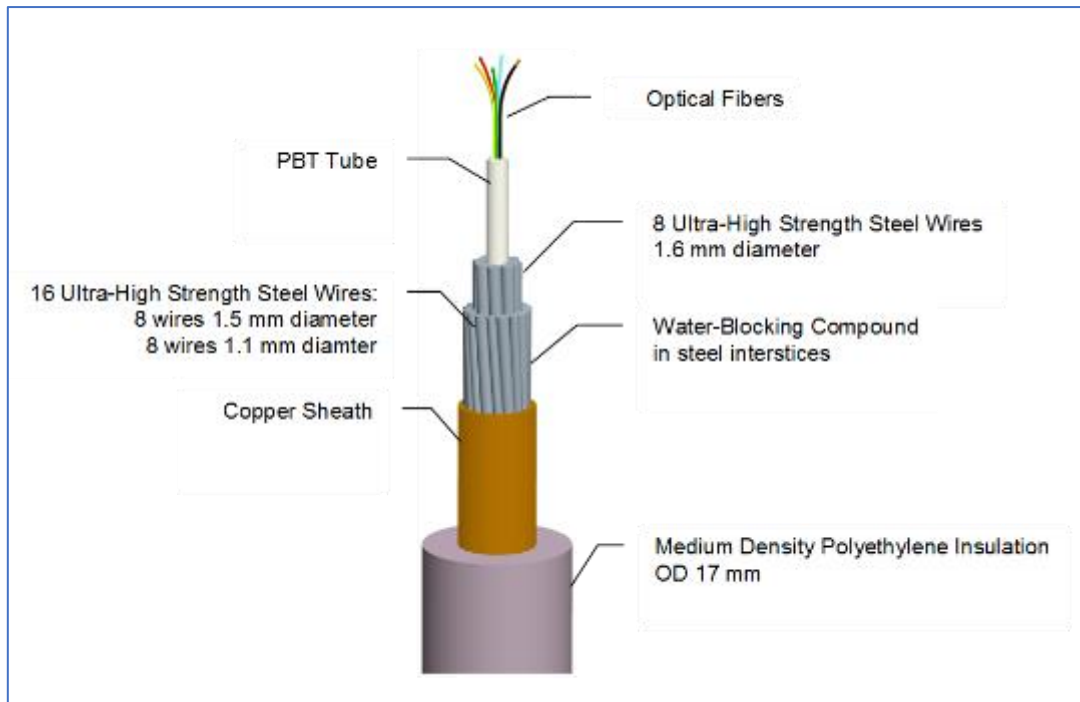
Figure 1-2. SubCom SL17 Lightweight cable

A set of 24 ultra-high-strength steel wires are helically formed around the fiber core (UFS) with a lay length of 305 mm [12 in.]. These 24 wires are configured into two layers. The first layer consists of 8 wires, 1.59 mm [0.0627 in] diameter.

The second layer consists of 16 alternating wires of which 8 are 1.50 mm [0.0592 in] diameter, and 8 are 1.13 mm [0.0446 in] diameter. The wires provide tensile stiffness which limits cable and fiber elongation during handling. They also isolate and protect the UFS by forming a pressure vessel. The interstices between the steel wires are filled with a hydrophobic elastomeric water-blocking material which resists longitudinal water ingress.

Outside this, a continuously seam-welded copper sheath is formed around the wires. The sheath forms a seal against radial water and hydrogen diffusion and conducts system power and signals used for cable monitoring and maintenance. A thin layer of ethylene-acrylic acid copolymer and a medium-density polyethylene jacket are then coextruded over the copper sheath. The ethylene-acrylic acid copolymer insures the bonding between the jacket and copper sheath. The polyethylene jacket provides high-voltage insulation, abrasion resistance, and corrosion protection. The polyethylene jacket also provides protection from typical hydrogen sulfide concentrations and provides a suitable finish for cable handling.

The nominal cable diameter of this resultant Lightweight (LW) cable is 17 mm [0.67 in.].

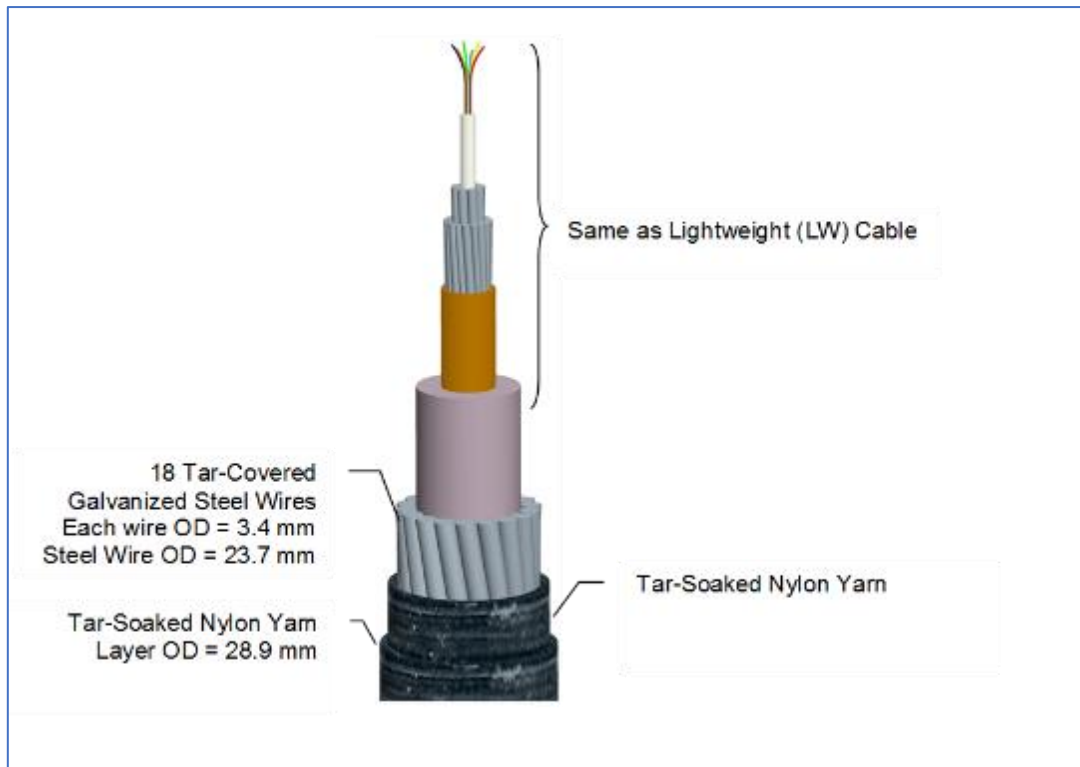
Figure 1-3. SL17 Light Wire armored cable

SL17 Light Wire Armoured (LWA) cable is used in areas above the continental shelf where the cable is buried and where there is moderate to low risk of external aggression damaging the cable. The construction of LWA cable begins with a finished lightweight (LW) cable which then has 18 tar covered, galvanized, 3.35 mm [0.132 in.] diameter steel wires placed around the LW cable with a lay length of 380 mm [15 in.]. The cable with the tar covered galvanized wires then has two layers of tar impregnated nylon yarn separately laid over the wires and counter laid to each other with a lay length of 152 mm [6.0 in.]. The nominal diameter of the resultant Light Wire Armour cable (LWA) is 28.9 mm [1.14 in.].

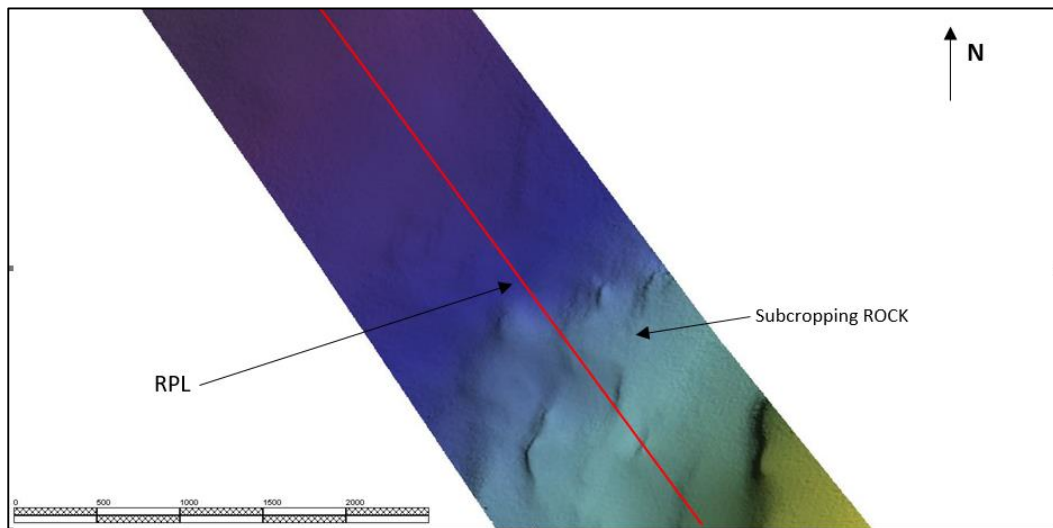
Figure 3-1 MBES Image of irregular seabed over subcropping ROCK. 54° 25.6585N, 11° 28.3378E

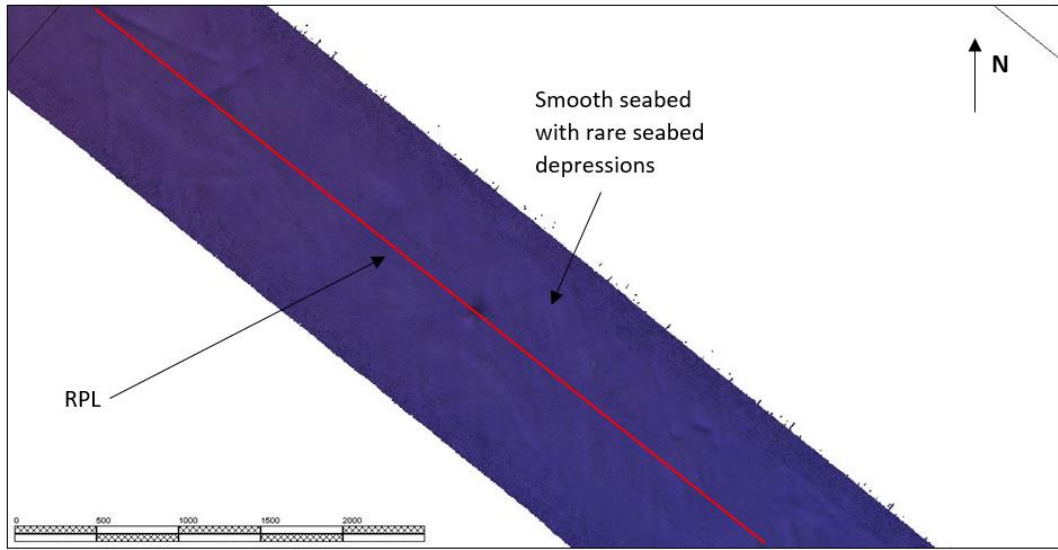
Figure 3-12 MBES Image showing smooth seabed with rare seabed depressions at 54° 15.0821'N, 011° 04.4110'W.

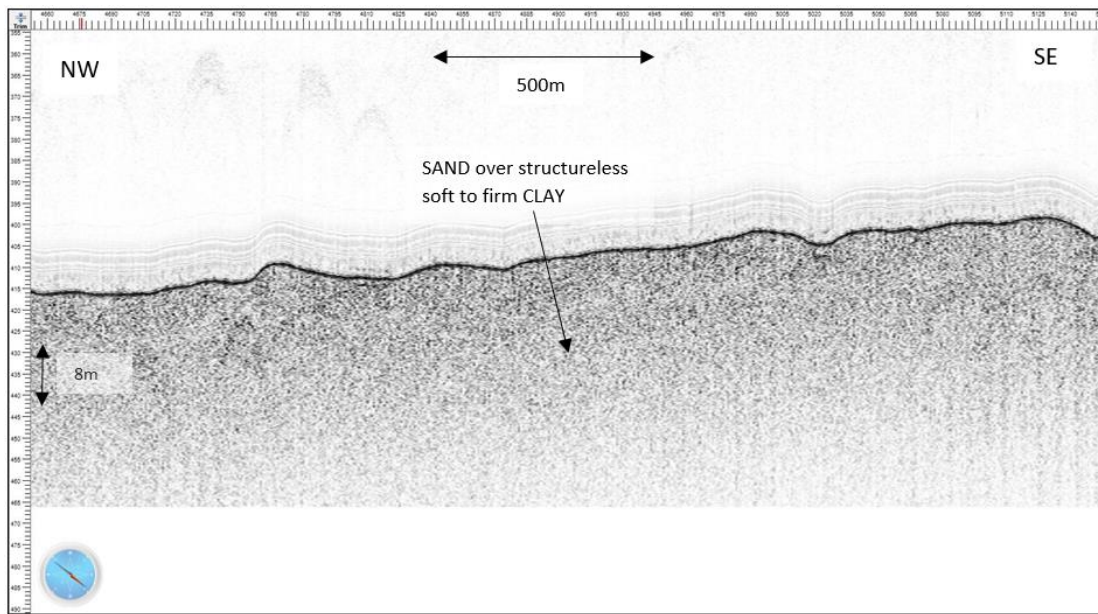
Figure 3-14 SBP Image showing SAND over structureless soft to firm CLAY, 54° 15.0821'N, 011° 04.4110'W

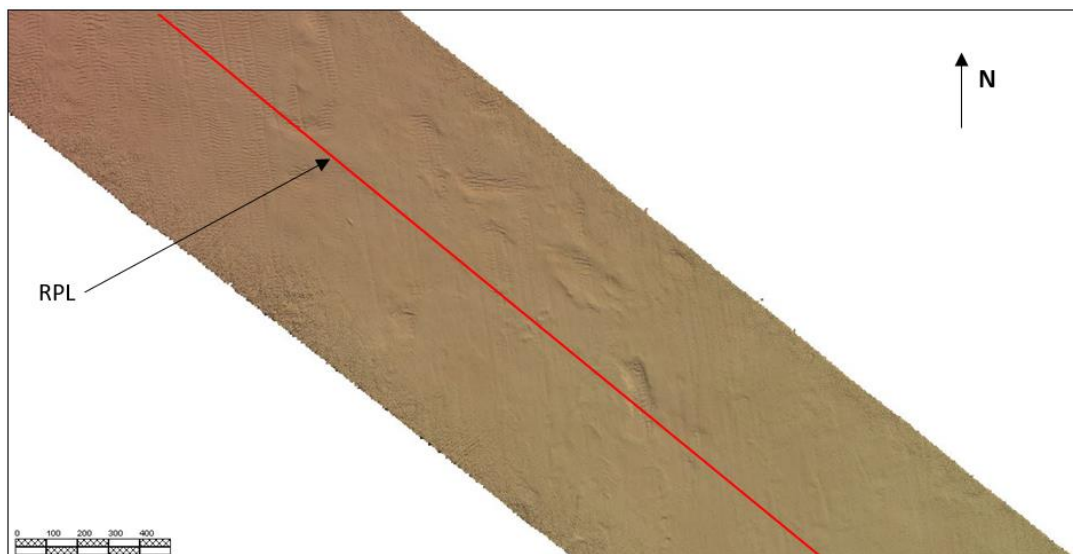
Figure 3-15 MBES Image showing gently undulating seabed. 54° 4.3438'N, 10° 40.4516'W

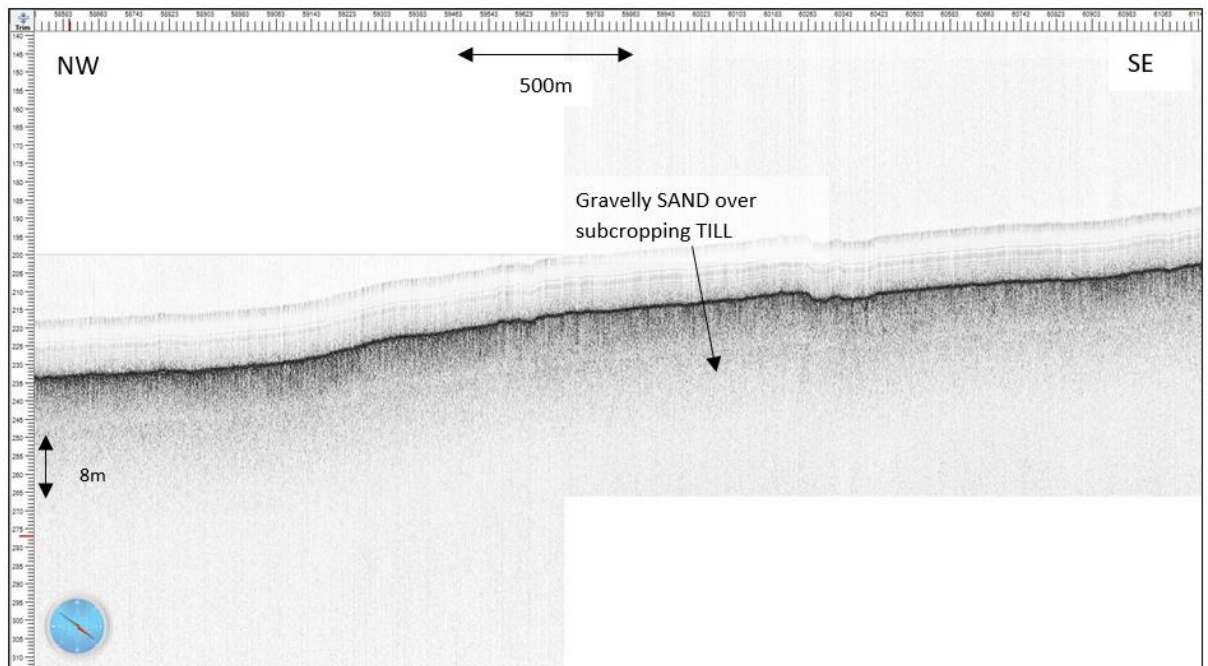
Figure 3-17 SBP Image showing poor penetration in TILL. 54° 4.3438'N, 10° 40.4516'W

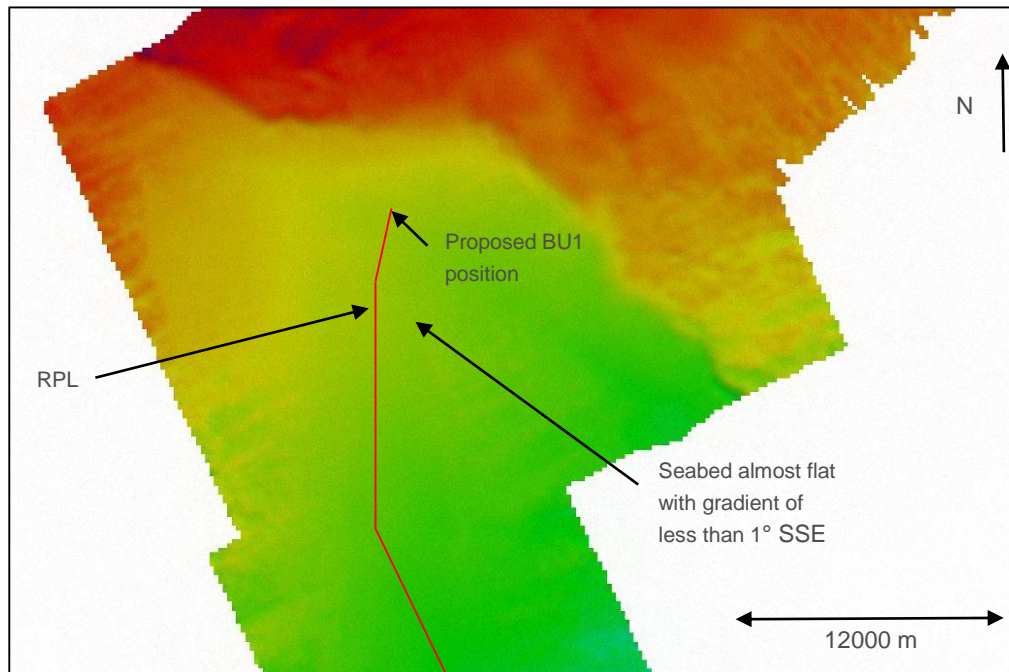
Figure 3-36 .....DTM Illustrating the seabed conditions at BU1

The S02 BU1 to BMH Oldhead survey commenced at the BU1 position at 55° 22.1387'N, 013° 03.1736'W in 2846m WD. At this position the proposed route runs to the SSW over an almost flat seabed at a gradient of less than 1° SSE. At 55° 21.0967'N, 013° 03.9453'W in a similar WD, the route alters course to S, still traversing an almost flat and featureless seabed over a gradient of less than 1° SSE (Figure 3-36).

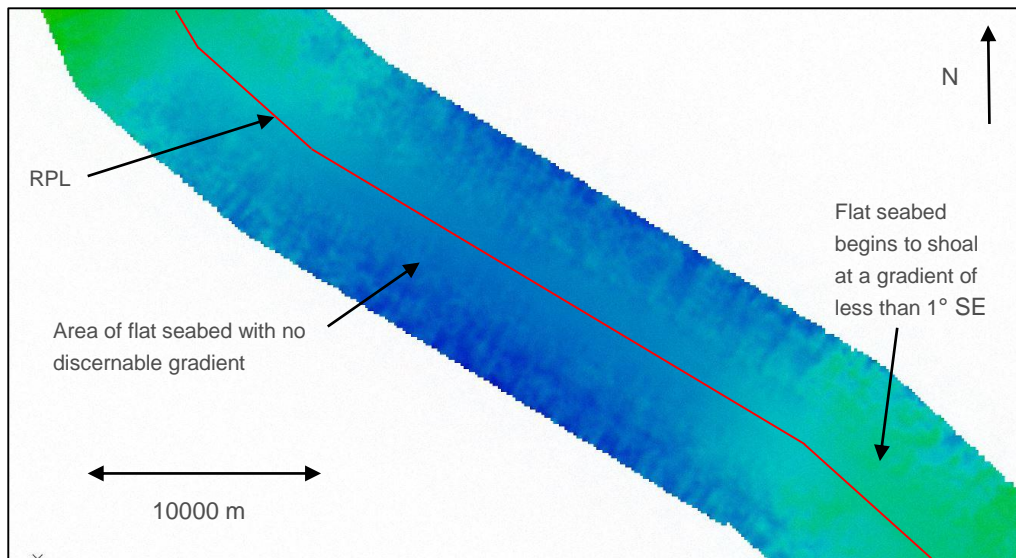
Figure 3-37 .....DTM Illustrating the flat seabed at 55° 08.5870'N, 012° 52.0177'W

After this point the seabed begins to shoal with a gradient of less than 1° NW as the route alters course slightly, still heading to the SE (Figure 3-37). At 54° 59.6663'N, 012° 28.5295'W in 2880m WD, the INS Hibernia seg A fibre optic cable is crossed by the proposed route as shown on the Client supplied data base. It is shown on the RPL at 107.6m SE of this position at 54° 59.6312'N, 012° 28.4633'W in 2880m WD.

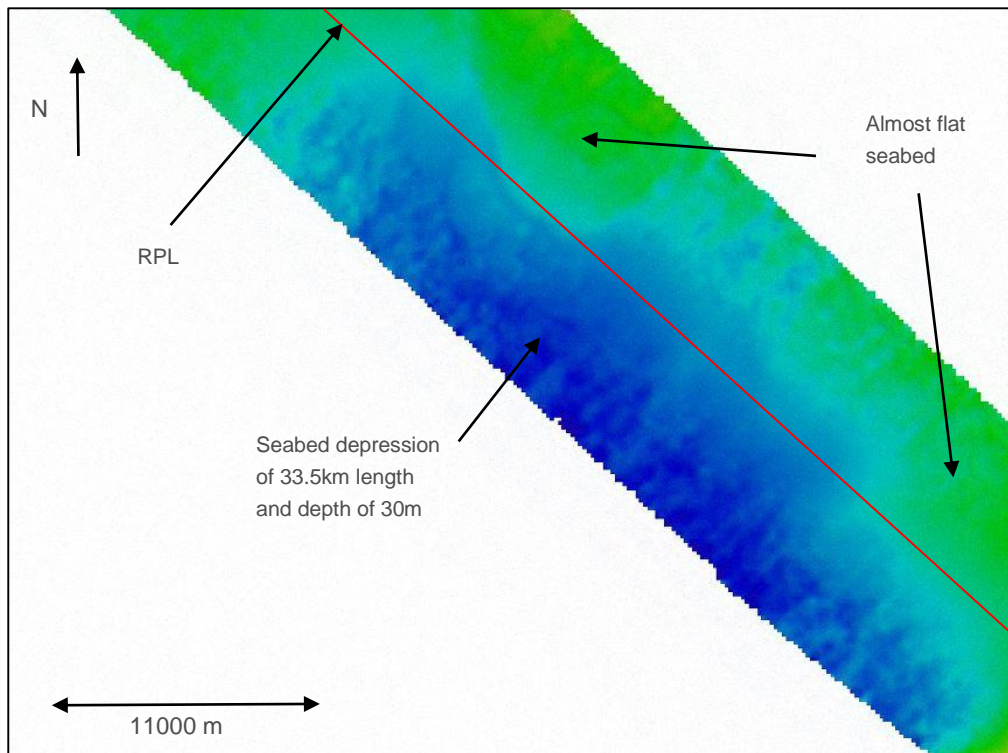
Figure 3-38 .....DTM Illustrating the shallow seabed depression observed at 54° 46.6734'N, 012° 04.0913'W

The route proceeds to shoal gently to the SE across an almost flat seabed with a gradient of less than 1° NW. Between 54° 46.6734'N, 012° 04.0913'W in 2880m WD and 54° 37.0324'N, 011° 46.0076'W in 2880m WD, the route traverses the NE periphery of a shallow seabed depression of 30m depth and 33.5km along track distance. The slope gradients of this depression are at less than 1° SW, which should not present any hazard to cable emplacement (Figure 3-38).

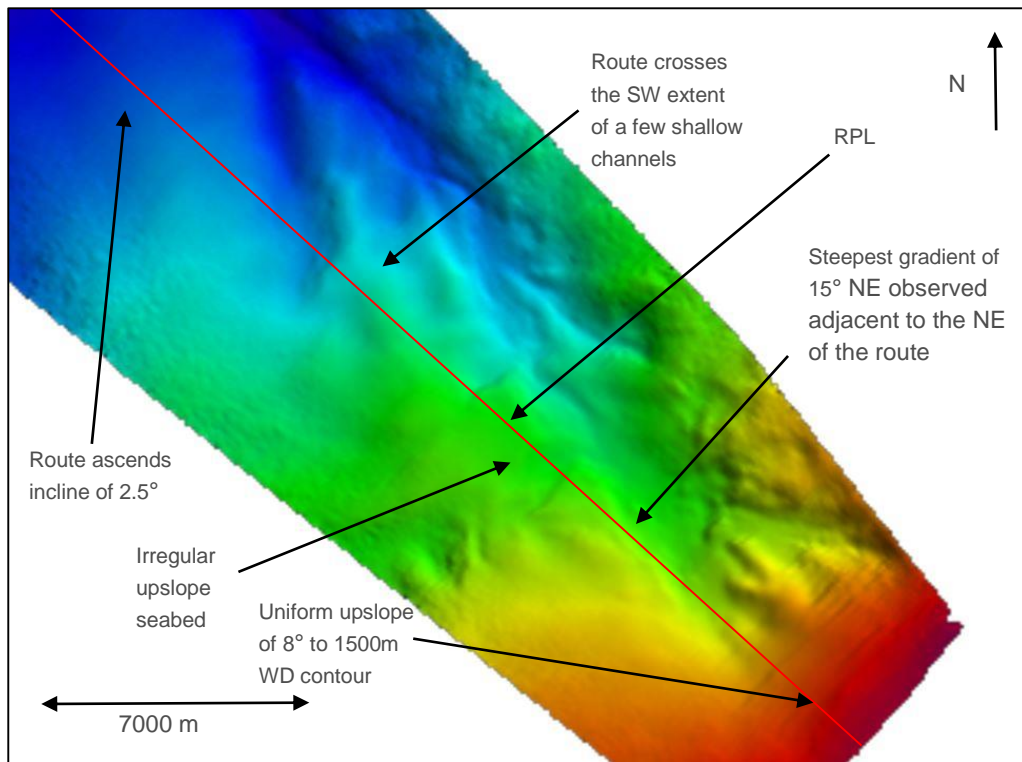
Figure 3-39 .....DTM Illustrating the irregular topography in the approach to the 1500m WD mark

Beyond this point, the seabed continues up a uniform slope of approximately 8° NNW to the 1500m WD contour at 54° 27.4074'N, 011° 28.2177'W at the end of the deep water survey (Figure 3-39).

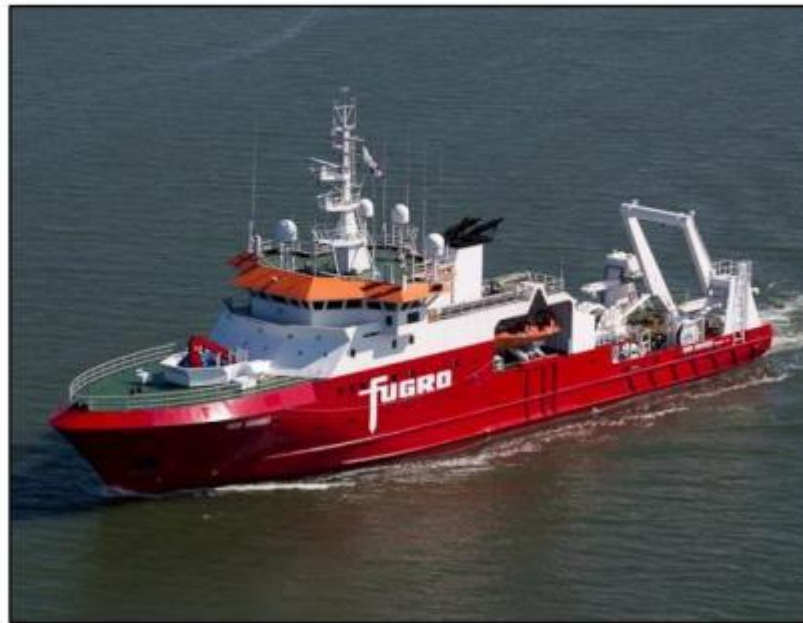
Figure 2. MV Fugro Discovery

MV Fugro Discovery

Length Overall	70.0 m
Length PP	61.4 m
Beam	12.6
Draught	6.0 m
Draught with Gondola	6.5 m
GRT	2018 t
Speed	Cruising speed: 10 kts, max. speed: 13 kts
SOLAS	IMO No.: 9152882, Call Sign: 3EKE6
Year of Construction	1997
Owner	Fugro

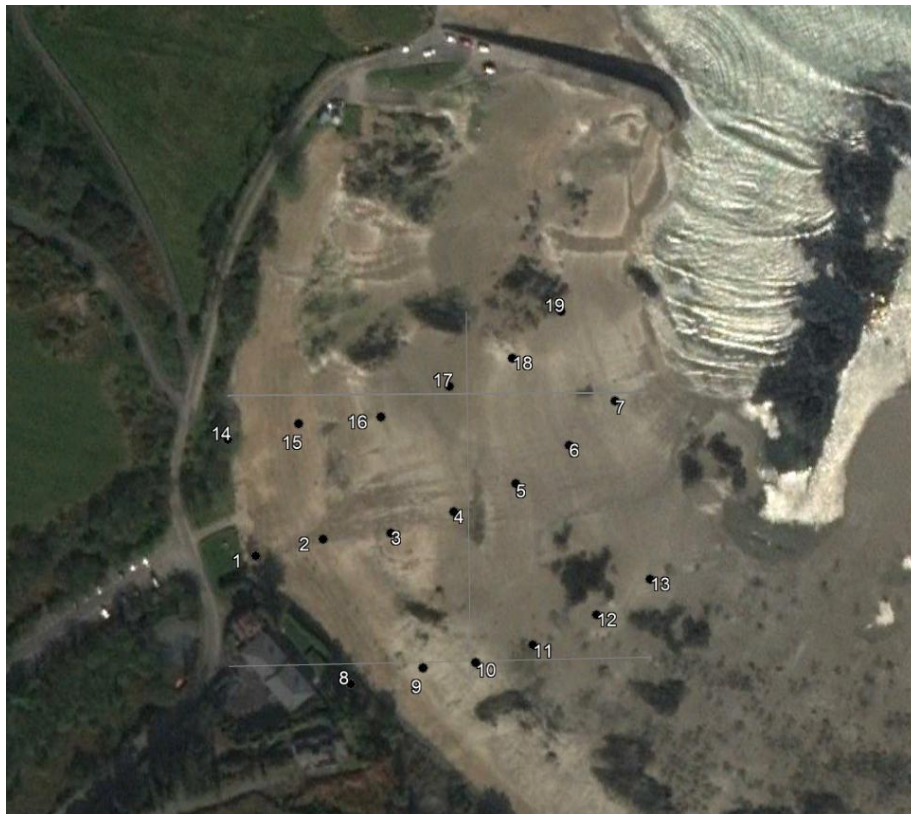
Figure 5. Beach probing locations Old Head

The probing revealed that the beach deposits were very shallow with only two of the locations revealing deposits in excess of 2m. The beach was observed to be composed of fine, and fine to medium SAND with occasional shell fragments and cobbles.

Nothing of any archaeological significance was noted.

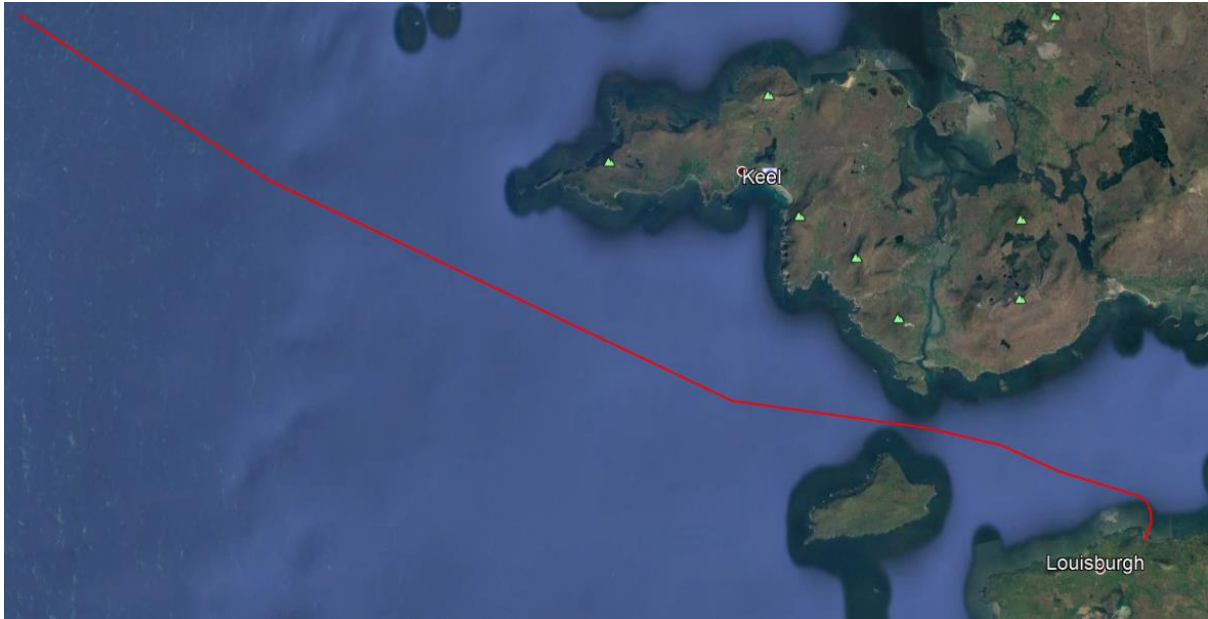
Figure 1. HAVFRUE cable route from 12NM limit to landfall at Oldhead

The proposed cable route comprises a 500m corridor over a distance of 71.571km, extending from the limit of the Irish territorial waters in a NW- SE orientation to run between Achill Island and Clare Island and into Clew Bay before turning south to make landfall at Old Head Beach on the south side of Clew Bay

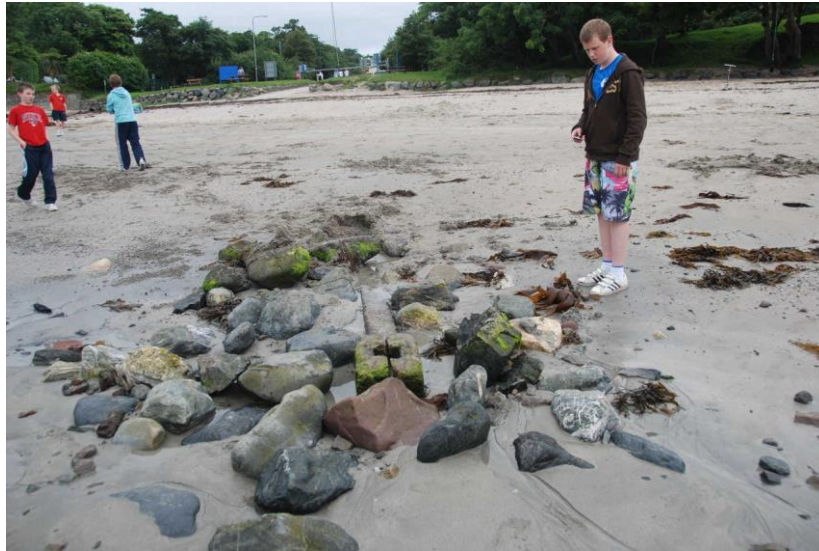
Figure 9. Timber beam and block on the beach at Oldhead

There is one known possible wreck (**W11423**) which was reported and identified in 2010 on Old Head beach which may be impacted by the proposed cable route making landfall. The timbers are c. 150m from the wheelchair access ramp for Old Head and are located at ITM co-ords: 0483329, 0782279. The timbers have been allocated a wreck no. W11423 with the National Shipwreck Inventory of Ireland. There is a possibility of the timbers being part of the Coastguard Station or Salt Pans shown on the 1<sup>st</sup> Ed. OS Map but due to the uncertainty of the amount of timbers they have been left in-situ on Old Head Beach. The initial proposed route was modified to stay further away from this feature.

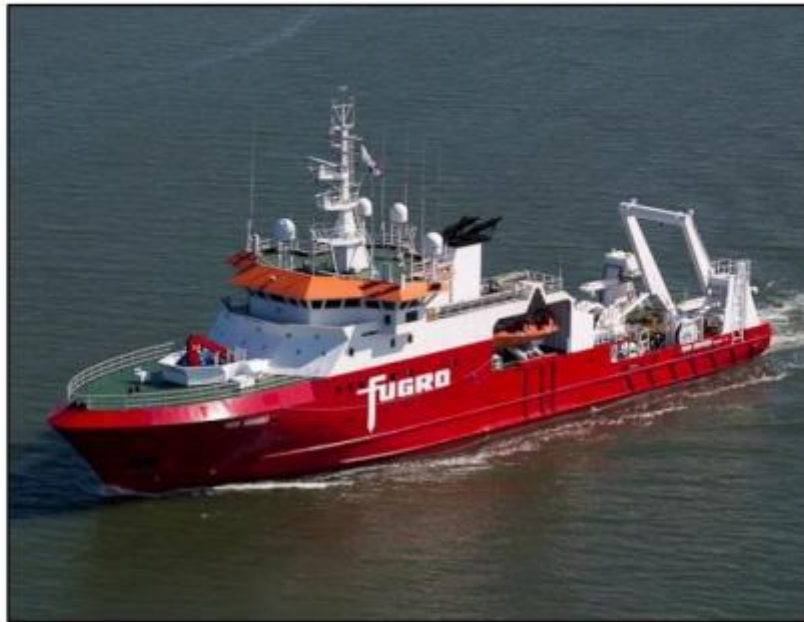
**MV Fugro Discovery**

The geophysical and geotechnical survey was undertaken utilizing the vessel MV Fugro Discovery operated by Fugro Germany Marine GmbH (FGMG).

Length Overall	70.0 m
Length PP	61.4 m
Beam	12.6
Draught	6.0 m
Draught with Gondola	6.5 m
GRT	2018 t
Speed	Cruising speed: 10 kts, max. speed: 13 kts
SOLAS	IMO No.: 9152882, Call Sign: 3EKE6
Year of Construction	1997
Owner	Fugro

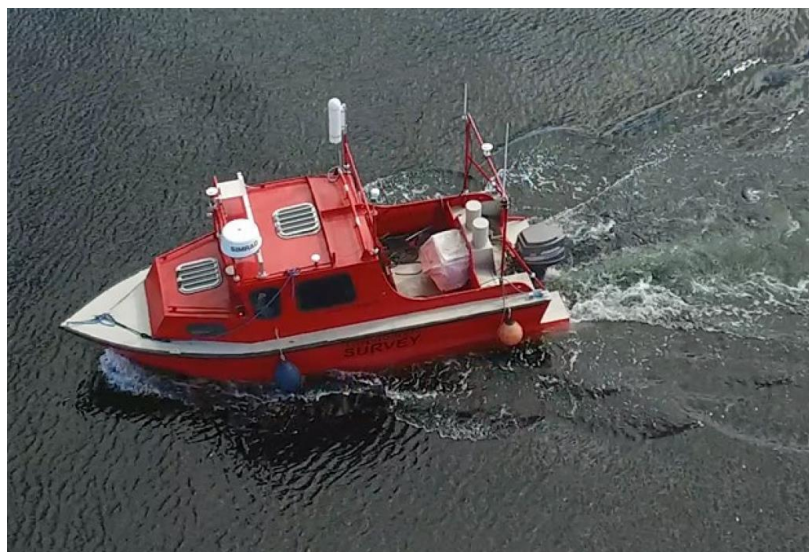
Figure 16. MV Alumaster

For the inshore survey the small boat Alumaster, operated by Fugro Germany Marine GmbH (FGMG) was used.

MV Alumaster	
<b>Length</b>	6.5m
<b>Beam</b>	2.3m
<b>Draught</b>	0.4
<b>Speed</b>	7Knts
<b>Type</b>	Aluminium Cabin Work Boat
<b>Propulsion</b>	36 HP YanmarDiesel Outboard
<b>Electrical Supply</b>	220/24/12 V
<b>Owner</b>	Fugro

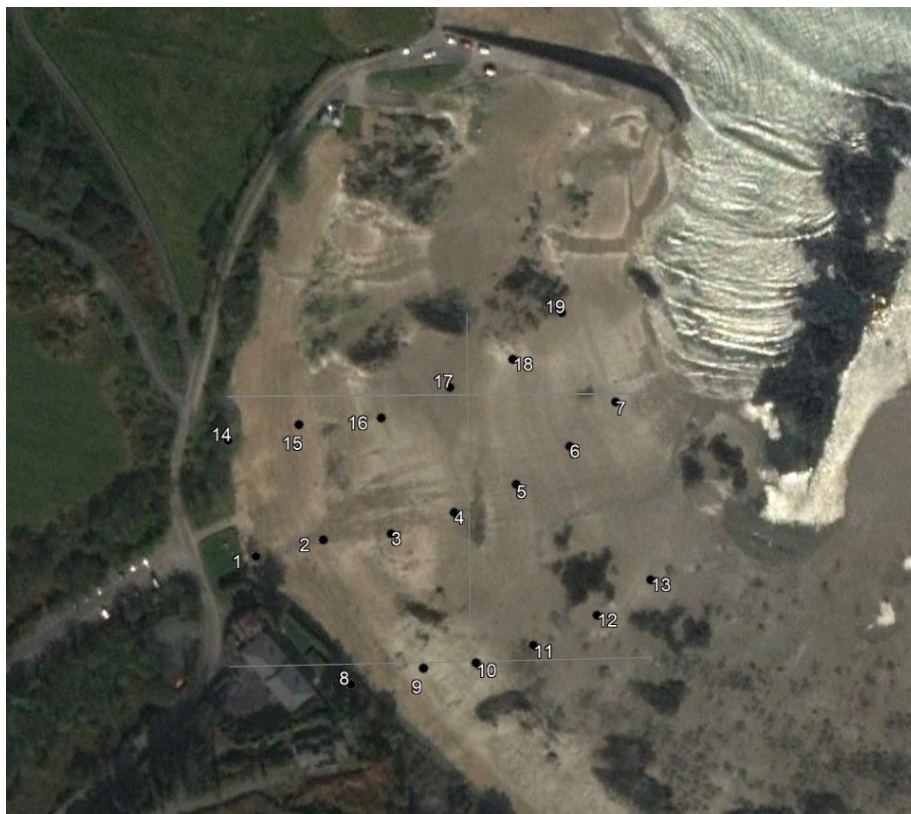
Figure 18. Beach probing locations Oldhead

The probing revealed that the beach deposits were very shallow with only two of the locations revealing deposits in excess of 2m. The beach was observed to be composed of fine, and fine to medium SAND with occasional shell fragments and cobbles.

Nothing of any archaeological significance was noted.

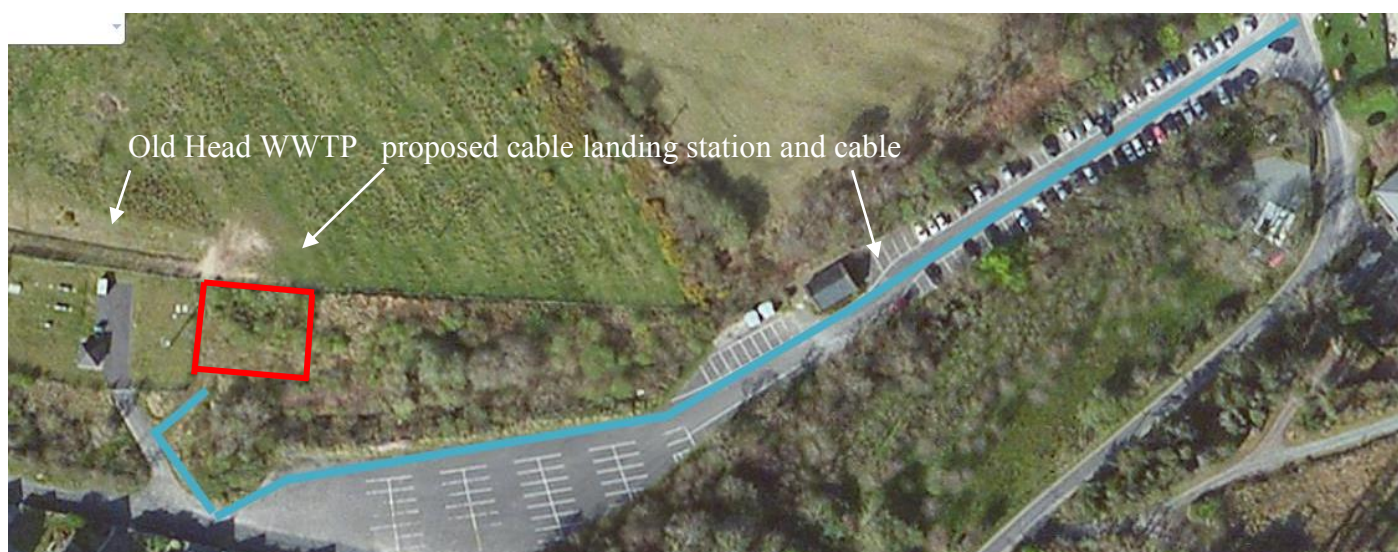
**Illus. 2 Aerial photograph of site under investigation, Oldhead townland, Louisburgh.**

The site under investigation comprises a small lowland area centrally located in the irregularly-shaped townland of Oldhead, to the north-west of a modern car park which leads from the public road to the east (Illus. 2). It is proposed that the cable will be excavated in a shallow trench leading westward through the car park, turning to the north to connect with the cable landing station site.

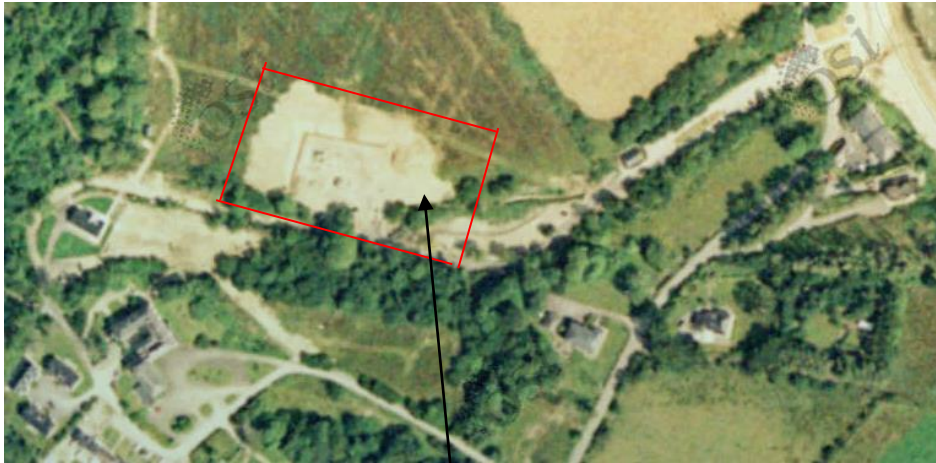
**Plate 7 Aerial photograph dating to 2000 showing groundworks associated with the construction of the Old Head WWTP.**

Due to uneven ground and dense vegetation, comprising trees, shrubs and ground trailing vegetation, the area to the east of the grassed pathway was not walked. The Old Head WWTP was constructed in 2000 and aerial photographs from that time show the plant during construction (Plate 7). The groundworks associated with the WWTP extended into the area of the proposed cable landing station site and it appears that topsoil stripping was undertaken over much of the area now proposed for development.

Area proposed for cable landing station
